CONDITION REPORT 2024

of
HOLBEACH CEMETERY CHAPELS

Date of inspection: 19th June 2024

**CONDITION REPORT: UPDATED 2024
HOLBEACH CEMETERY CHAPELS**

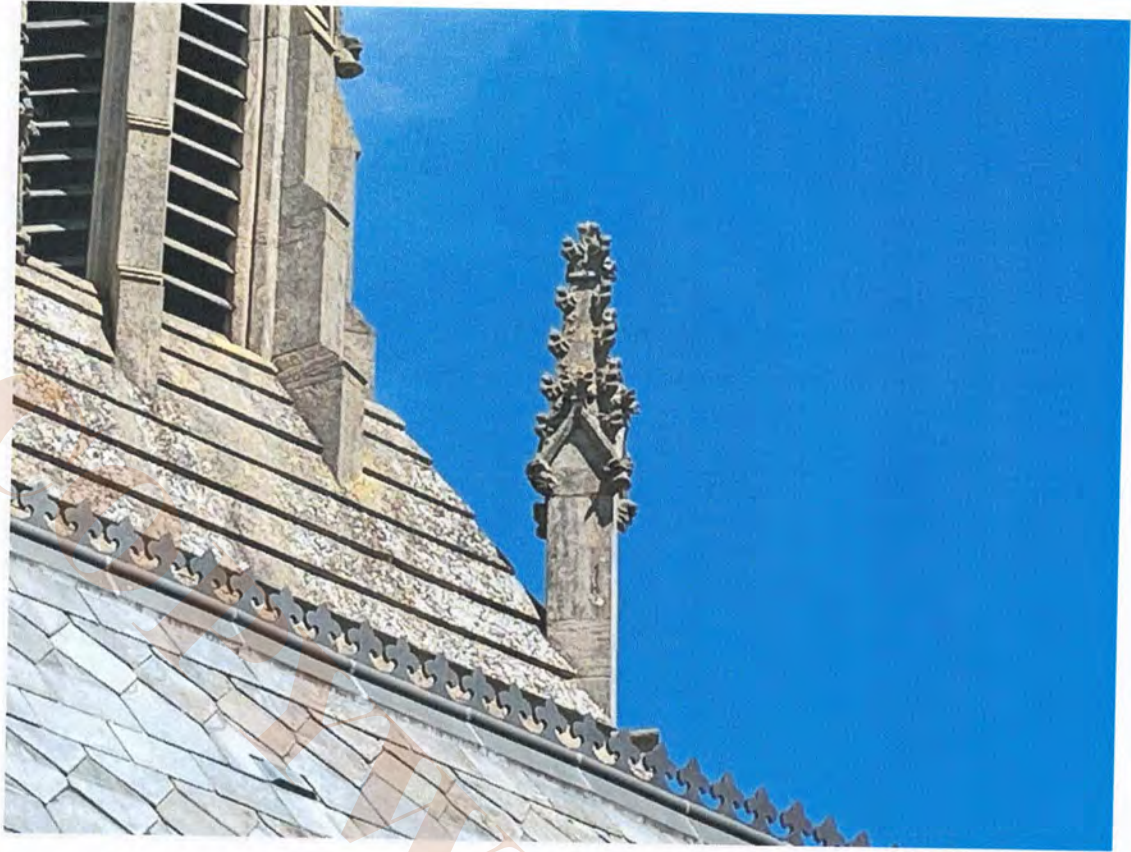
7.5 Octagon SSE buttress
7.7 south east pinnacle

7.5 The stonework of the octagon buttress stages is satisfactory. One stone in the SSE buttress lower slope has a marking which may be a crack, slate louvres are becoming thin seen from inside and some renewal with piece repairs of stonework is needed.

7.7 There are signs of cracking of an eroding bed in the south east pinnacle rectangular shaft. Check when scaffolding is in place, but assume that the top will need to be dismantled and rebuilt, renewing the rectangular section.

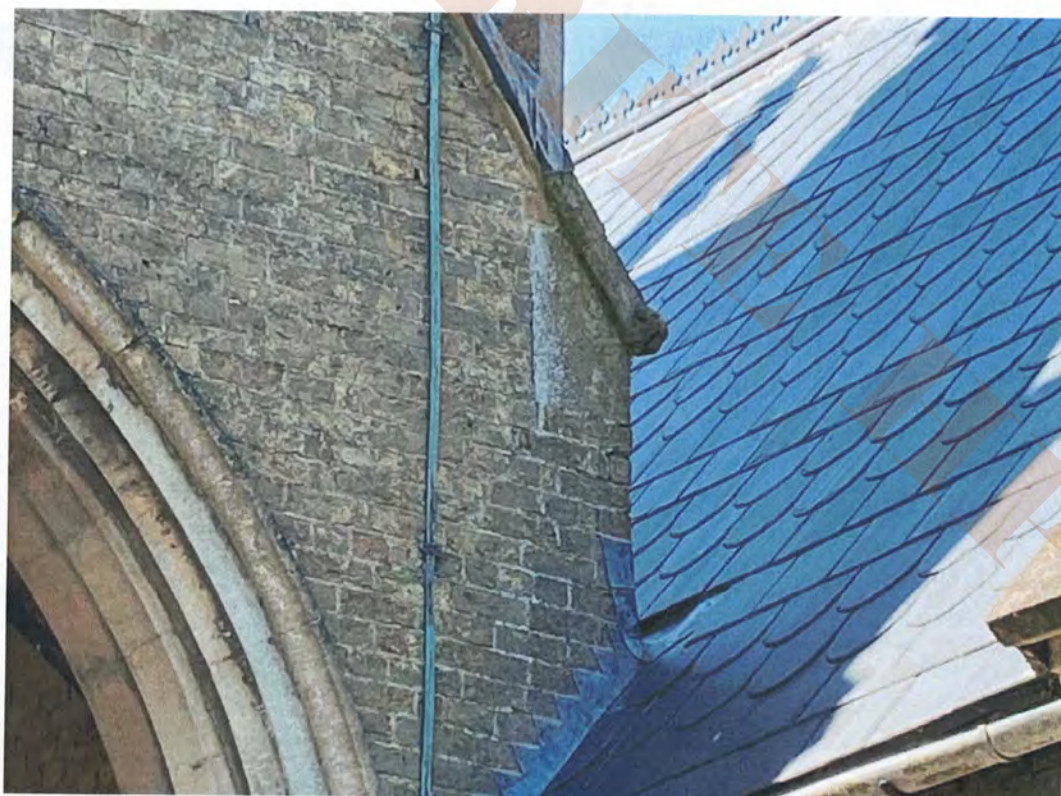
**8.5 East elevation cracking
8.7 kneeler**

8.5 The stone offset below is sound. Triangular brickwork panels below that are satisfactory. The stonework of the gable is satisfactory: there are lead flashings over the face and stepped flashings in the brickwork which appear satisfactory. Brick walling below this level down to chapel eaves is in fair condition: point minor movement cracks north and south of the arch and the horizontal joint which seems to relate to the buried ironwork.

8.7 The north east corner kneeler shows minor movement away from the walling and there is some small scale cracking below that suggesting a past movement. There is no obvious sign of movement in the fabric at the vault in this corner inside the carriage porch. Ordinarily this might be kept under review but if the building is to be put into a reliably sound state cut out defective bricks and fit tie bars or other restraining mechanism (movement also shows in the north wall face at the corner).

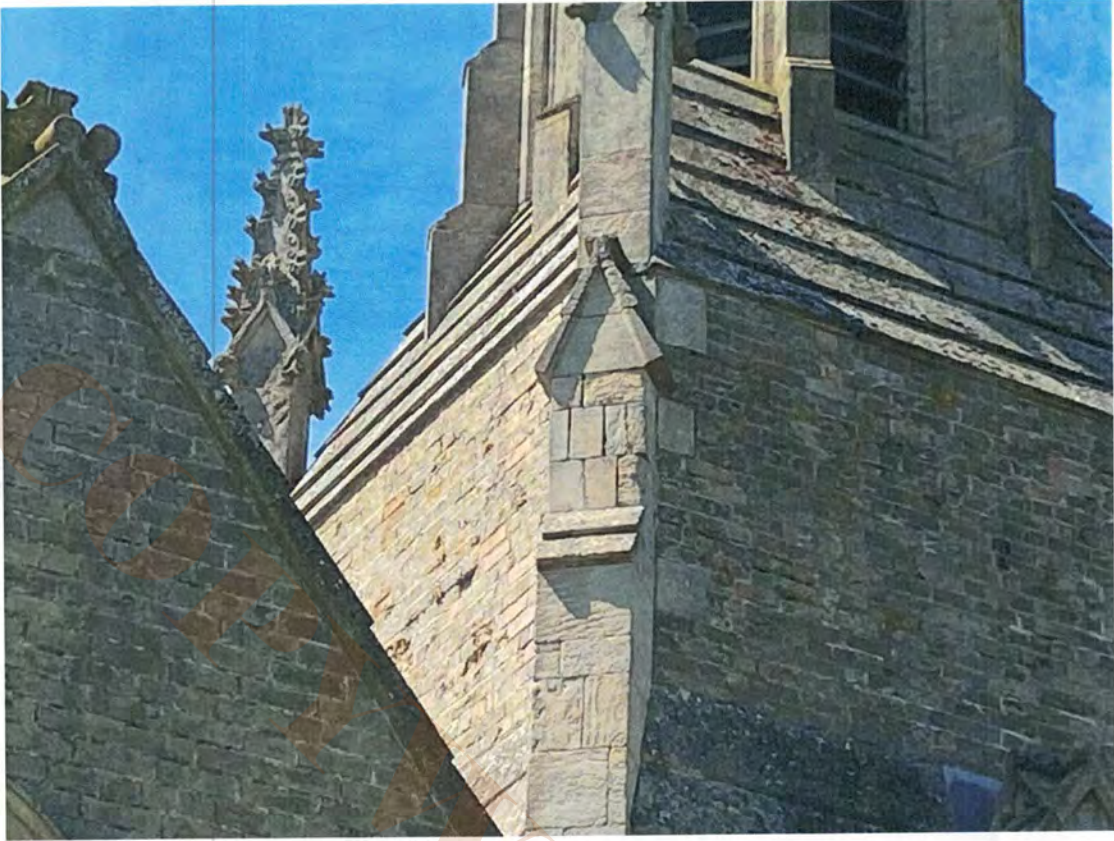
8.6 Tower south east buttress

8.6 The stonework of the north east buttress is satisfactory subject to the defects at the head noted above. The south east buttress requires pointing and one quoin in the top stage at the north east corner should be renewed.

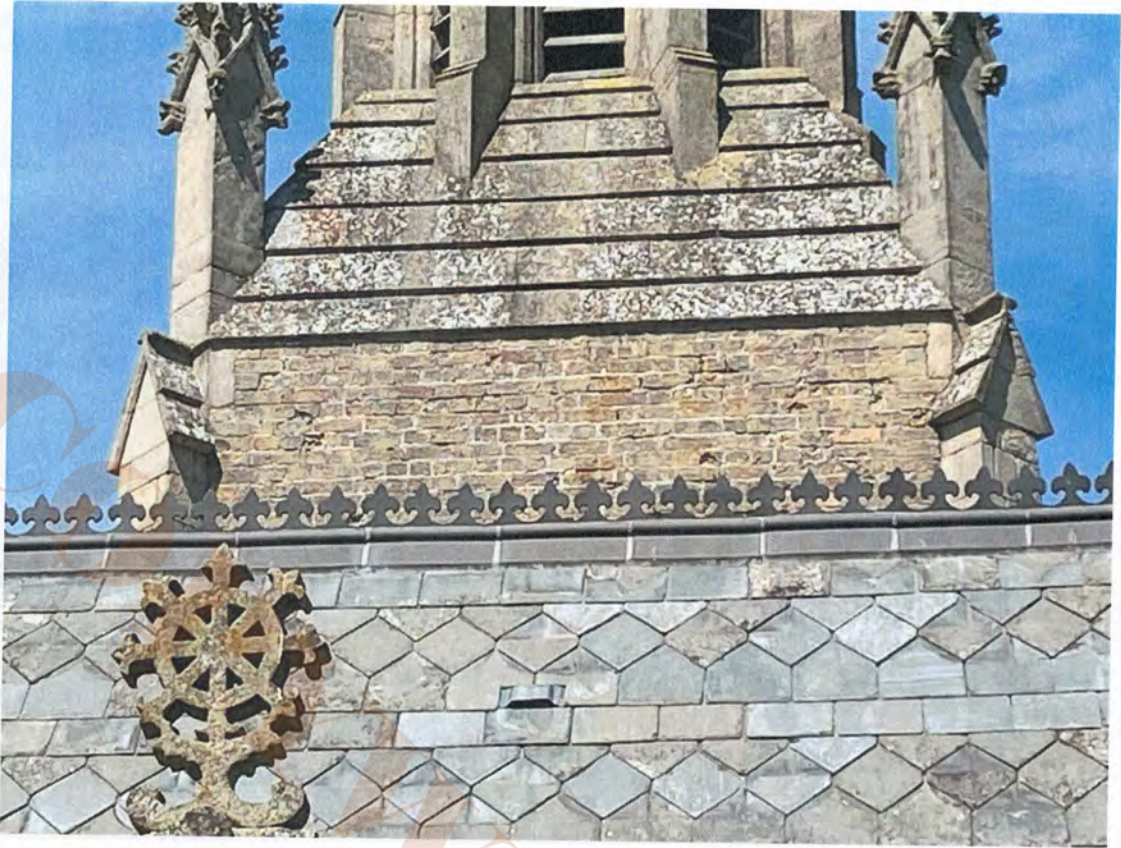
8.10 Tower south elevation seen over chapel roof

ITEM	B	
8.9	The panel on the south side is satisfactory.			
8.10	Tower south elevation: the brickwork where visible from ground level, (the south chapel roof obscures view) is in fair order. There is spalling of bricks in places. Minor pointing is required to some joints together with the removal of plant growth, renew approx. 50 bricks.

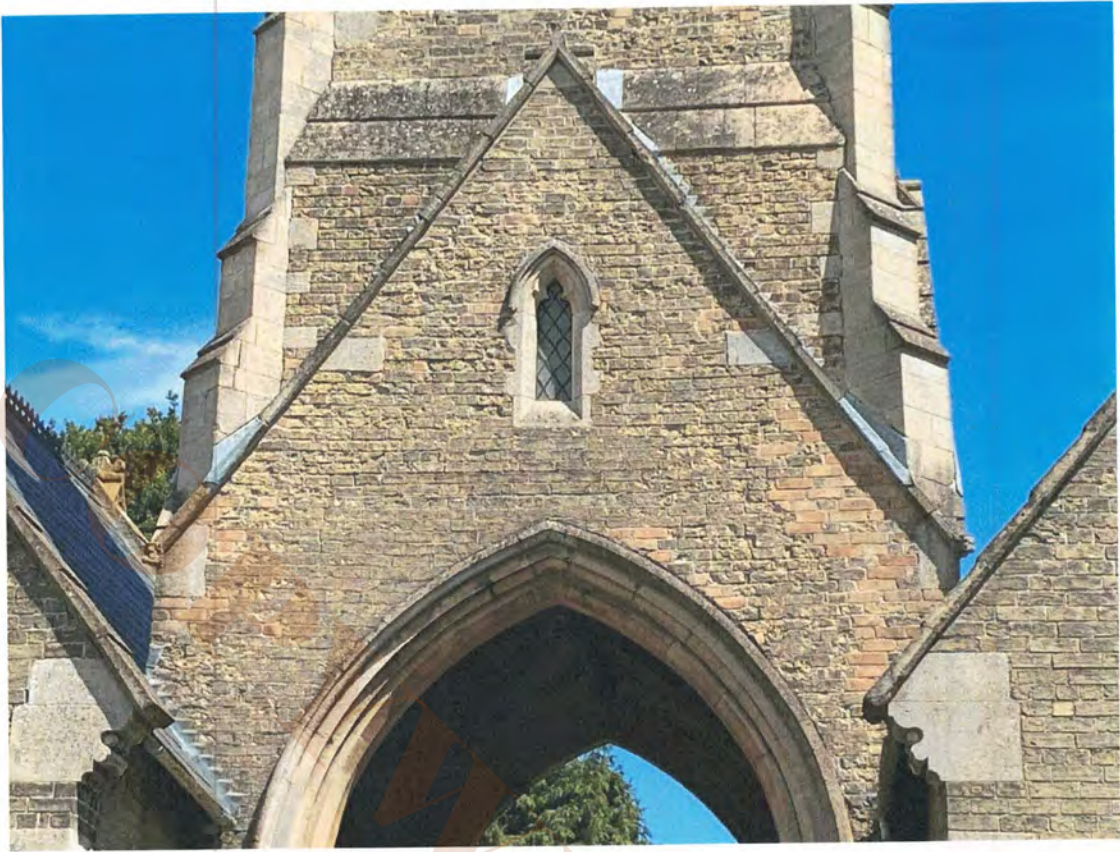
8.14 West elevation

ITEM	B	
8.14	The stone coping of the gable and the lead flashings are sound. The brickwork of the gable is in fair order: there is occasional spalling of bricks. There is hairline cracking on the northern side above the carriage porch north jamb. There are no obvious signs of movement internally at this point. Ordinarily this might be kept under longer term review but to achieve reliably sound fabric as part of a major repair project, stitch across the brick joints with associated pointing.

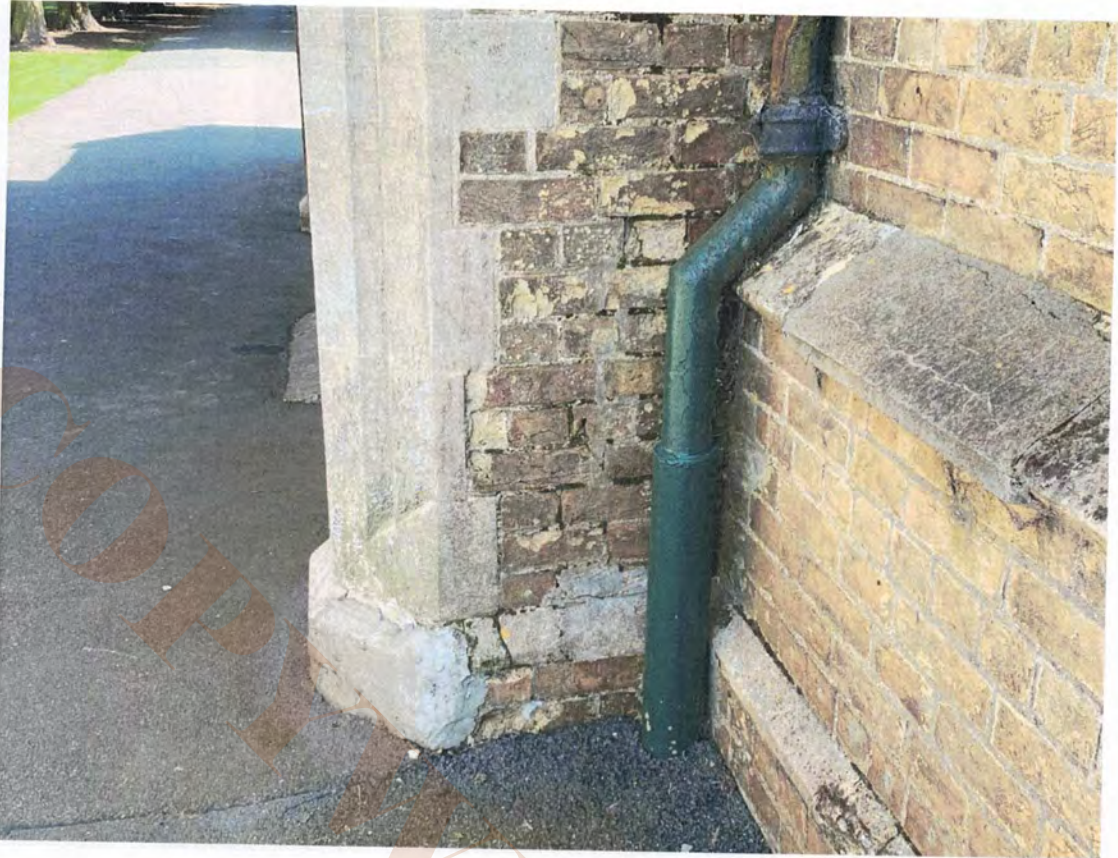
8.16 West elevation south pier

8.16 The brickwork on the west face from chapel eaves level down to ground has spalled in places, possibly due to the later cement rich mortar pointing. Minor brick renewals/pointing are needed at the base where bricks have failed on the north and south piers.

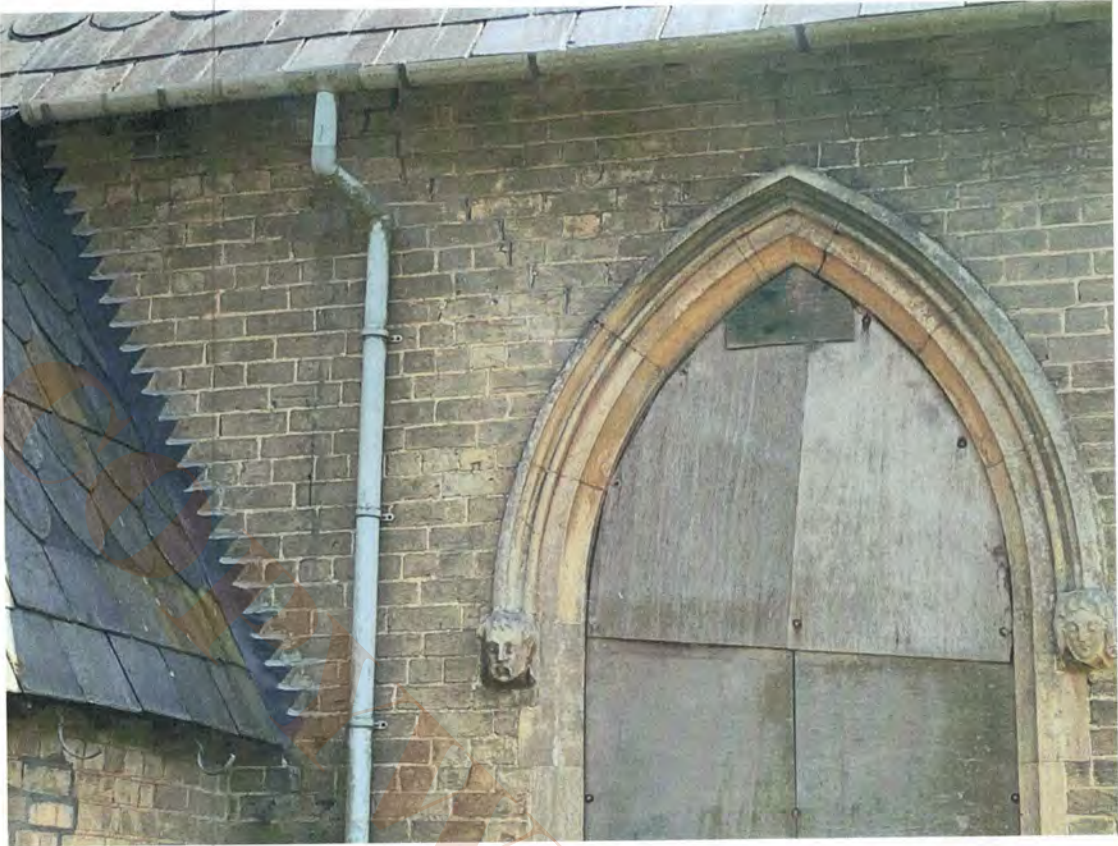
8.19 North chapel north elevation west of porch

8.19 **North elevation west of porch:** the brick surfaces and the stone offsets are generally satisfactory but there has been past movement above/to the east of the window opening. This has been pointed in the past in cement mortar which has cracked. Cut out and repoint in lime mortar.

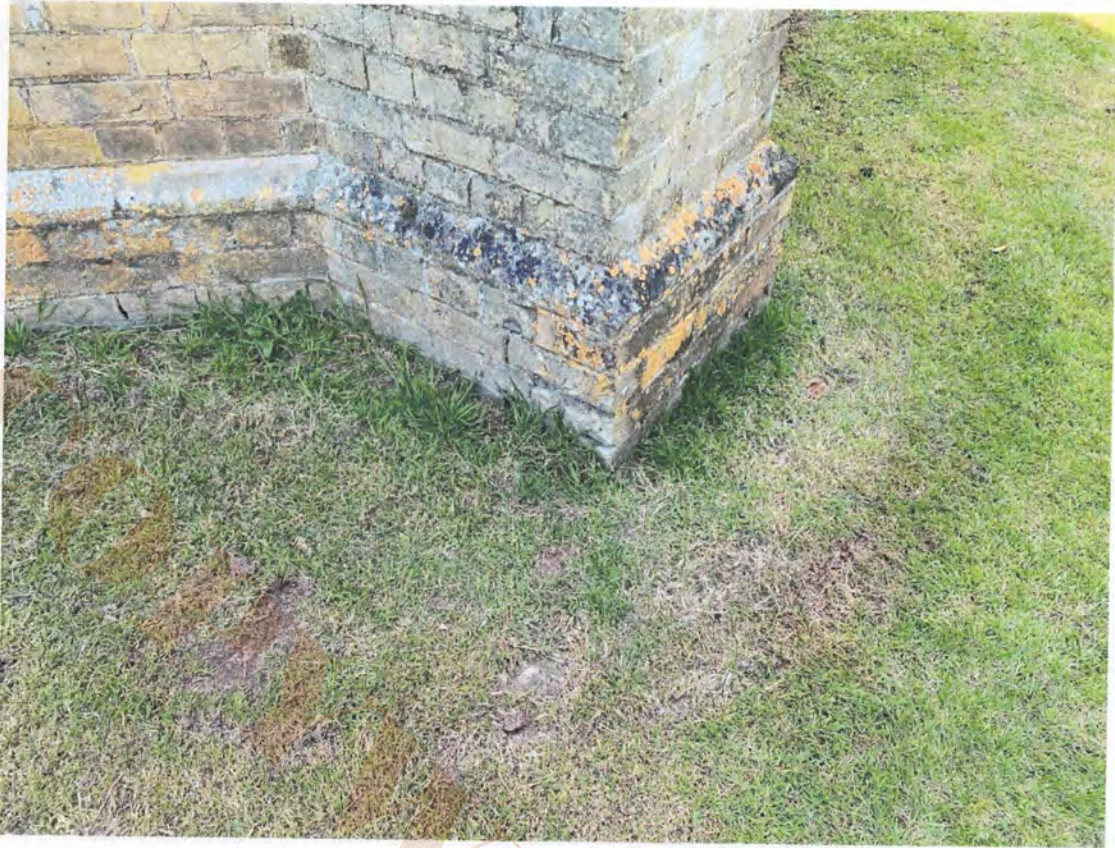
8.20 North elevation north east buttress

8.20 **East elevation:** the gable stonework is satisfactory; the apex detail suggests there may have been a cross here in the past but this is no longer extant. The brickwork including the two angle buttresses is generally sound. There has been minor spalling in places due probably to later cement based mortars. None of the spalling has a structural implication at this stage but one brick on the east elevation below the window south jamb should be cut out and renewed and there is some pointing needed to the east corner of the north east buttress and to the south east at plinth level (with brick renewals).

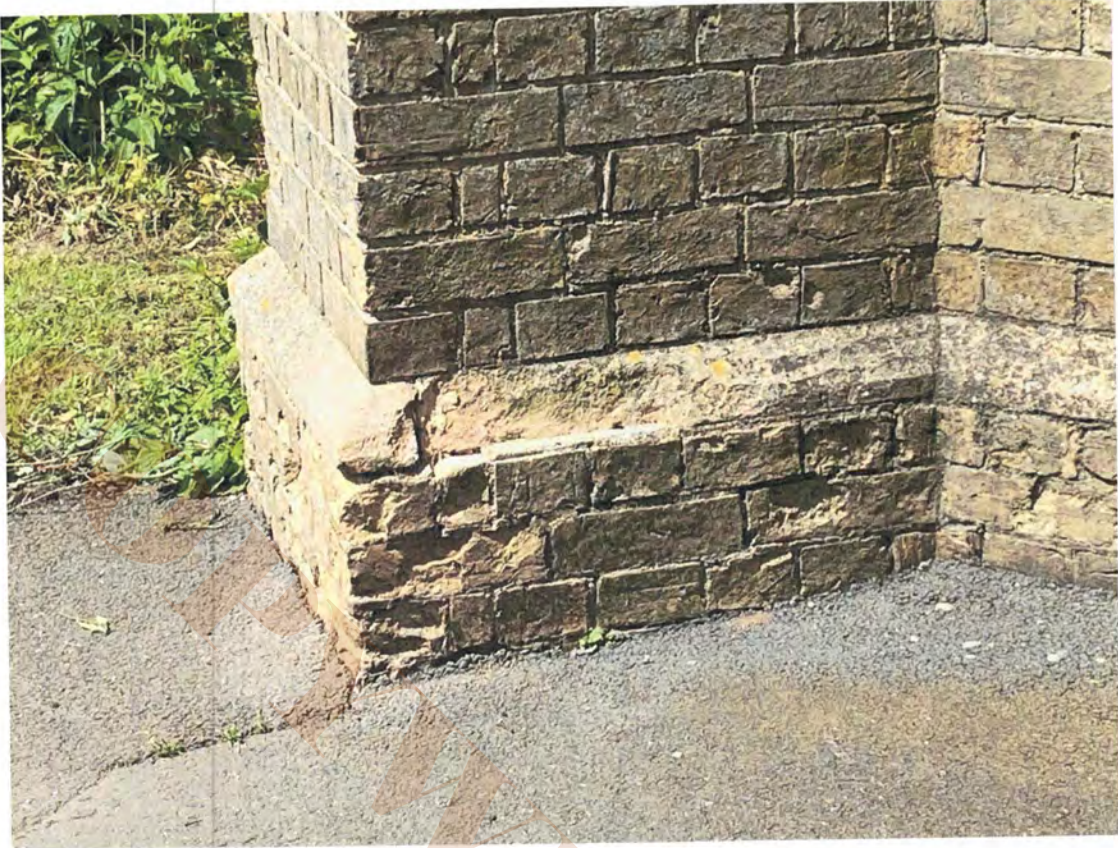
8.24 North chapel south west buttress

ITEM	B	
8.24	South elevation west of tower: stonework of the cill level offset and the plinth is satisfactory apart from minor spalling. Brick surfaces are generally sound: there is minor spalling at plinth level. Renew one length of plinth offset stone on the south west buttress south east face.

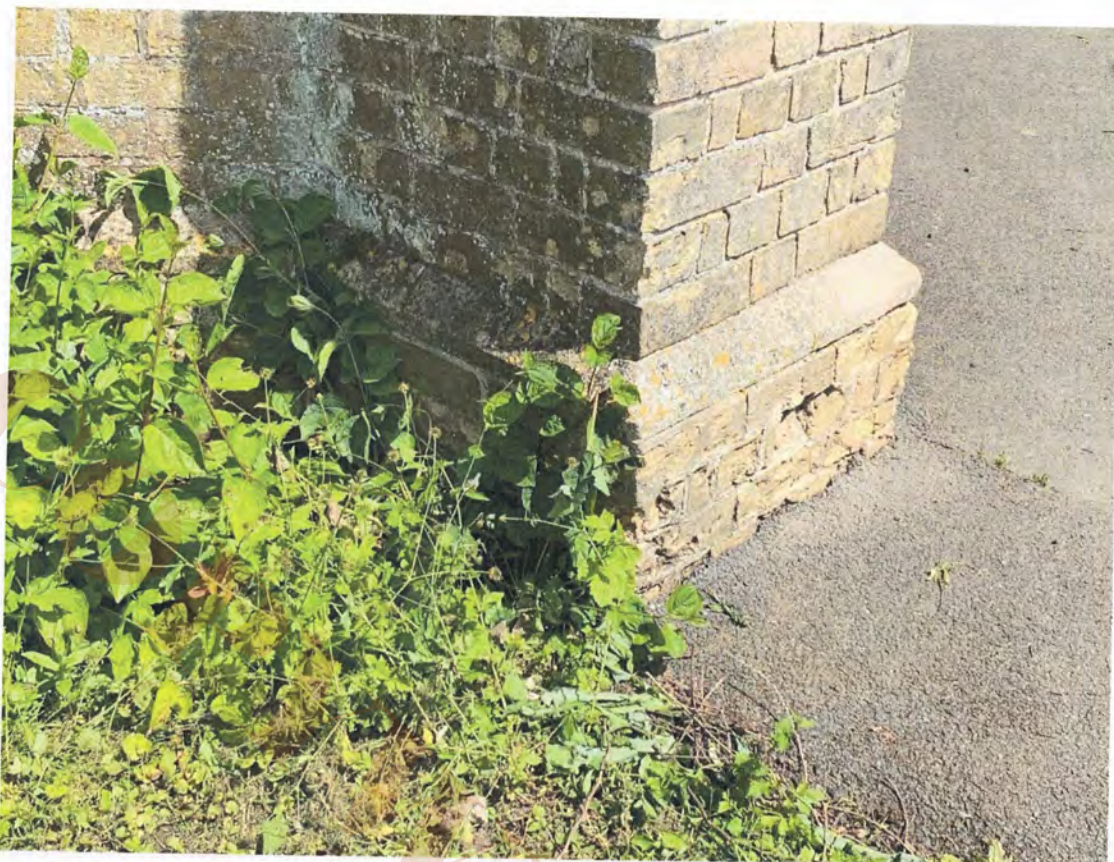
8.27 North chapel south west buttress

ITEM	B	
8.27	North chapel west elevation: the stone gable coping is satisfactory. The decorative element to the apex has again been lost. Brickwork is in reasonable order generally: there has been some spalling of the plinth stages of the two angle buttresses. Planting beds obscure much of the west elevation below plinth level and a detailed comment is not possible at that point, but some pointing is obviously needed including refacing the south west buttress plinth.

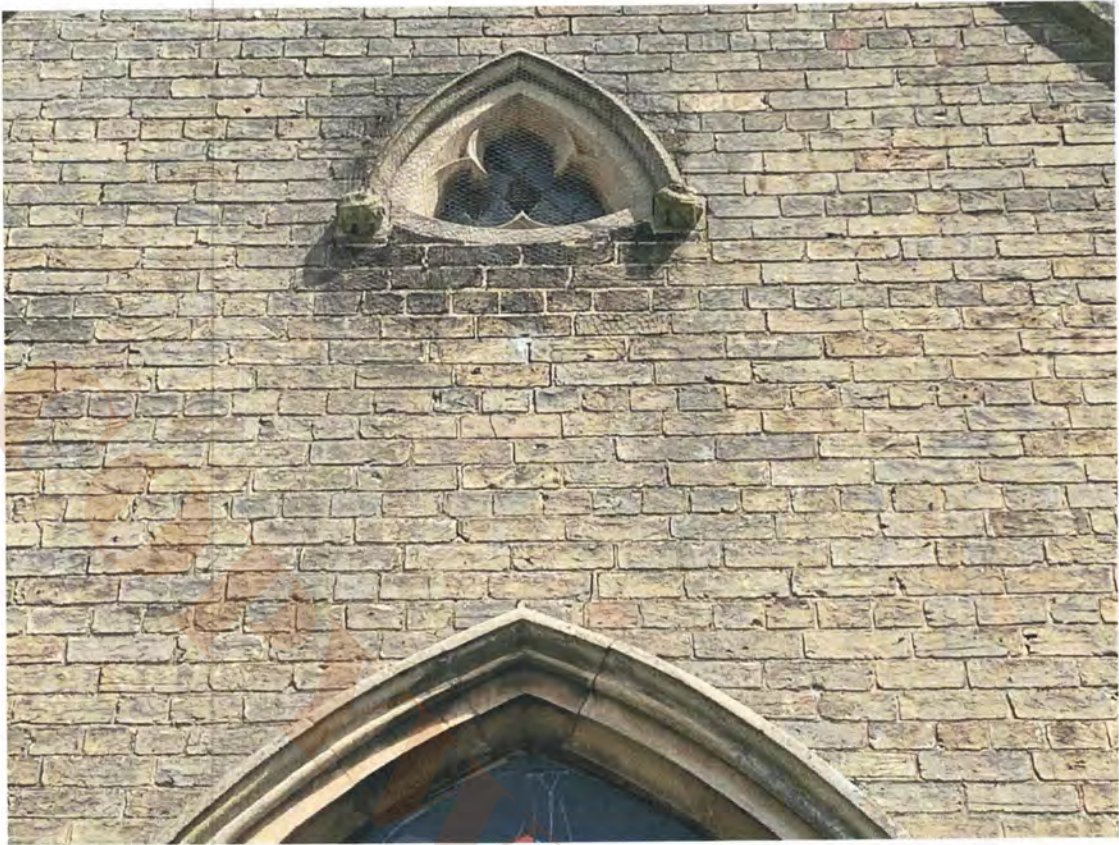
8.28 North chapel west elevation

ITEM	B	
8.28	There has been some movement between the lower window head and the upper trefoil opening. This does not extend into the walling above: rake out and point. Point up the gap between the brickwork and the south west gable kneeler stonework and the small amount of cracking above in association.

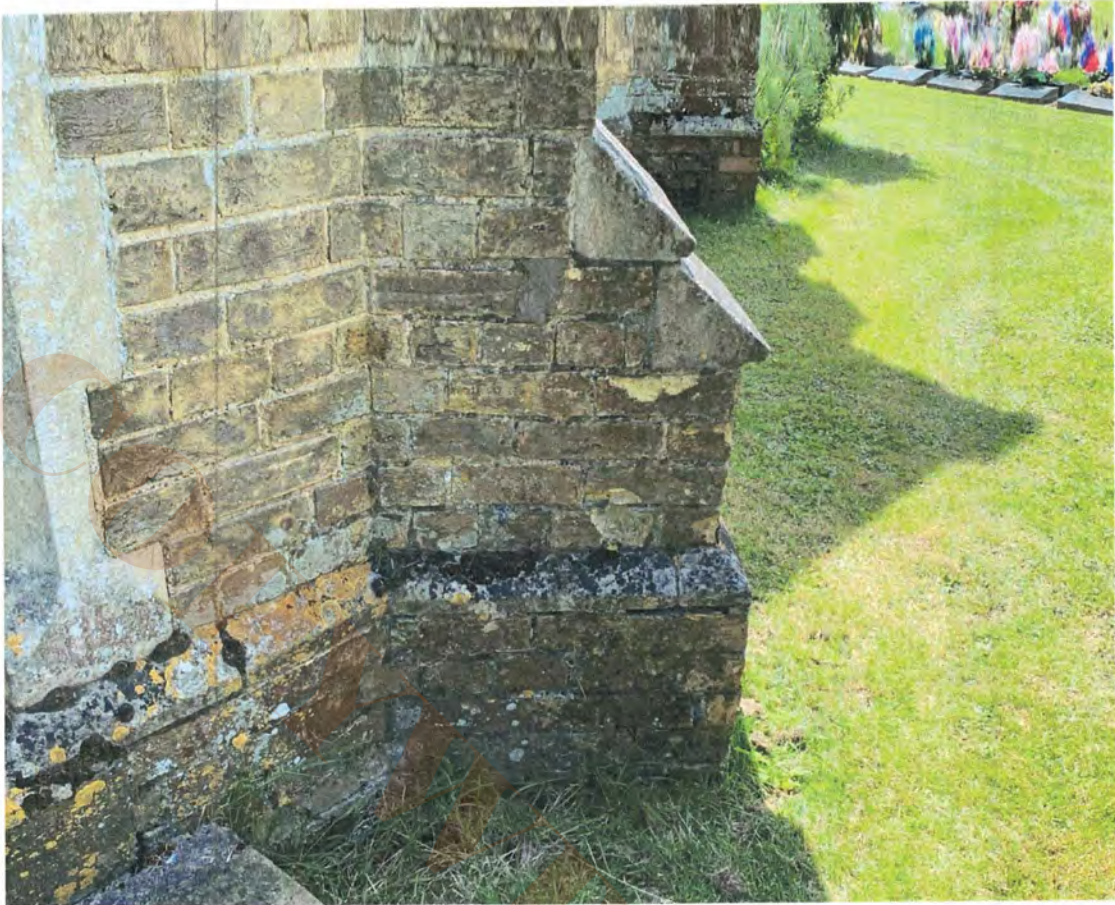
8.33 North porch north west buttress

8.33 The brickwork is generally satisfactory including the two angle buttresses although a small patch of crude cement mortar repair on the north east face of the north west buttress and some pointing in cement mortar on the north east face of the north west buttress should be cut out/pointed to preserve the adjacent fabric, together with renewing decaying bricks.

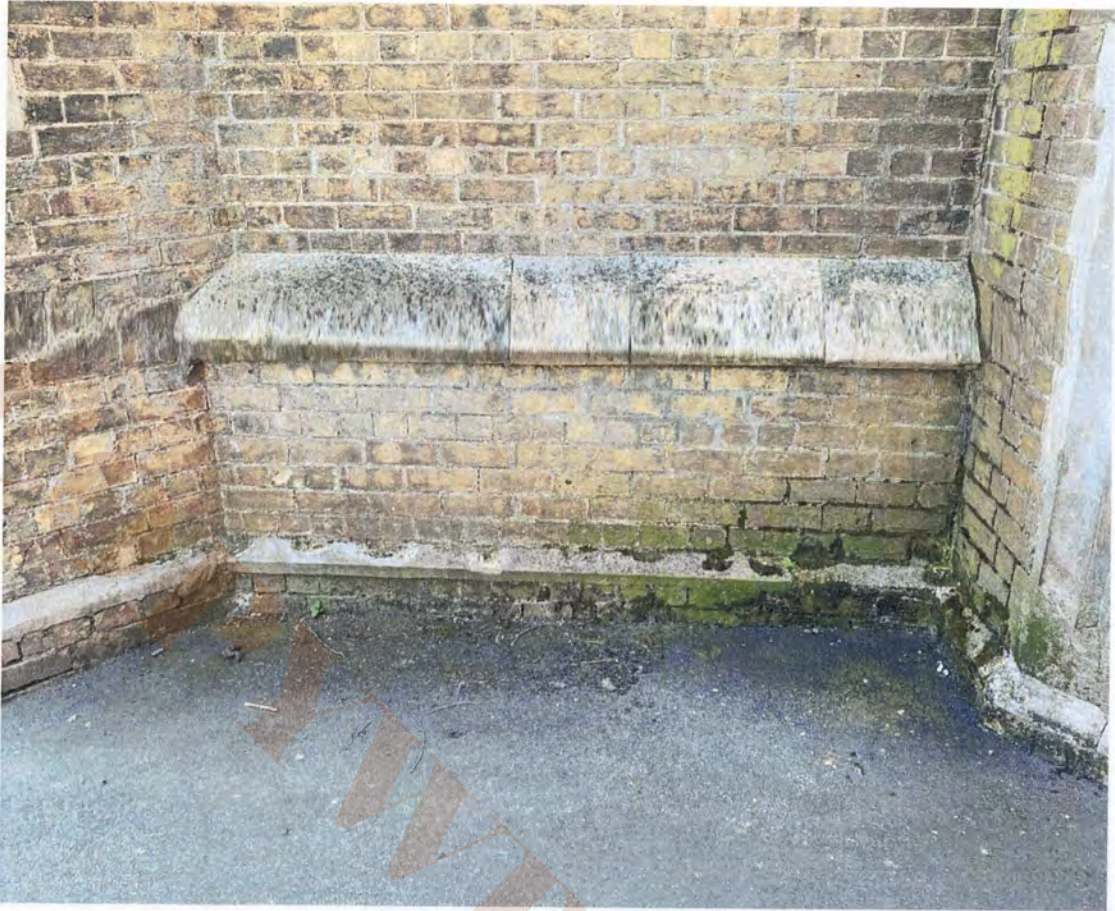
8.36 South chapel north elevation east of tower

8.36 **South chapel north elevation east of tower:** the brickwork and the cill level offset stonework are generally satisfactory. Stonework of the plinth offset has been rendered up at some stage and this is slowly failing. This should be renewed.

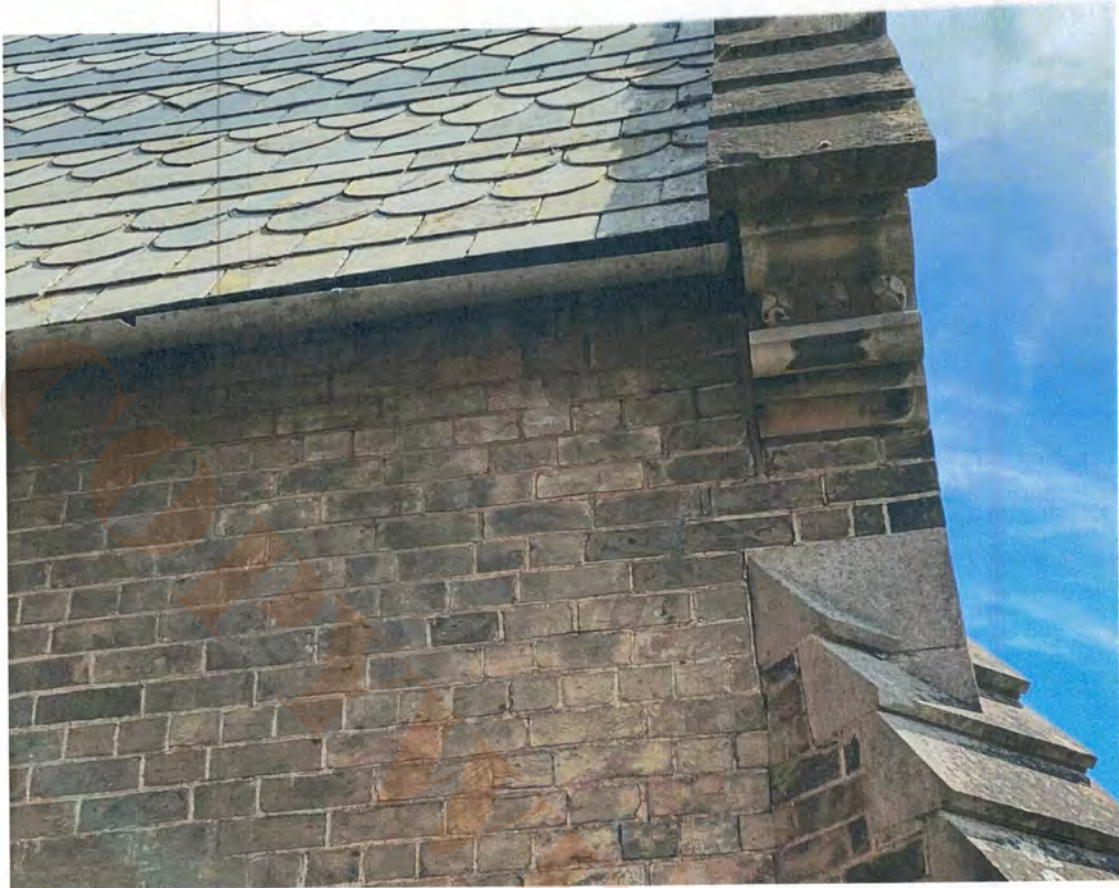
8.38 South chapel north elevation west of tower

PRIORITY	BUDGET	COSTS
		B/FWD		
8.38	South chapel north elevation west of tower: the brickwork is in fair order. There is minor spalling at low level. There are small signs of past movement at the upper west corner: rake out and point.

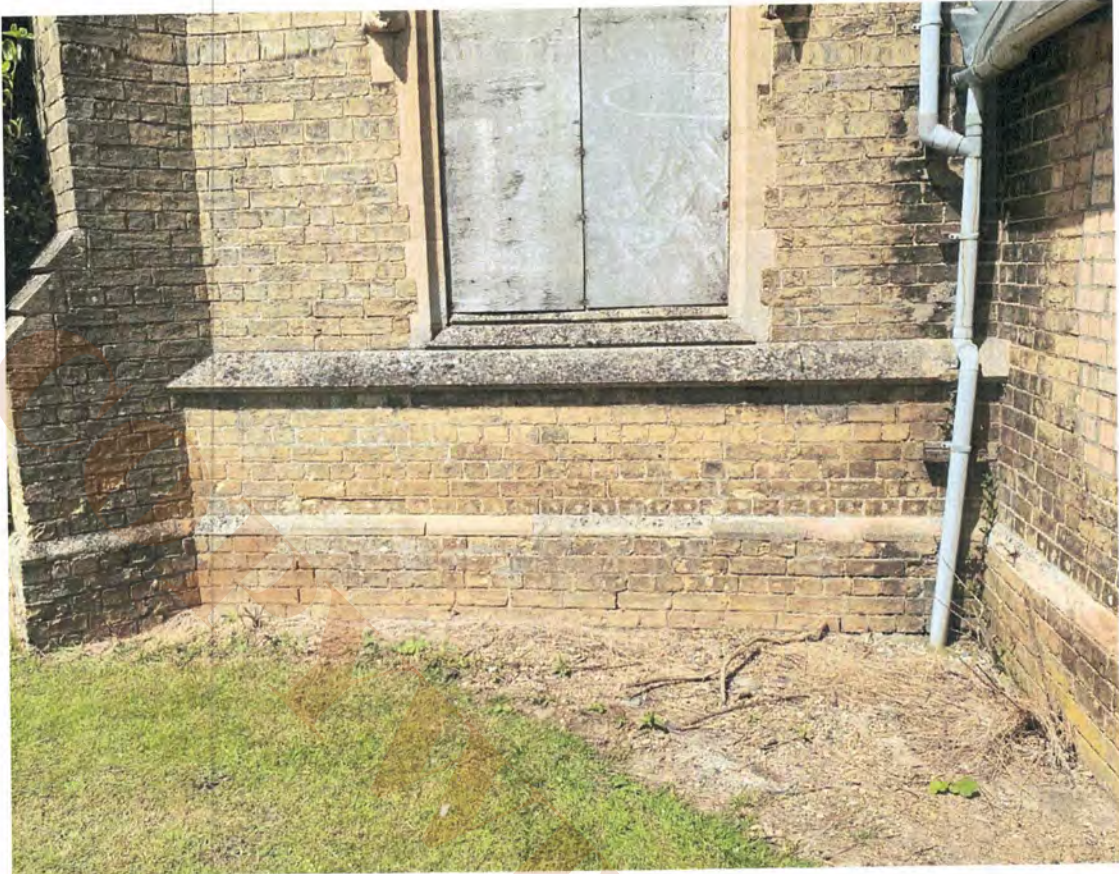
8.51 South chapel west elevation

PRIORITY	BUDGET	COSTS
8.51	South chapel west elevation: the stone coping is generally satisfactory: again the apex detail has been lost. There has been some delamination in one place on the north face but the stone here is covered with lichen/dirt similar to elsewhere and there was no ongoing erosion (noted in 2020). Brickwork above window cill level is satisfactory apart from minor cracking above the lower window head: rake out and point.	B/FWD

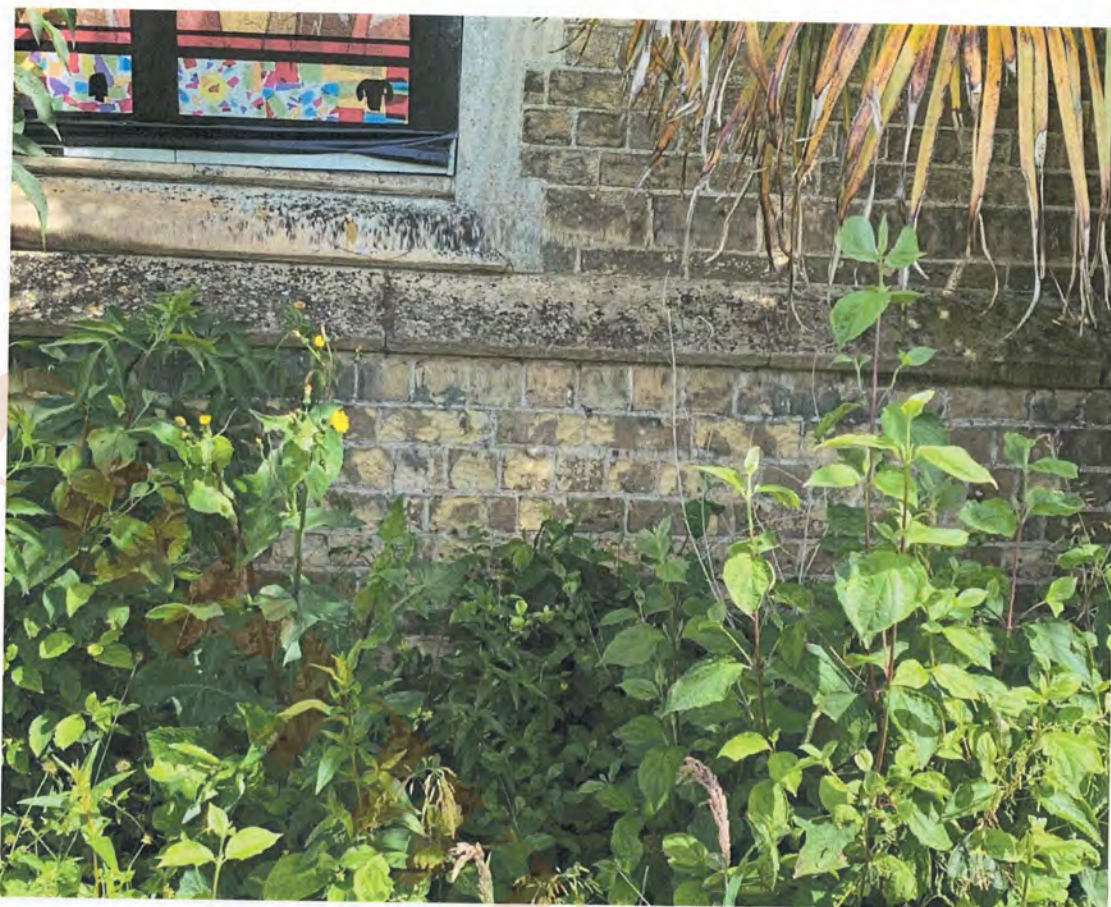
8.52 South chapel west elevation

8.52	Brickwork below the window cill level is partly obscured by plants. It can be seen that a damp proof course has been injected above the plinth and there is a substantial amount of cement pointing which has caused loss of some of the brick faces. For the better preservation of the building rake out and repoint here although this will bring forward the renewal of a substantial number of bricks.	ITEM B

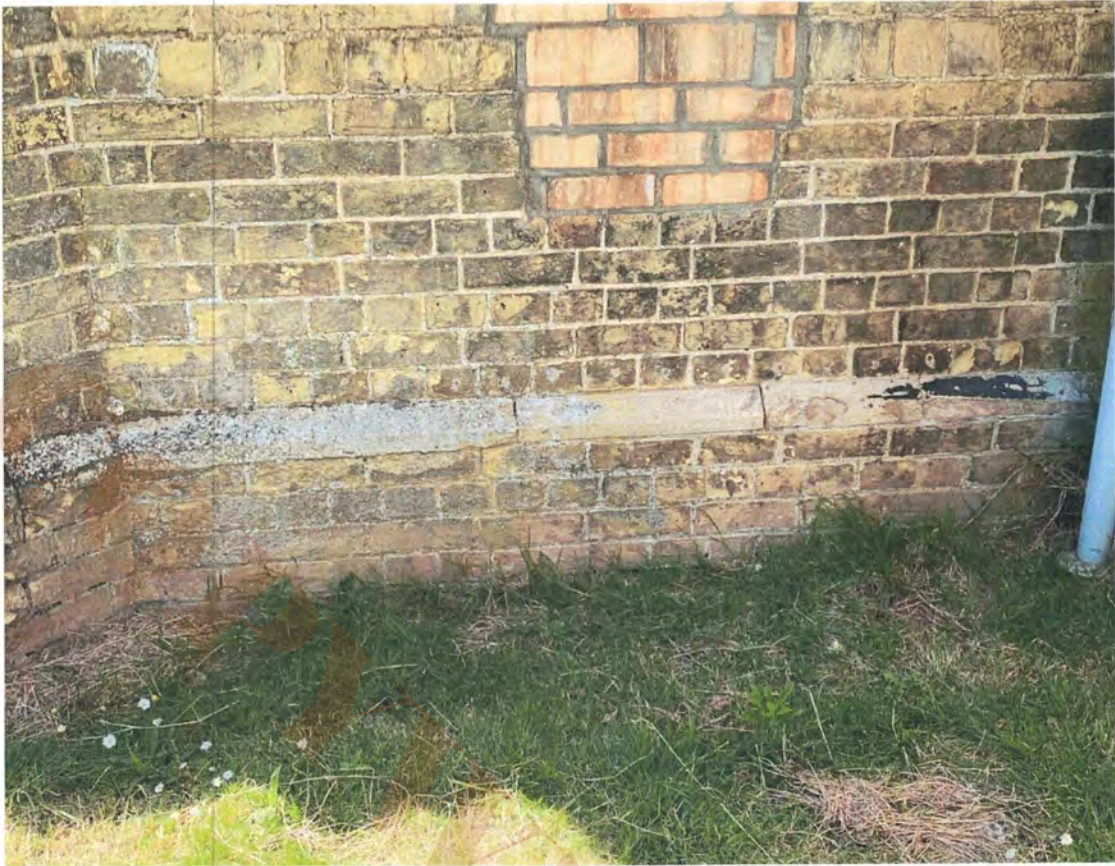
8.54 south porch east elevation

8.54	South porch east elevation: brickwork is in fair order: there has been a damp proof course injected above the plinth offset. There is minor spalling above and below the plinth offset. The stonework of the offset is failing in the northern part: the southern part appears to be made out of render? In the northern part this is now eroding back beyond the front edge of the brickwork and should be renewed.	ITEM B

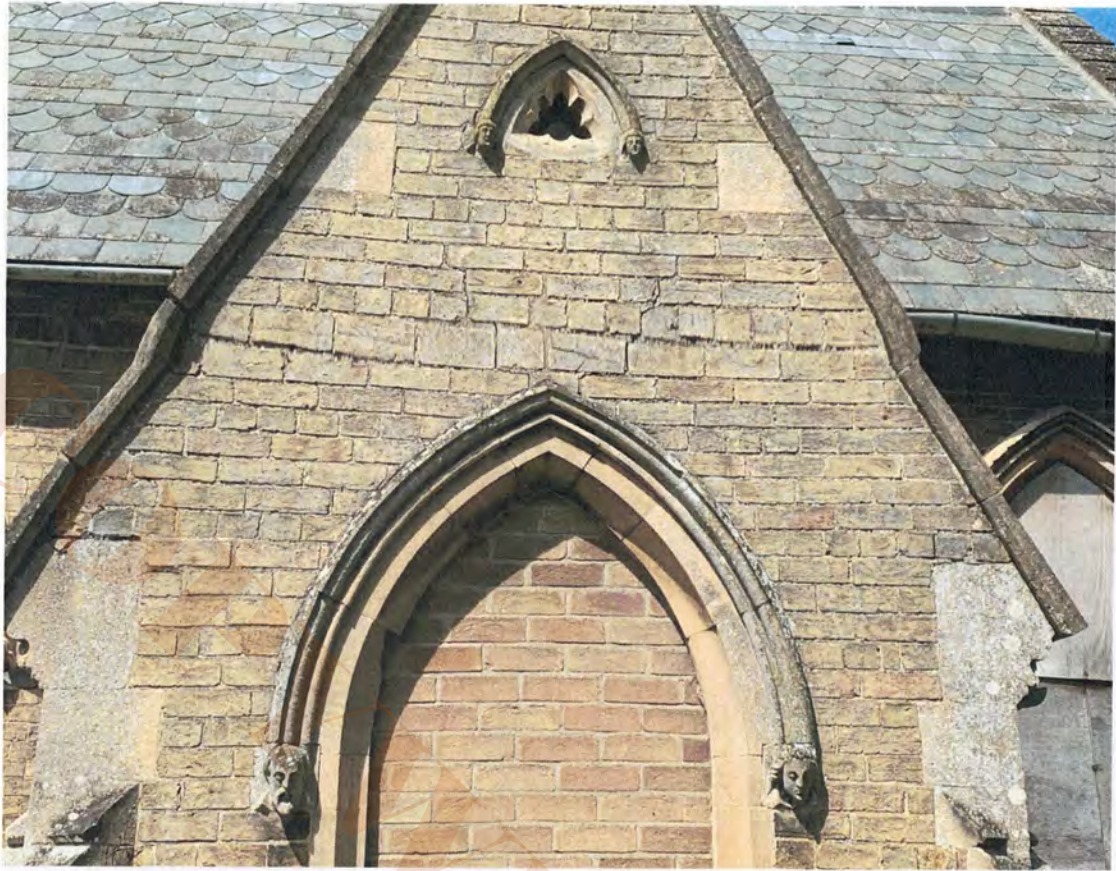
8.56 South porch south elevation

PRIORITY	BUDGET	COSTS
		B/FWD		
8.56	The brickwork to the south elevation generally is in fair order: rake out and point up movement cracking above the door head and adjacent to the buttress.

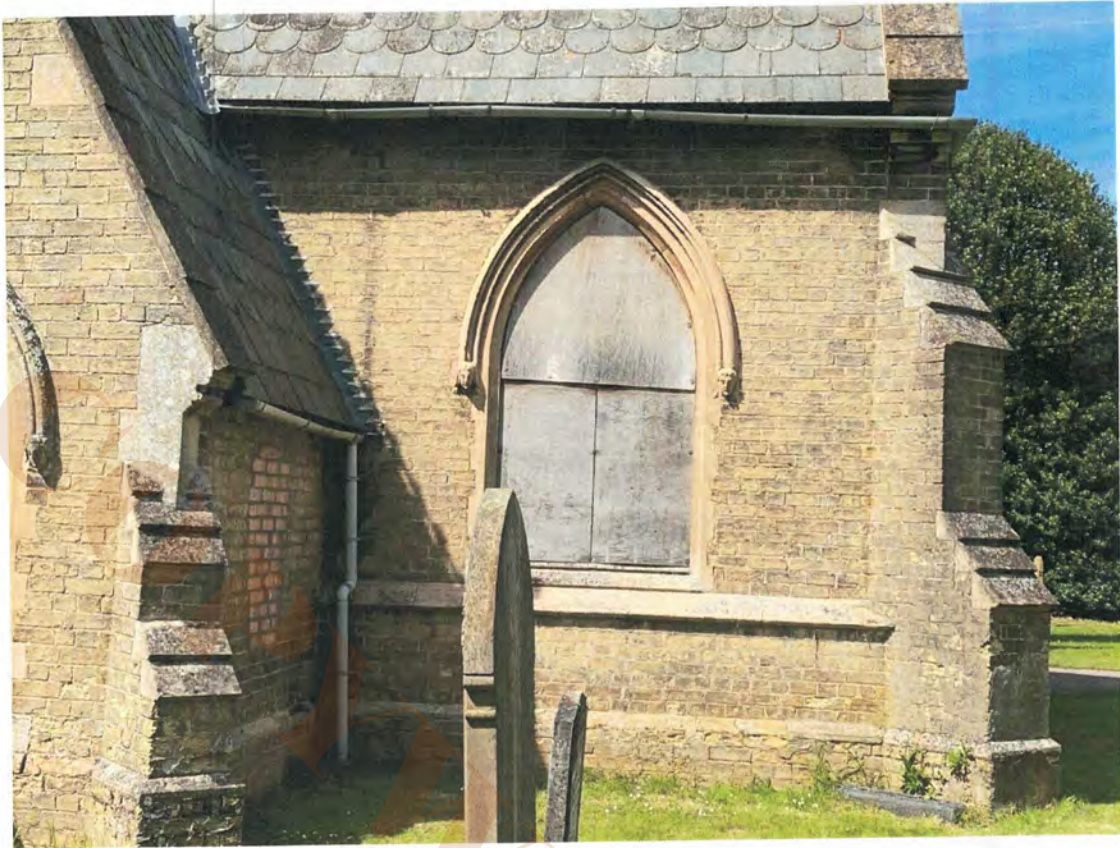
10.10 south chapel south rainwater goods east of porch

10.10 **South chapel south east eaves:** grey uPVC gutter returning around the east elevation as noted above. Renew in durable materials in association with window work, provide new rainwater pipe in this drain adjacent to porch.
