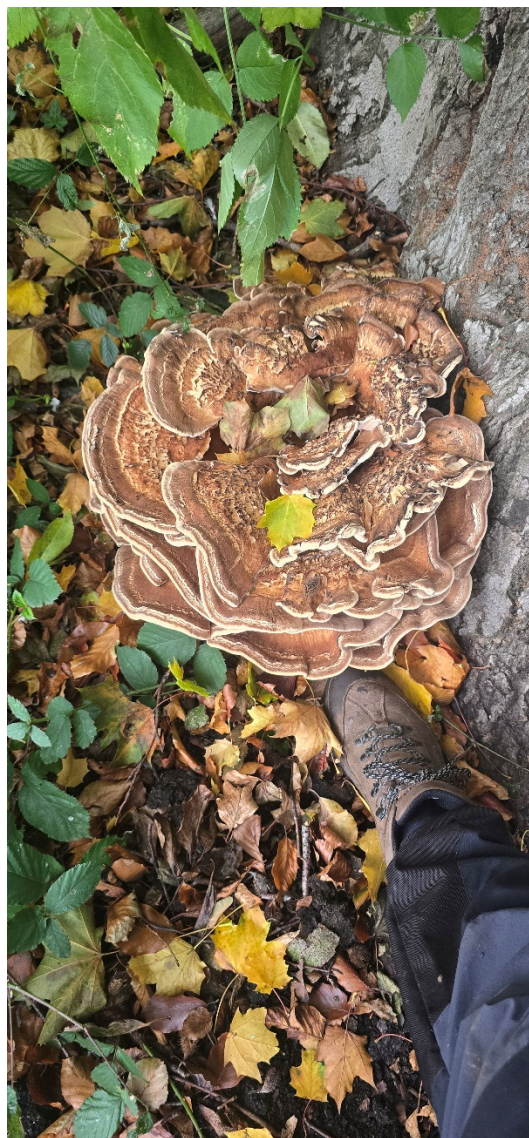
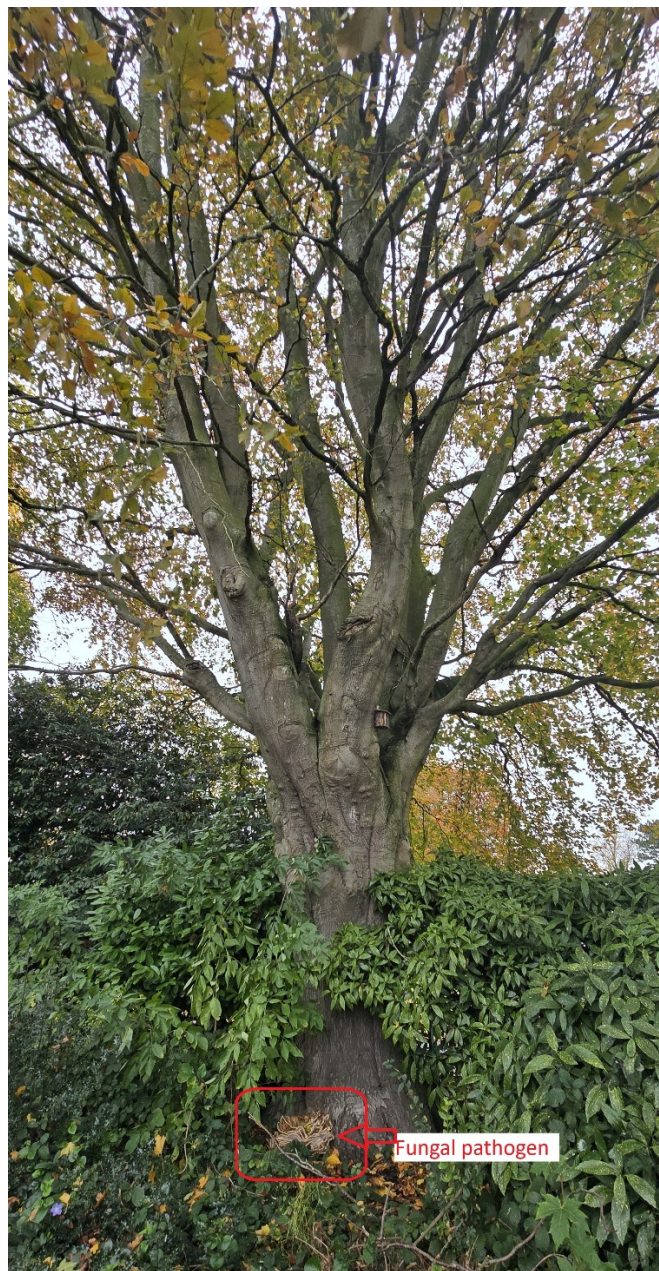
There is a large fungal pathogen, *Meripilus giganteus* at the base.

Meripilus giganteus is a fungus that causes root decay in mature broadleaf trees, especially Beech. It often enters through damaged roots and spreads throughout the main root system and into the lower trunk.

As Beech trees age, their central tap root becomes less active and more vulnerable to infection. This allows the fungus to create decay beneath the stem. When decay spreads slowly, the tree may adapt by strengthening its root buttresses to maintain stability. However, if decay progresses rapidly, particularly on the underside of the roots, the tree may fail structurally before it can adapt.

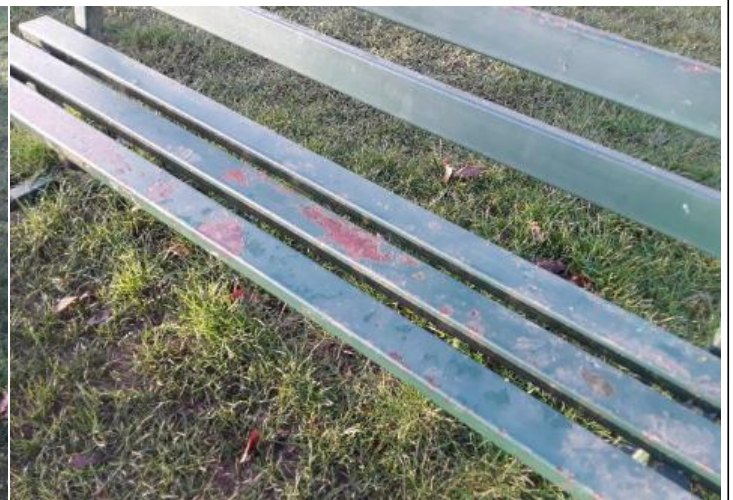
Finding: The paintwork on this item has been damaged or worn exposing the metal underneath which is rusting / corroding
Action: Treat affected areas and repaint

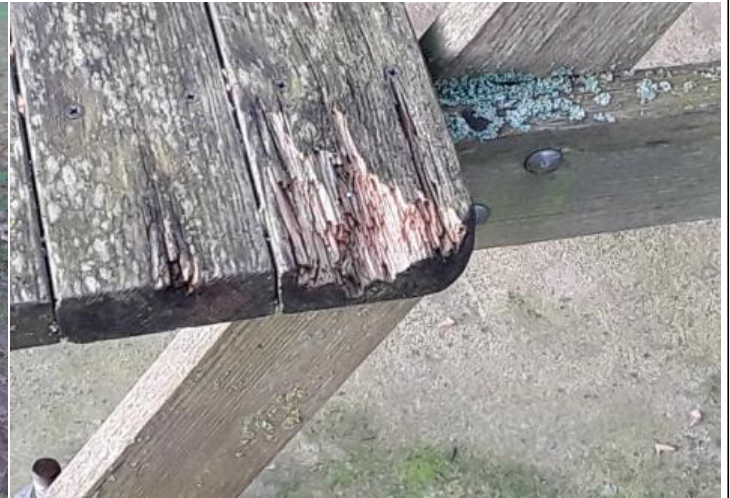
Finding: There is minor rot in the timber

Action: Monitor for any further deterioration and replace as required

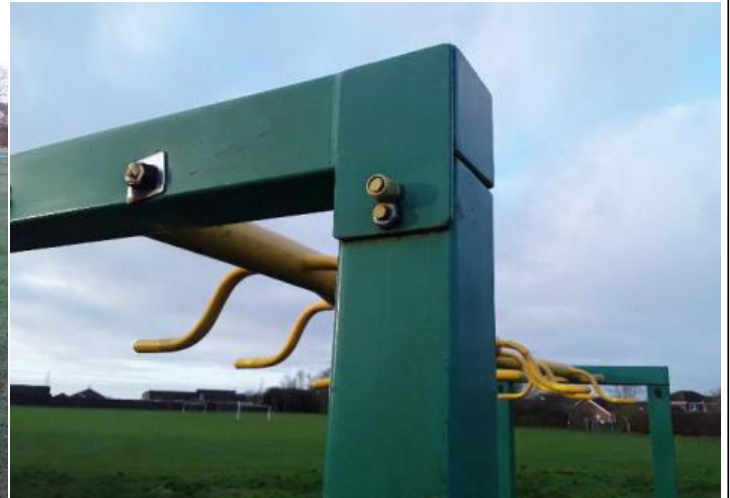
Finding: There is/are bolt cap covers missing or damaged on the item

Action: Replace missing or damaged bolt cap covers

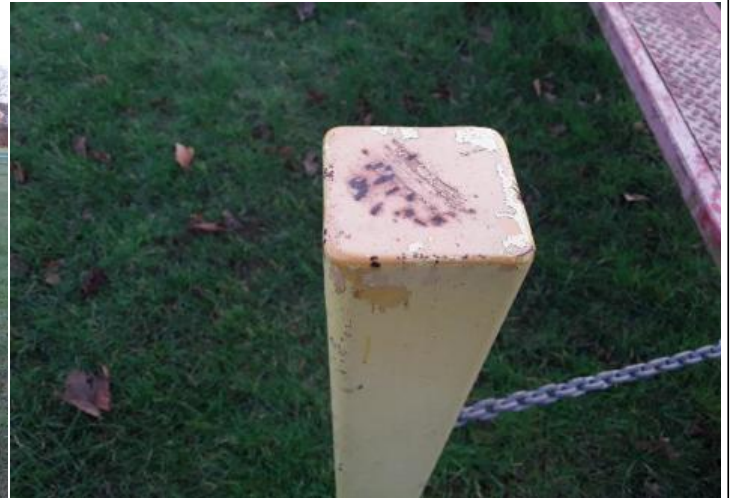
Finding: The paintwork on this item has been damaged or worn exposing the metal underneath which is rusting / corroding

Action: Treat affected areas and repaint

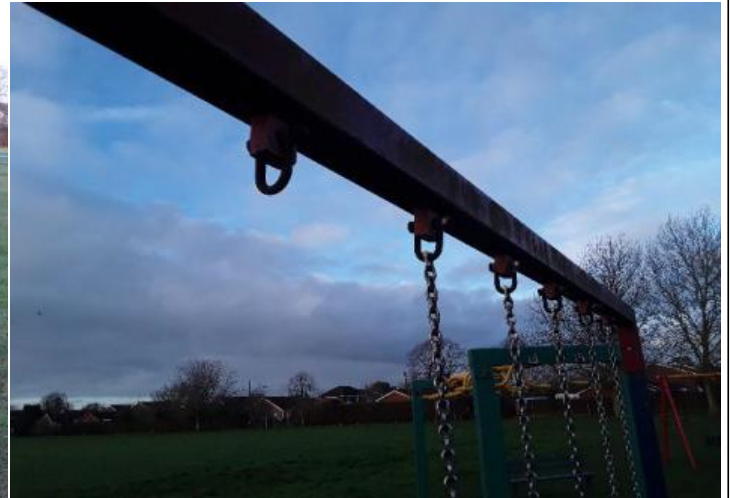
Finding: The item has a missing grab chain

Action: Replace the missing chain

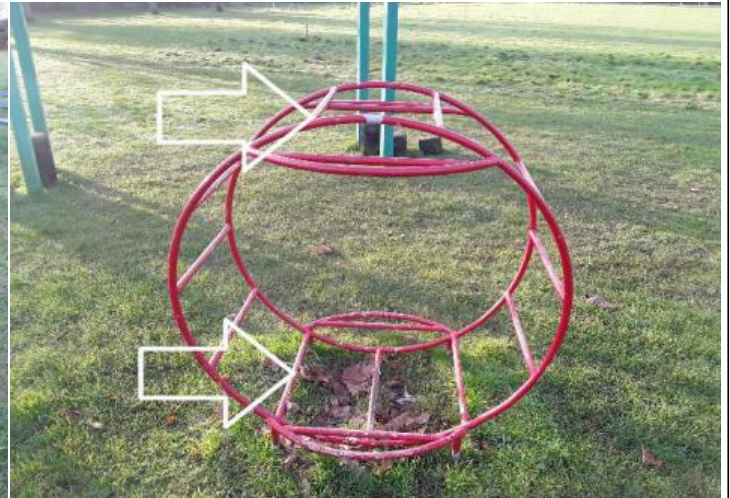
Finding: There are falls in excess of 600mm between adjacent components on the structure, in contravention of the recommendations set out in BS EN 1176 Part 1; 4.2.8.4

Action: Monitor - No action given the risk assessment

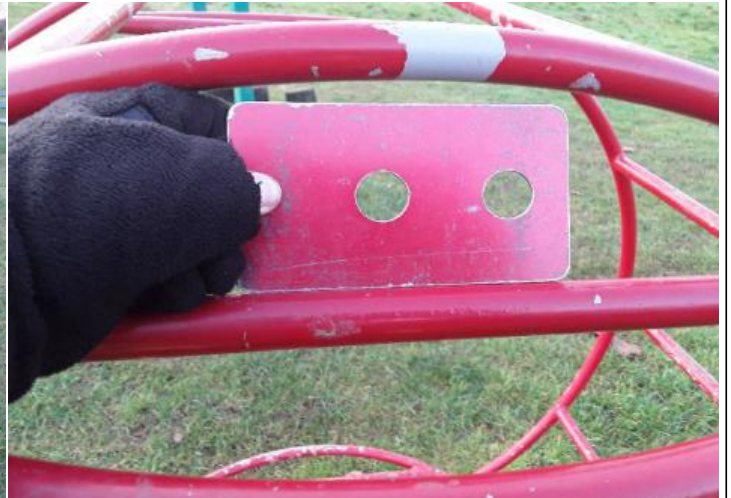
Finding: The item fails to meet the requirements of BS EN 1176 Part 1 4.2.7.2 for head and neck entrapment in the framework

Action: Monitor - No action given the risk assessment

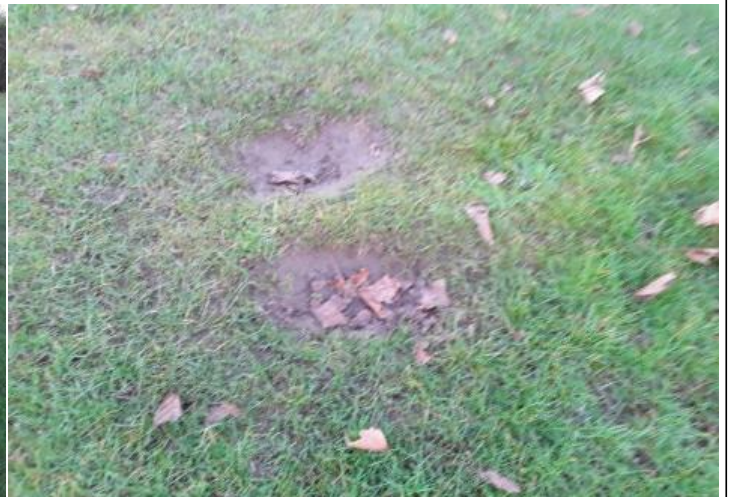
Finding: The area around the item has eroded creating trip hazards and may become slippery when wet

Action: Reinstate eroded area

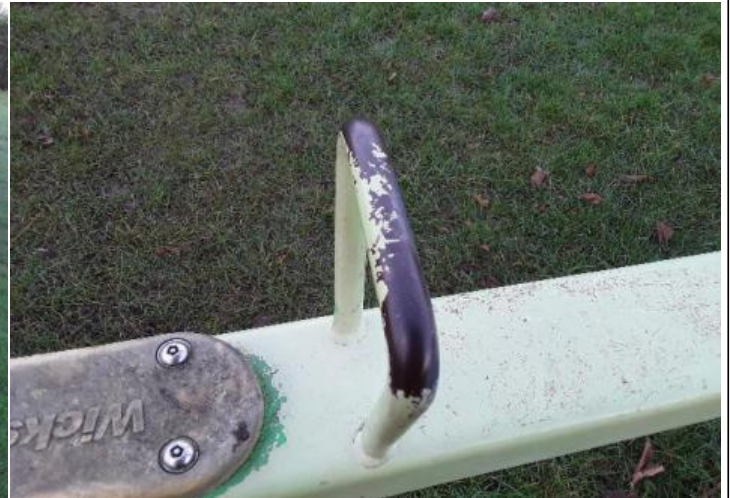
Finding: There is surface corrosion / rust present on the item

Action: Consider treating the item

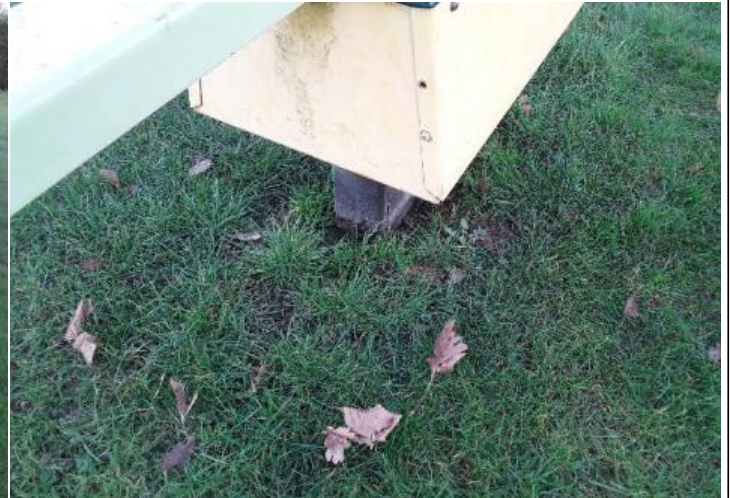
Finding: The item is slightly loose in its foundations

Action: Monitor for any further deterioration and repair as required

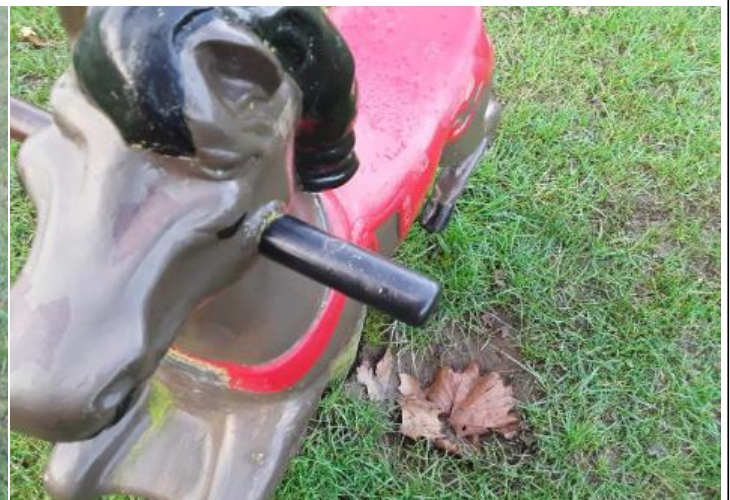
Finding: The end of handgrips and/or footrests have a cross section of less than 15cm² and fail to meet the requirements of BS EN 1176 Part 6

Action: Monitor - No action given the risk assessment

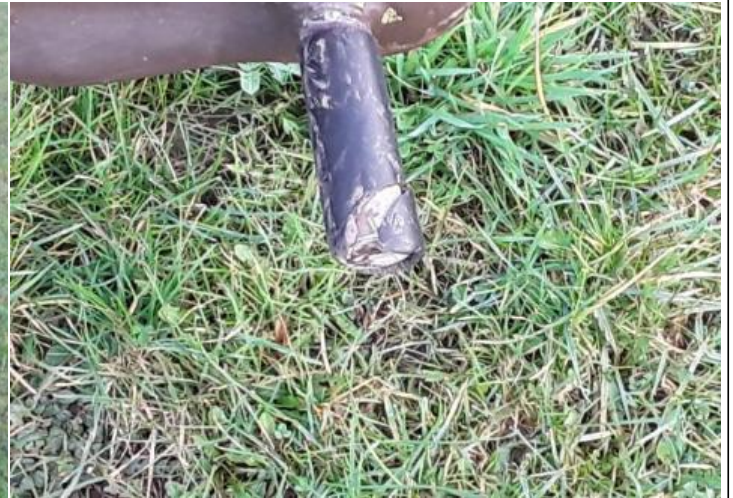
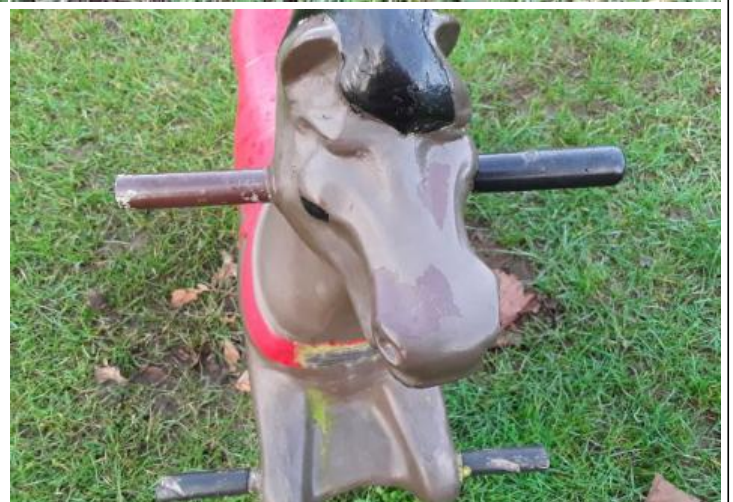
Finding: The handgrips / footrests are damaged or missing **Action:** Replace the handgrips / footrests

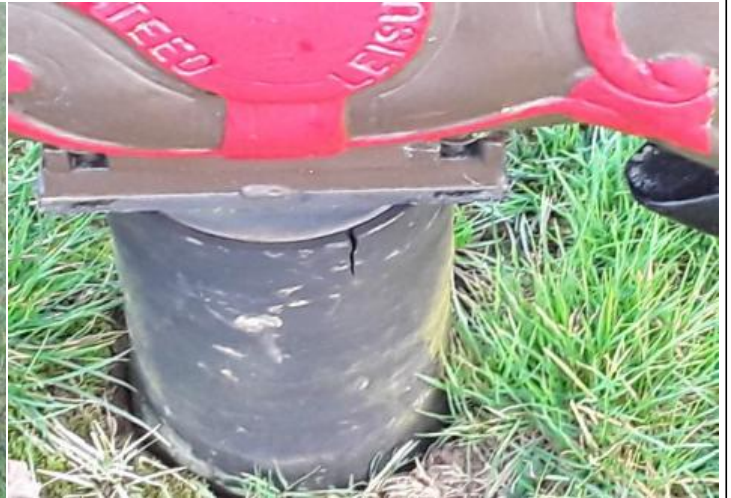
Finding: The spring cover is damaged

Action: Monitor and replace the cover if required

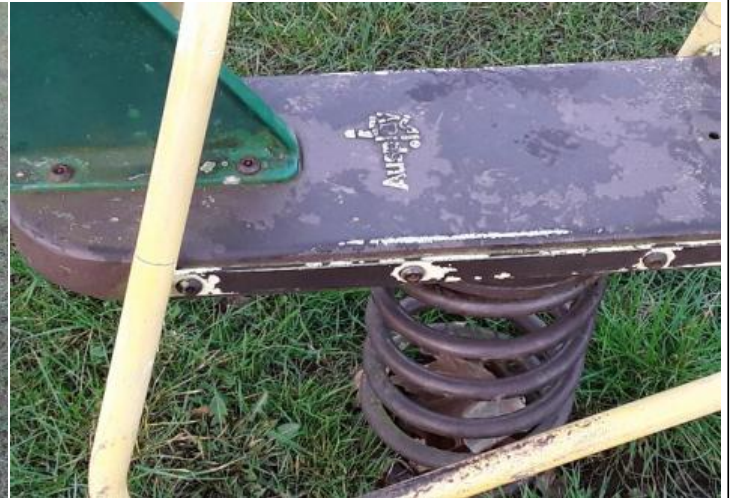
Finding: There is surface corrosion / rust present on the item

Action: Consider treating the item

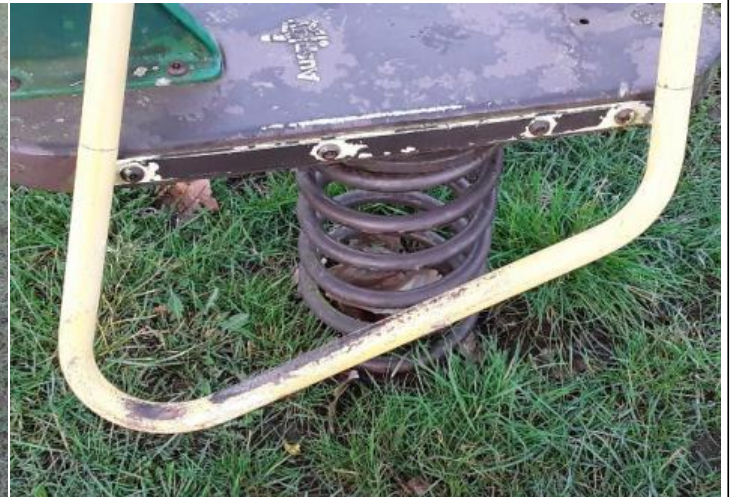
Finding: The paintwork on the spring has been damaged or worn exposing the metal underneath which is rusting

Action: Treat any rusting components and repaint

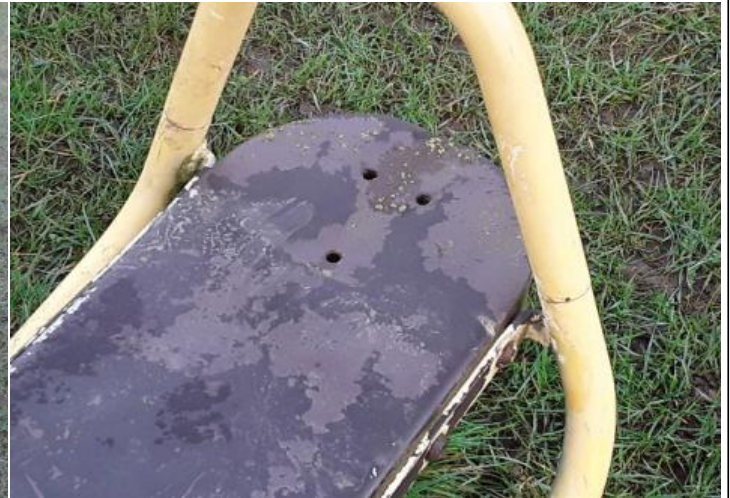
Finding: The item has missing component(s)

Action: Consider replacing missing components

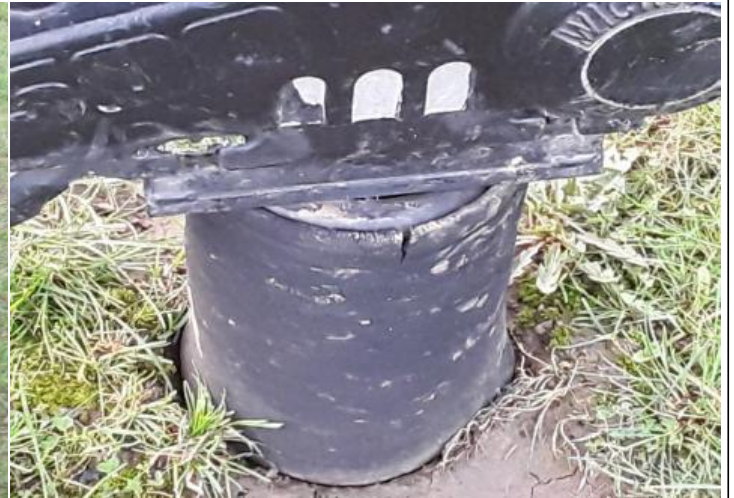
Finding: The spring cover is damaged

Action: Monitor and replace the cover if required

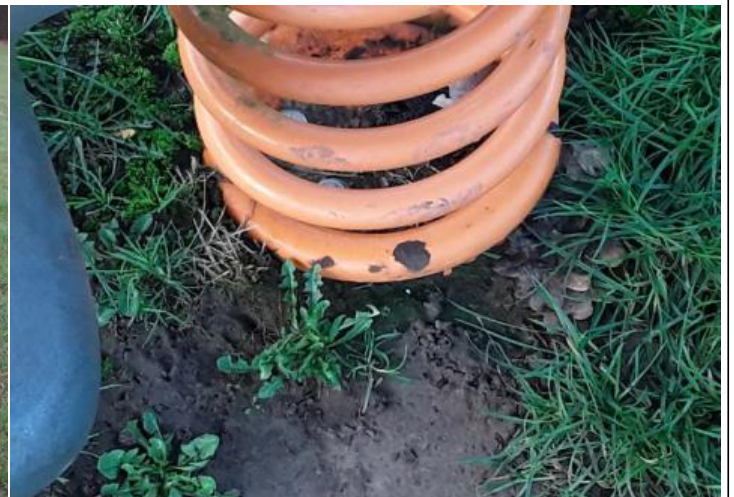
Finding: The paintwork on the spring has been damaged or worn exposing the metal underneath which is rusting

Action: Treat any rusting components and repaint

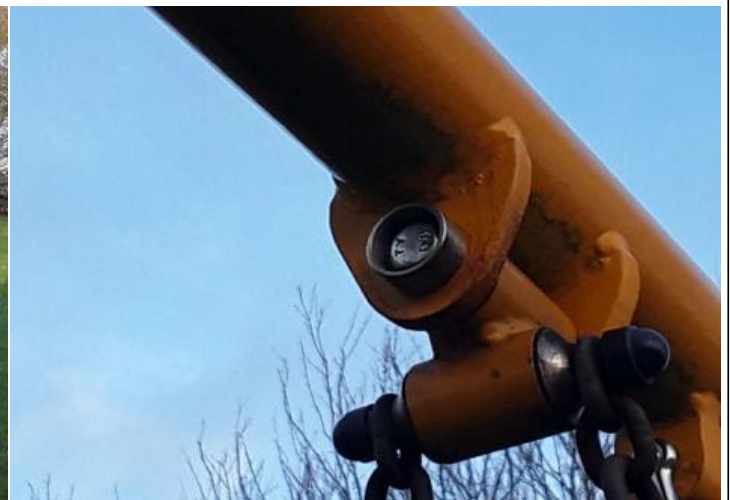
Finding: There is/are bolt cap covers missing or damaged on the item

Action: Replace missing or damaged bolt cap covers

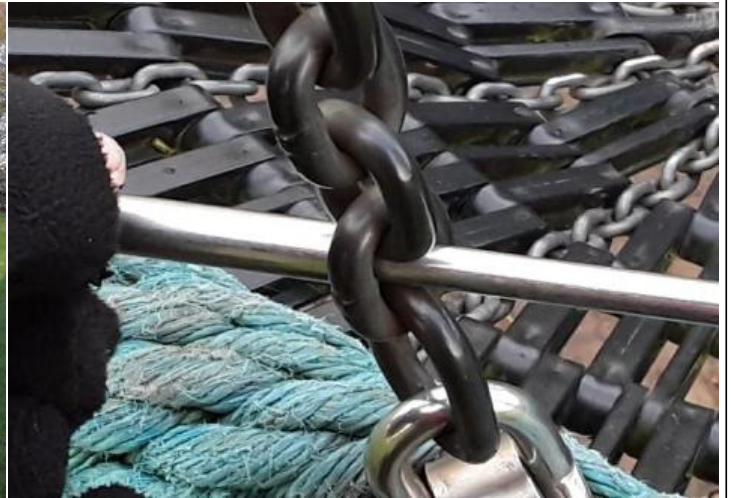
Finding: The chain openings are in excess of the 8.6mm as recommended by BS EN 1176
Action: Monitor - No action given the risk assessment

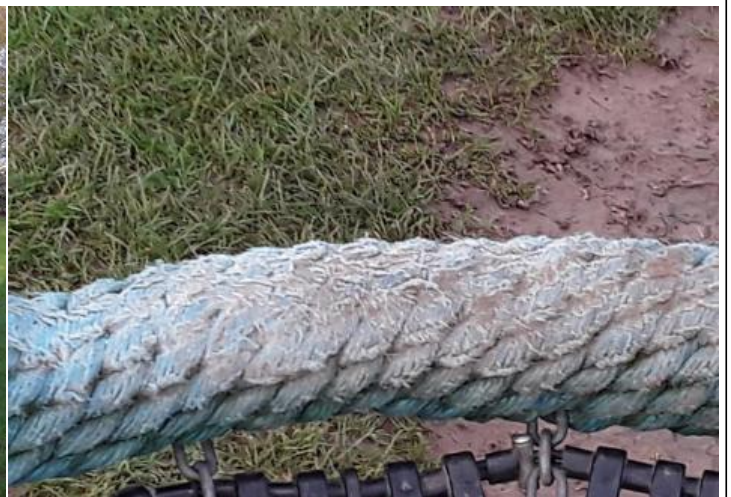
Finding: The ropes/nets are worn/damaged in places
Action: Monitor for any further deterioration and repair or replace as required

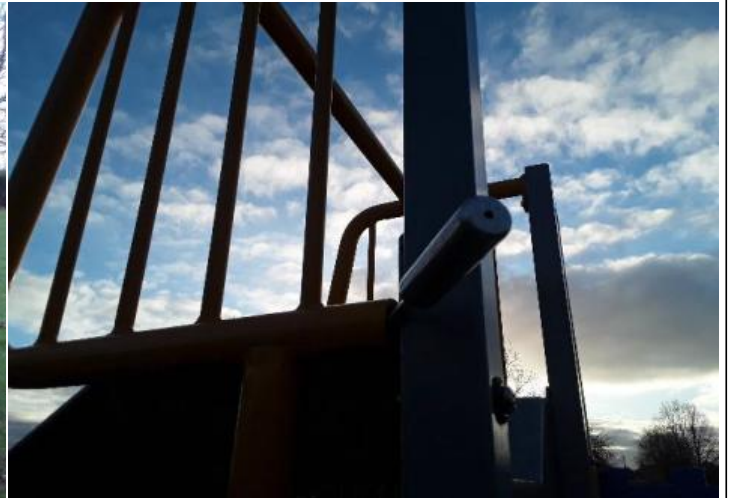
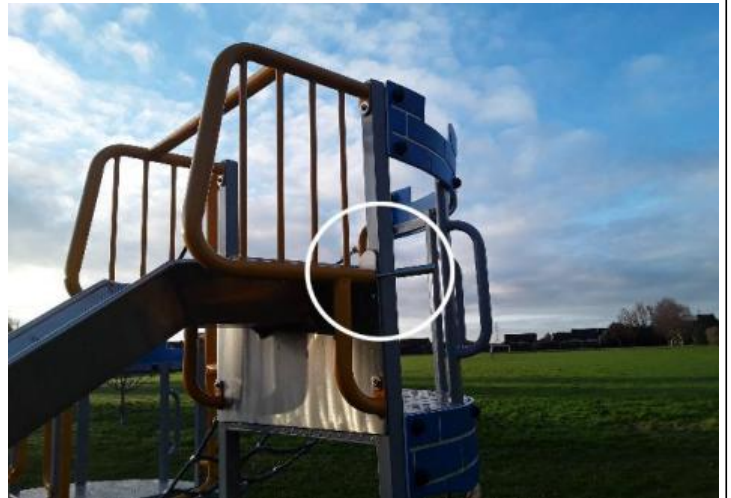
Finding: There is/are end caps missing creating finger entrapment/s in the end openings and the item fails to meet the requirements of BS EN 1176 Part 1 4.2.7.6 Entrapment of fingers

Action: Replace the missing end caps

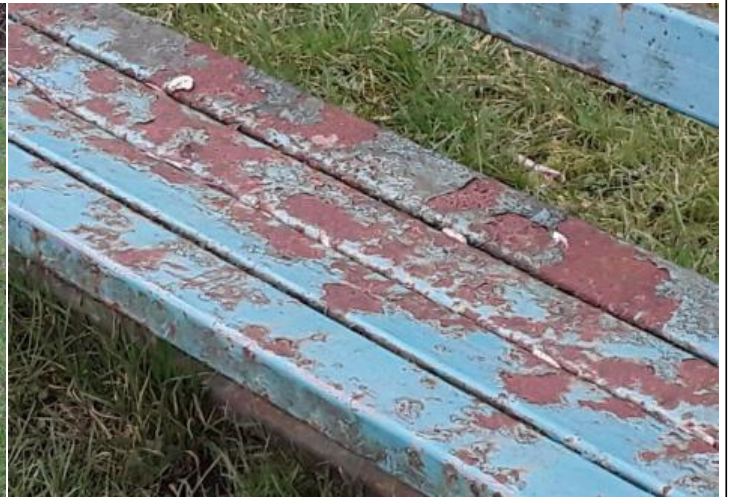
Finding: The paintwork on this item has been damaged or worn exposing the metal underneath which is rusting / corroding

Action: Treat affected areas and repaint

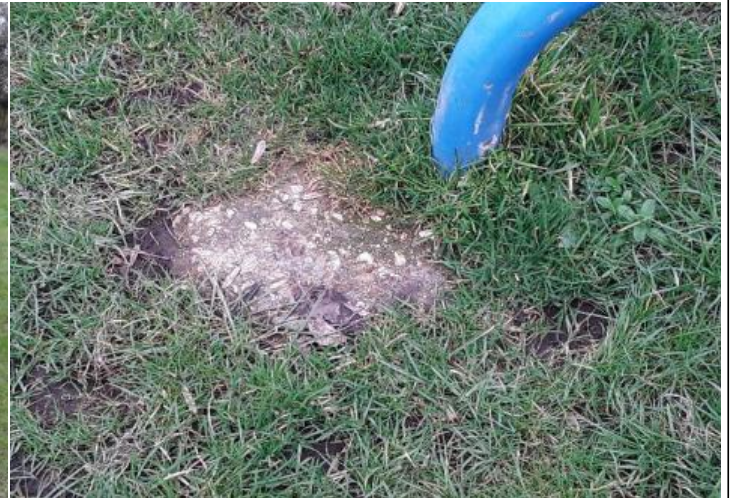
Finding: The foundations are exposed

Action: Reinstate surrounding surfaces to cover the foundations

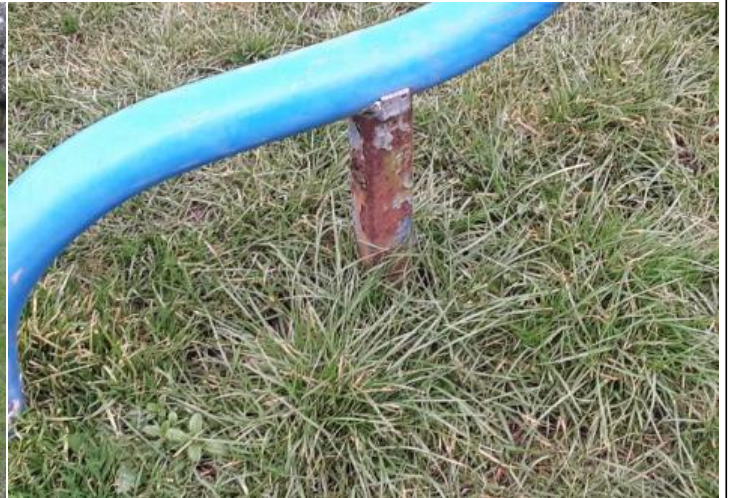
Finding: The paintwork on this item has been damaged or worn exposing the metal underneath which is rusting / corroding

Action: Treat affected areas and repaint

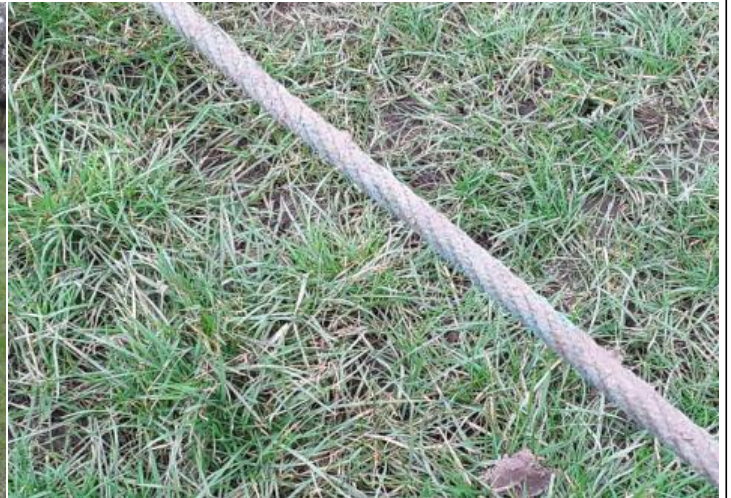
Finding: The ropes/nets are worn/damaged in places

Action: Monitor for any further deterioration and repair or replace as required

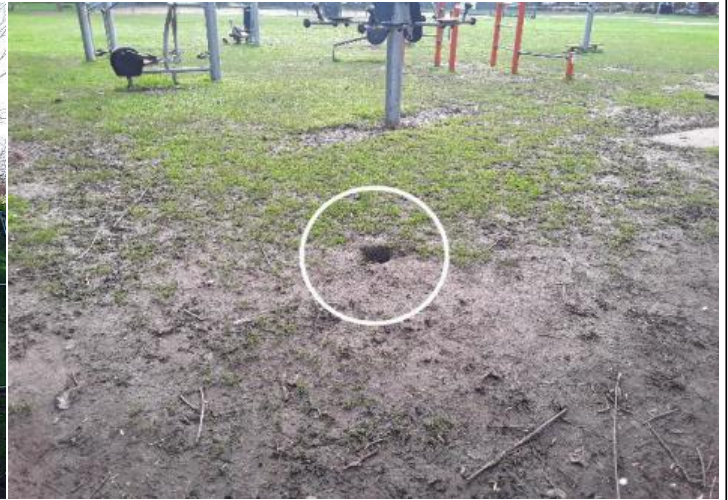
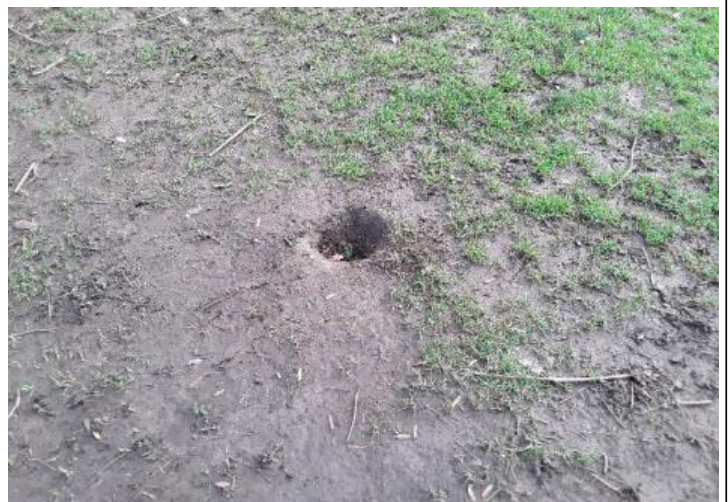
Finding: There are holes in the surface adjacent to the fitness equipment that may cause users to trip or roll ankles

Action: Infill to provide a sound reasonably level surface.

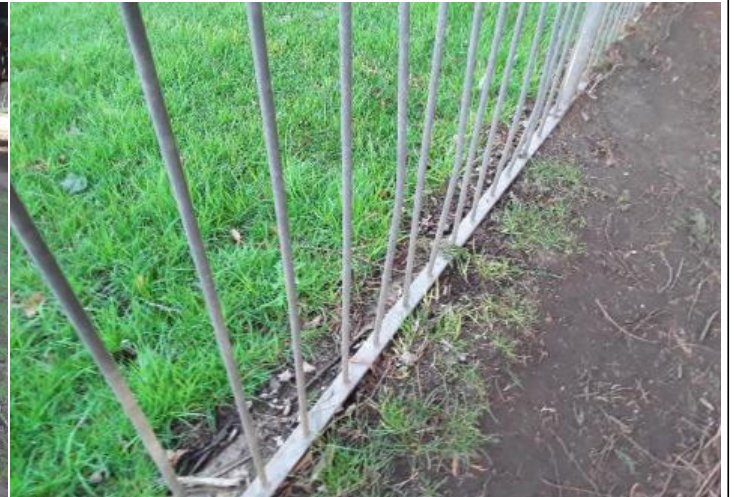
Finding: There is minor damage to the fence sections **Action:** Monitor for any further deterioration and repair as required

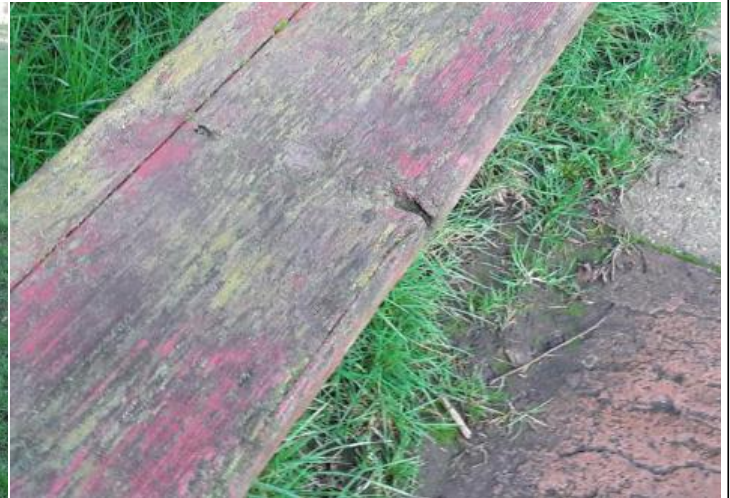
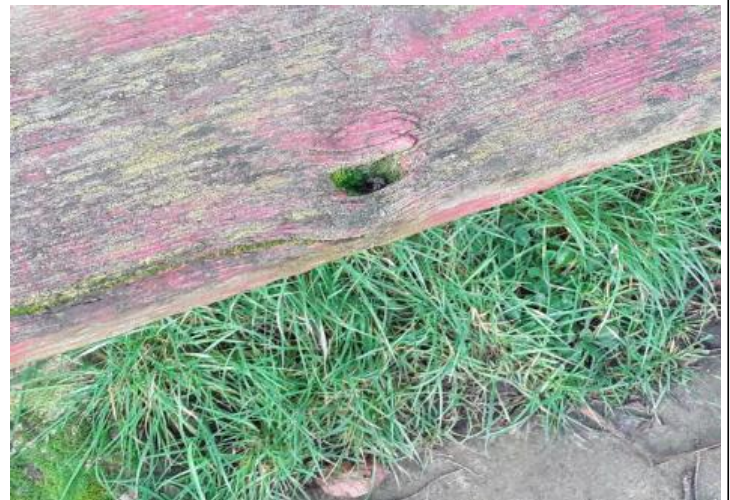
Finding: There is minor vandalism damage to the bench

Action: Monitor and repair if required

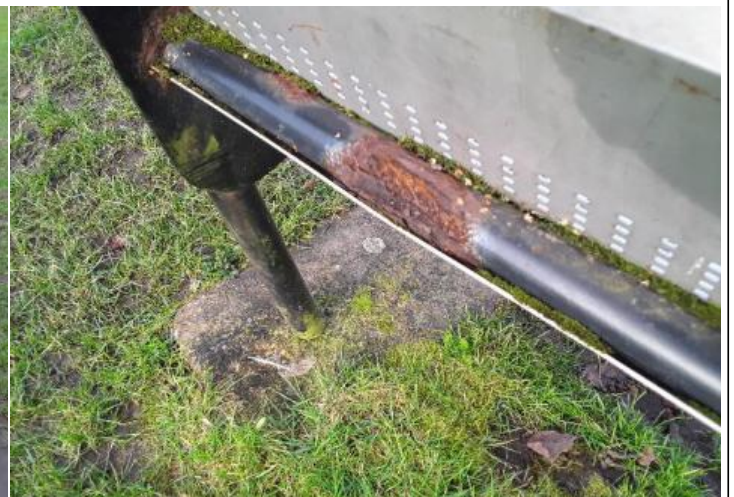
Finding: The paintwork on this item has been damaged or worn exposing the metal underneath which is rusting / corroding

Action: Treat affected areas and repaint

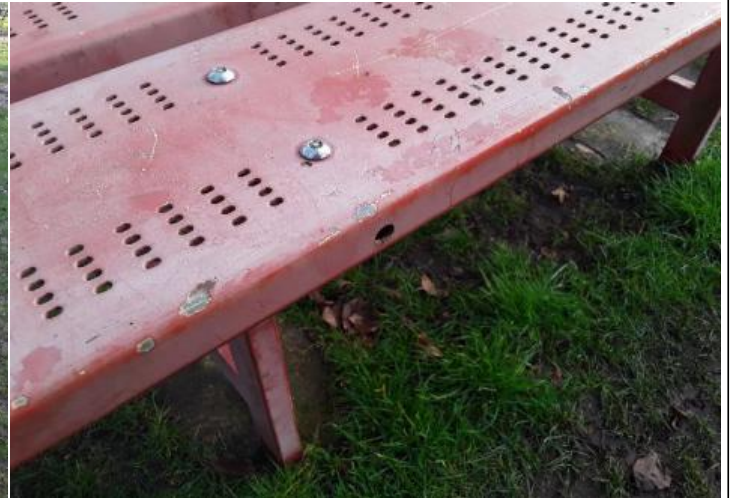
Finding: There is/are inserts missing

Action: Replace missing inserts

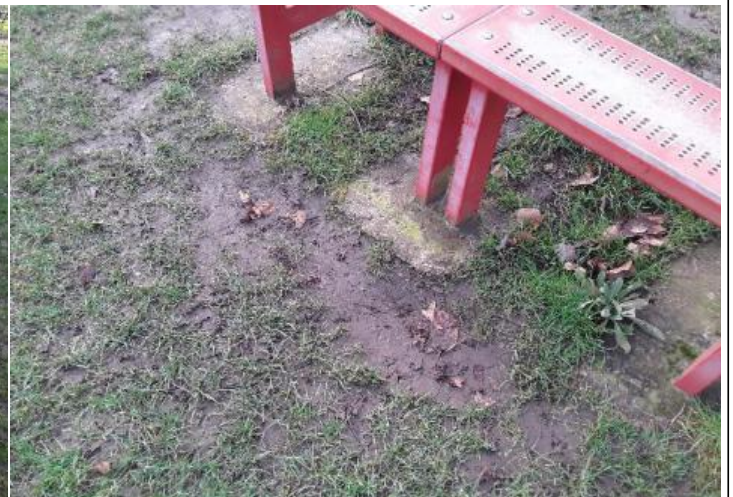
Finding: The surface has eroded and the foundations are exposed

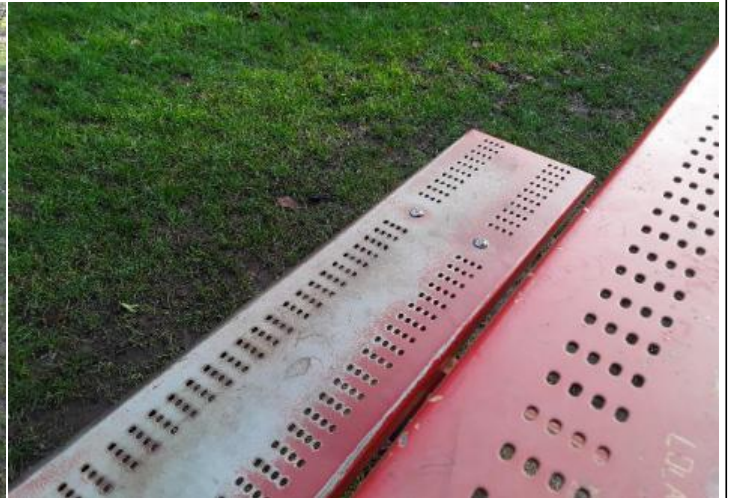
Finding: There is surface corrosion / rust present on the item

Action: Consider treating the item

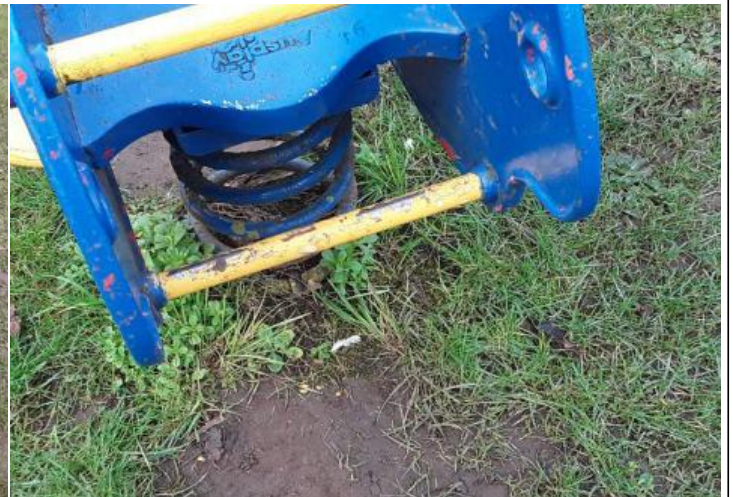
Finding: There is surface corrosion / rust present on the item
Action: Consider treating the item

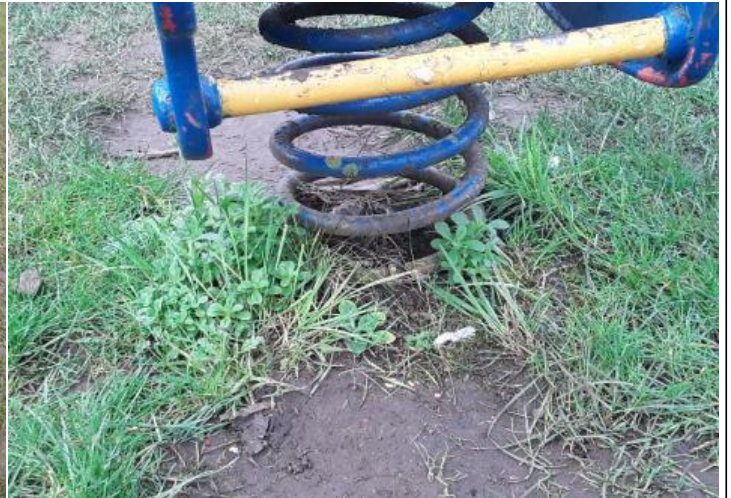
Finding: The spring clamps are loose

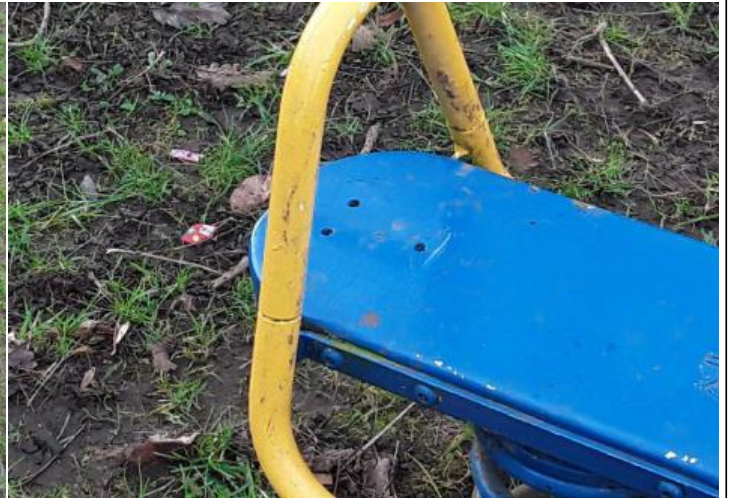
Finding: The item has missing component(s)

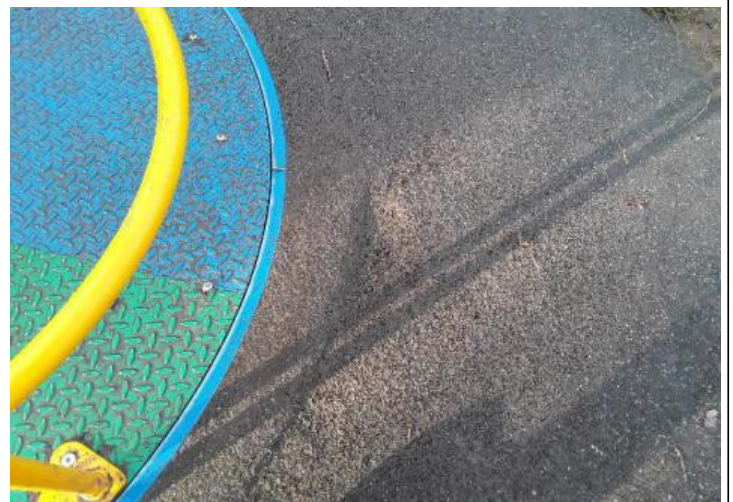
Finding: The surfacing is severely damaged

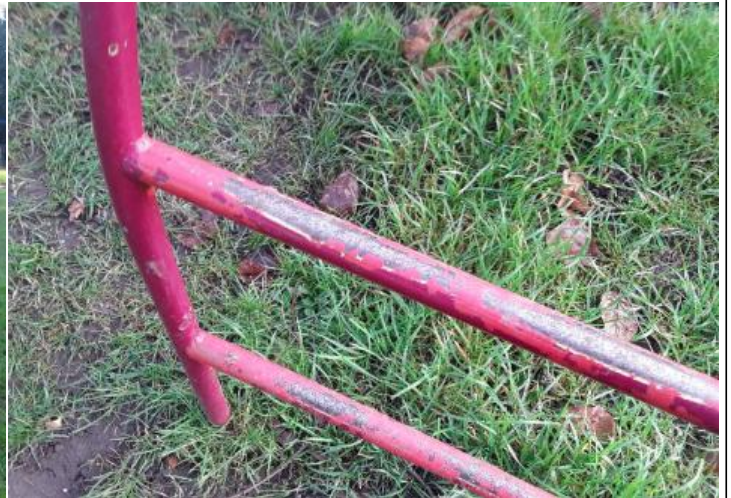
Finding: There is surface corrosion / rust present on the item

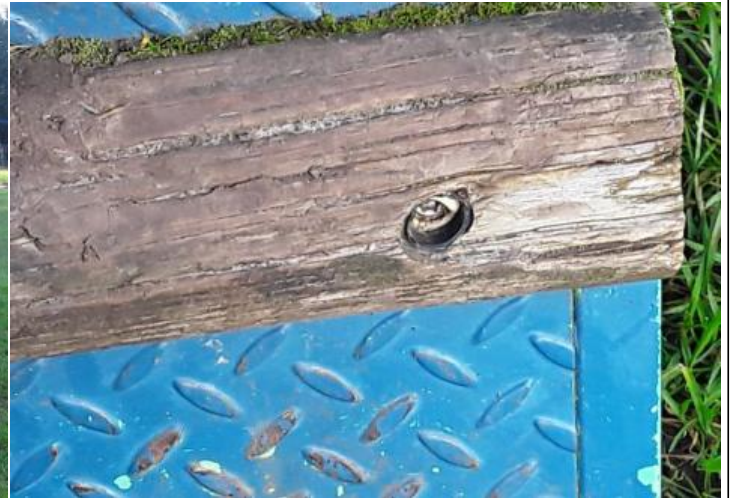
Finding: There is/are bolt cap covers missing or damaged on the item

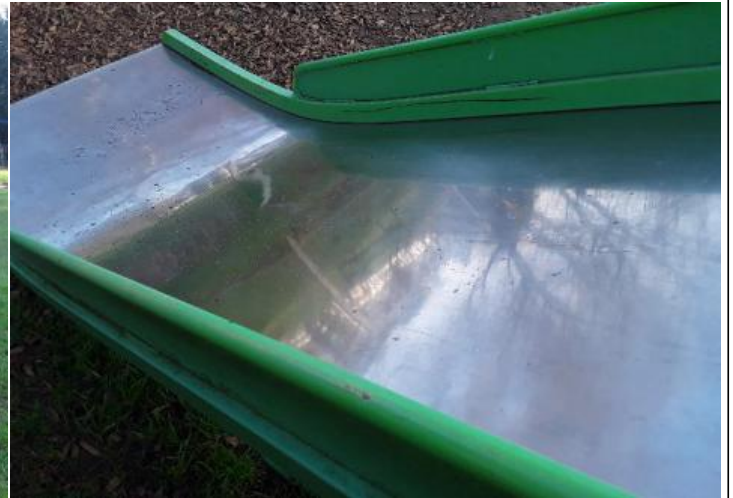
Finding: There are a number of dents in the slide surface

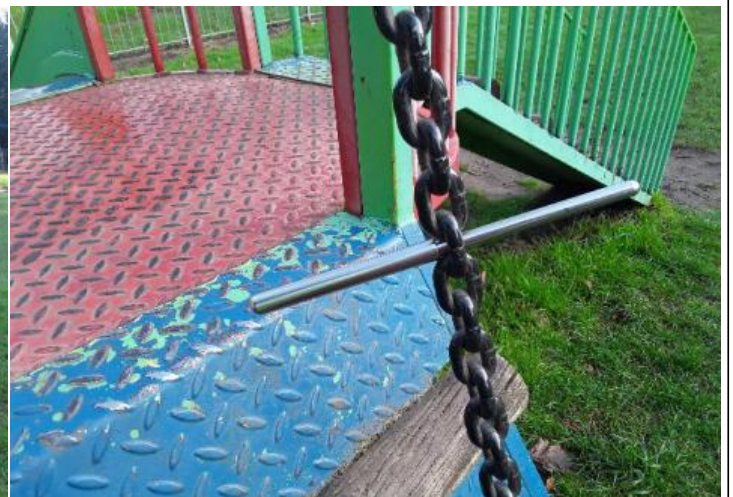
Finding: The chain openings are in excess of 8.6mm and do not meet the recommendations of BS EN 1176 Part 1

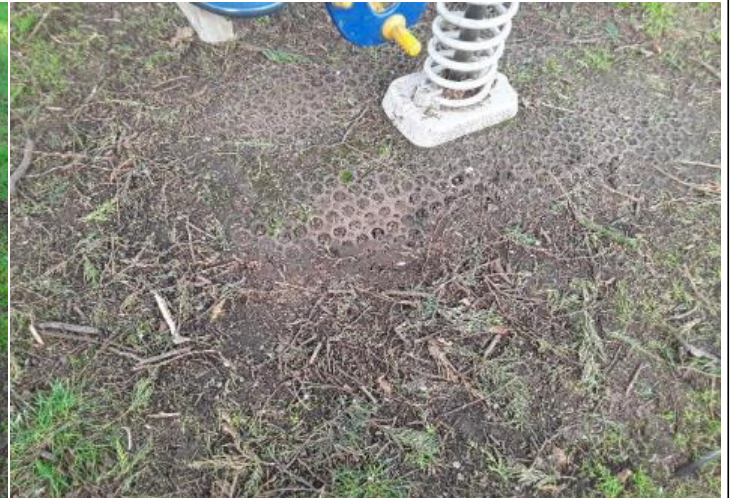
Finding: The surface has subsided in some areas

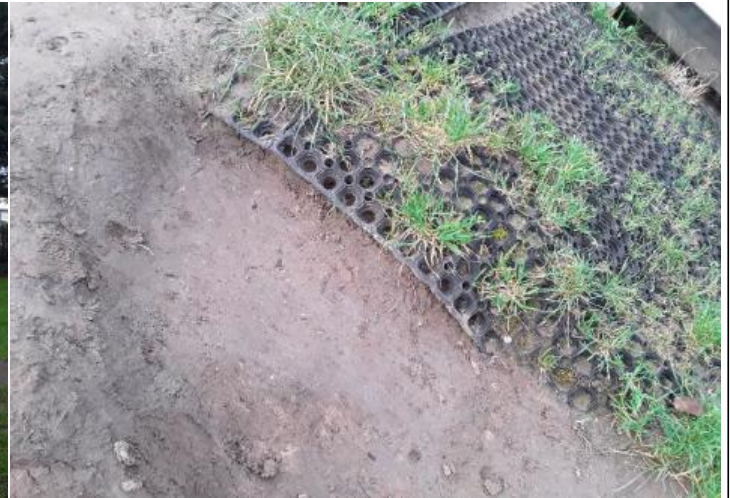
Finding: The edges of the grass mat surface are raised / lifting above the surrounding surface

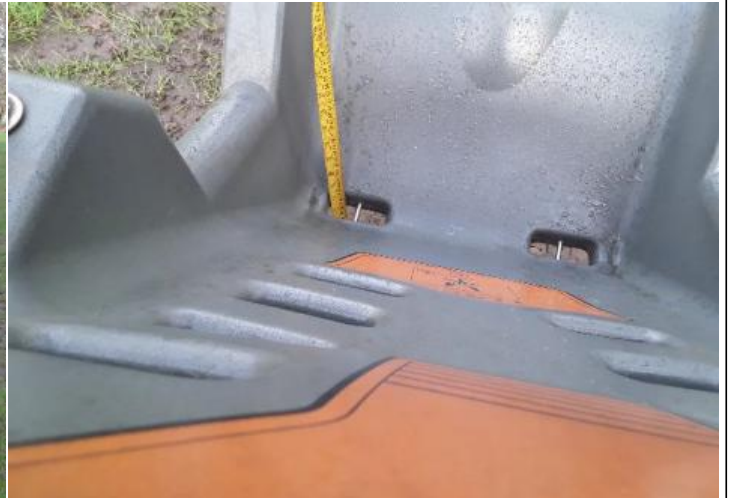
Finding: The seat clearance from finished surface level to the underside of the seat is too low and does not meet the requirements of BS EN 1176 Part 2 (350mm minimum clearance required)

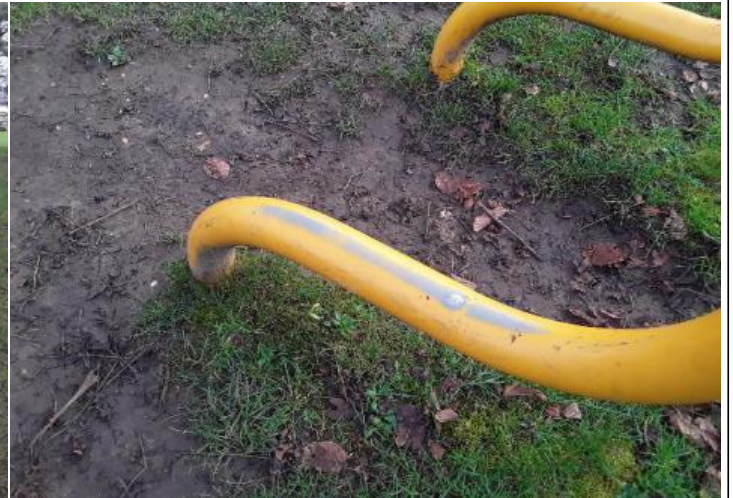
Finding: There is surface corrosion / rust present on the item

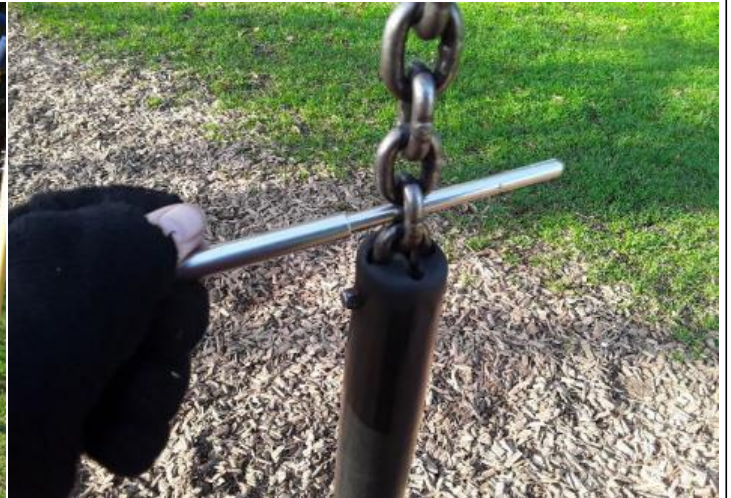
Finding: The chain openings are in excess of 8.6mm and do not meet the recommendations of BS EN 1176 Part 1

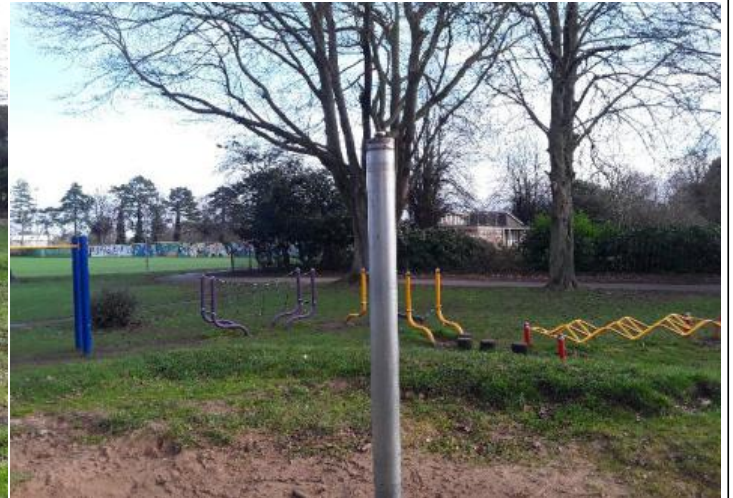
Finding: The item has missing component(s)

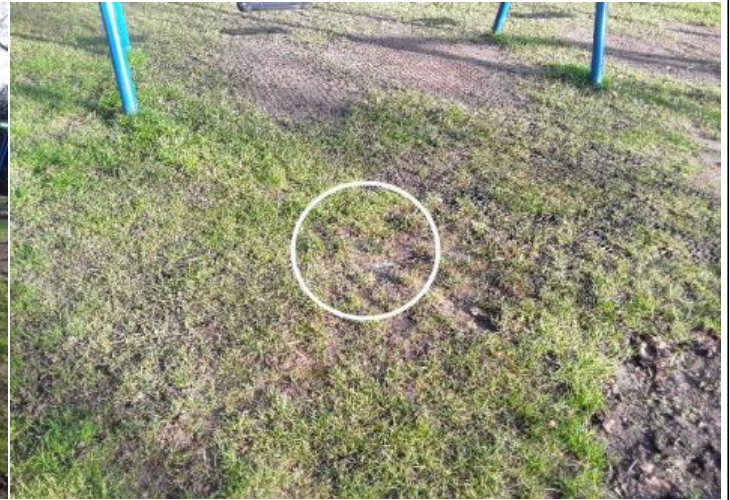
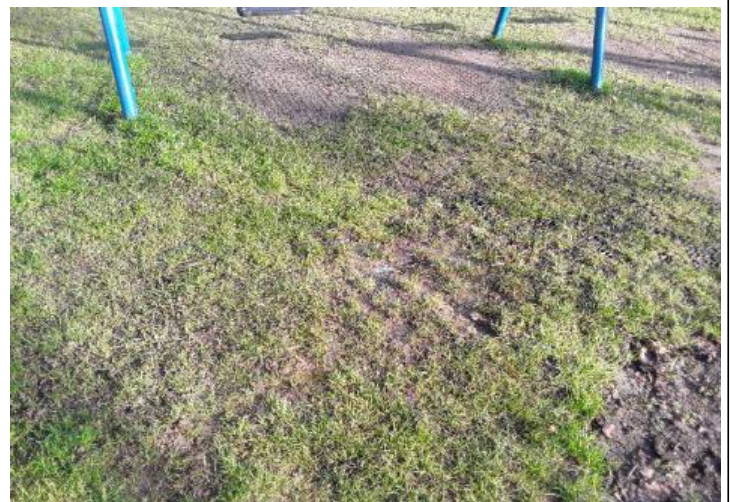
Finding: The surfacing is damaged

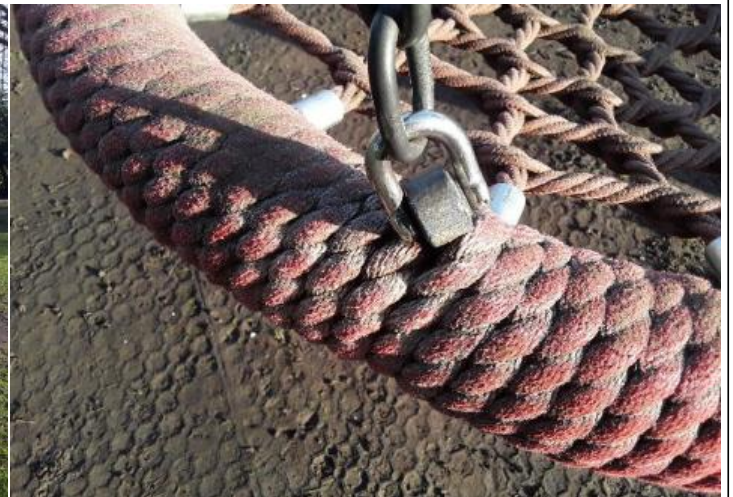
Finding: The basket bushes are showing signs of wear
Action: Monitor for any further deterioration and replace as required

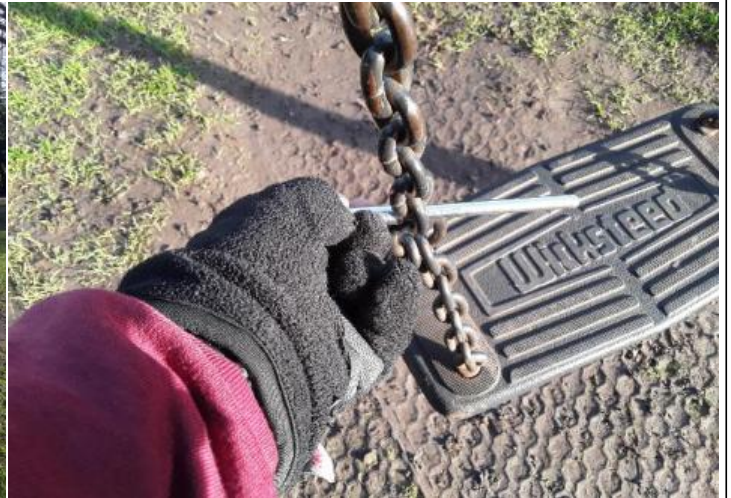
Finding: The chain openings are in excess of the 8.6mm as recommended by BS EN 1176
Action: Monitor - No action given the risk assessment
