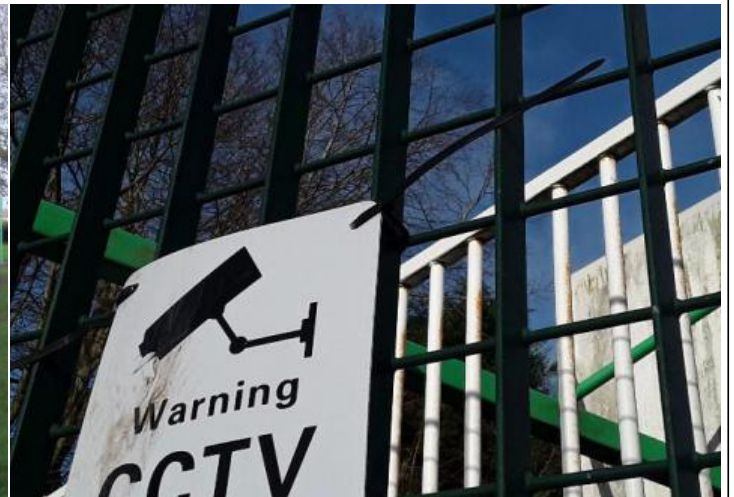
Finding: Cable ties are present

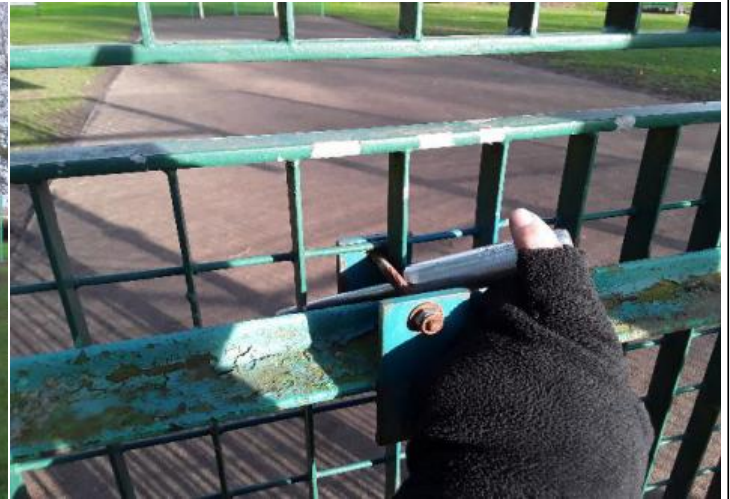
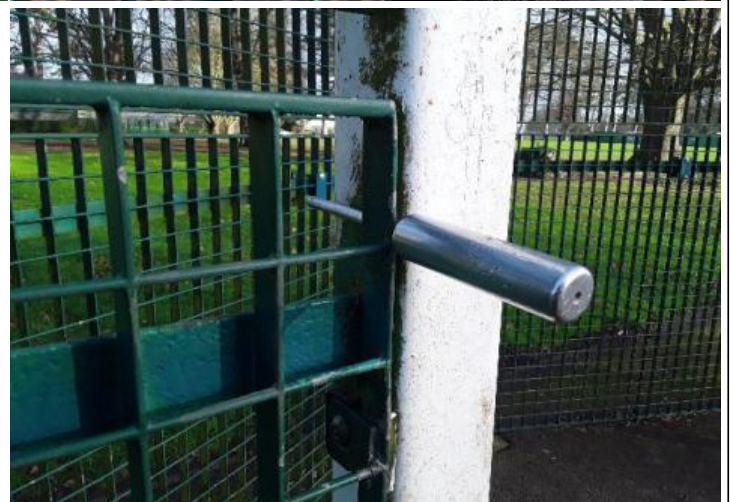
Finding: There is/are finger entrapments in the mesh openings and the item fails to meet the requirements of BS EN 15312 Clause 4.4.2.2 Entrapment of fingers

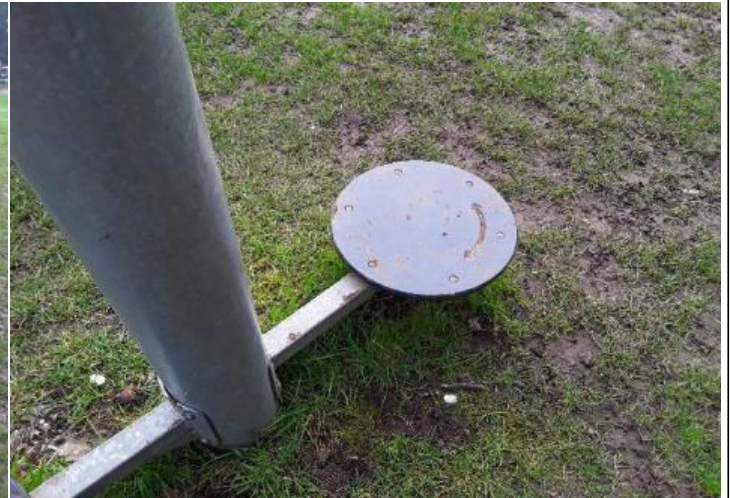
Finding: The bearing is showing signs of wear

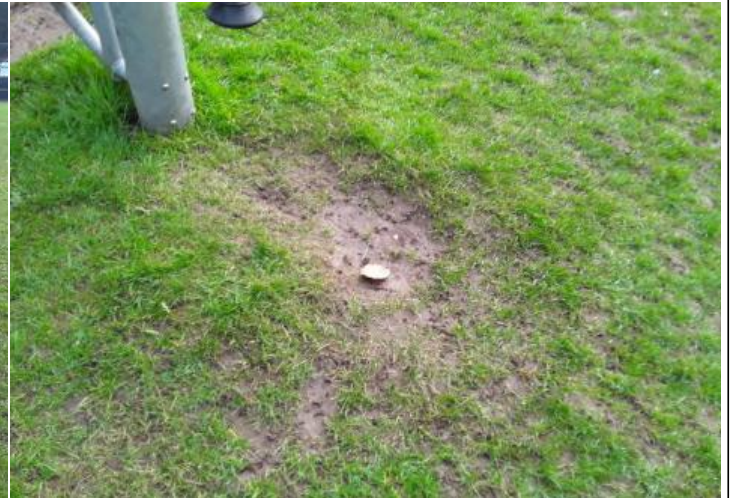
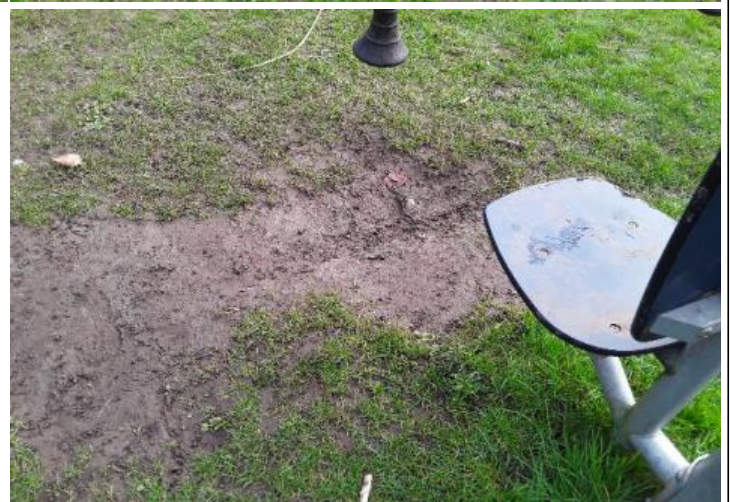
Finding: The surface has eroded / subsided

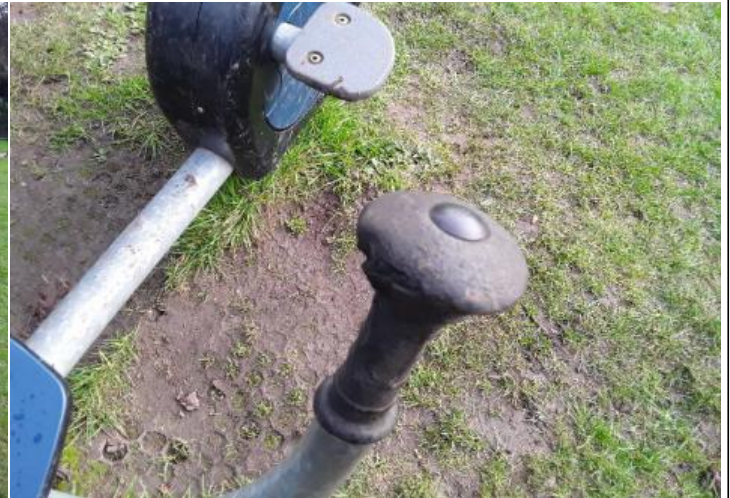
Finding: One or more handgrip(s) are damaged

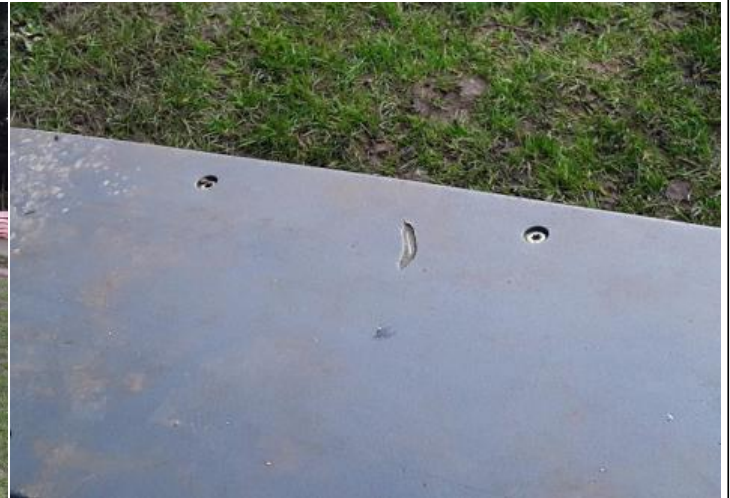
Finding: There is minor damage to the bench

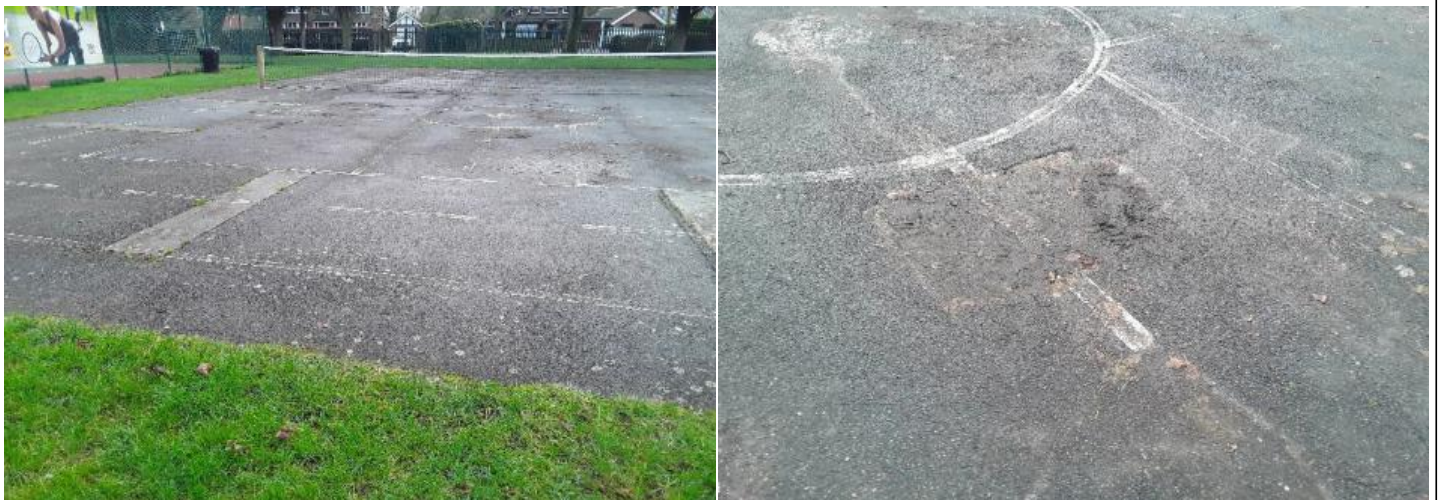
Finding: There is algae, silt or moss growth on the surface resulting in slippery conditions
Action: Clean and treat appropriately

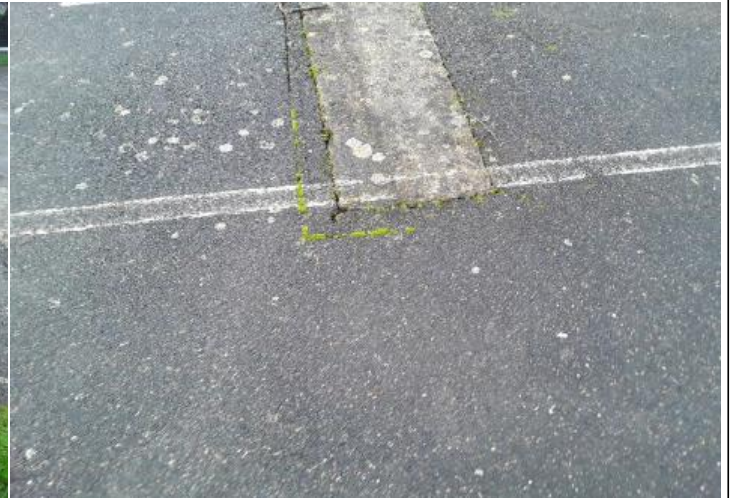
Finding: The surfacing is damaged
