CONDITION REPORT 2024

of
HOLBEACH CEMETERY CHAPELS

Date of inspection: 19th June 2024

**CONDITION REPORT: UPDATED 2024
HOLBEACH CEMETERY CHAPELS**

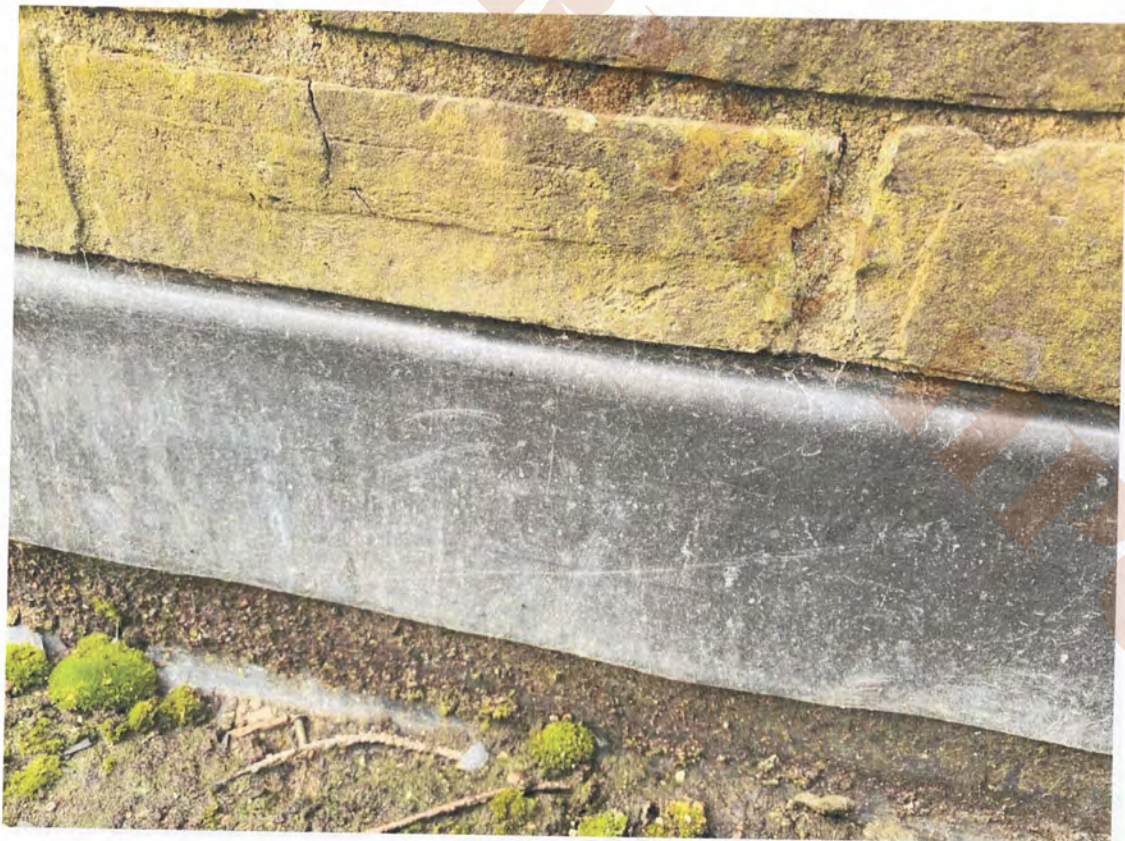
7.12 North chapel south roof/ tower flashing

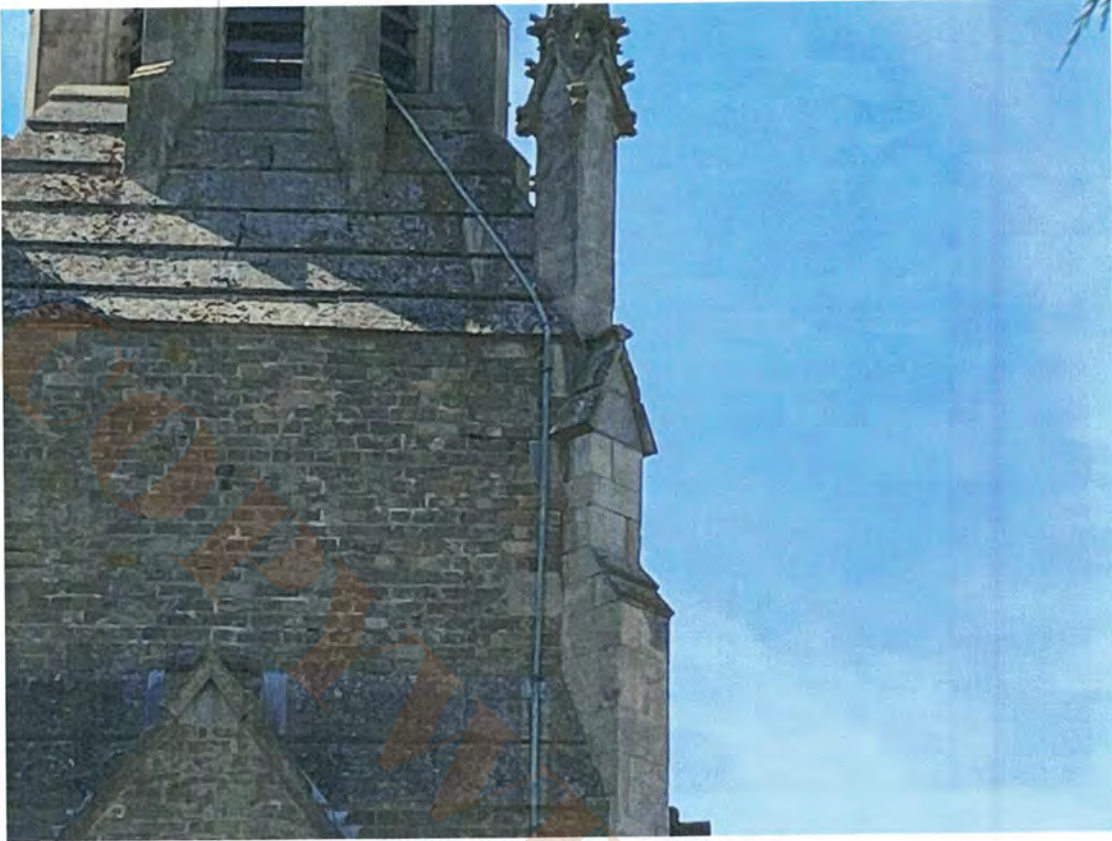
- 8.1 **Tower stage walling:** north elevation: this is largely obscured by the north chapel roof but where visible brickwork is sound. Stonework to the north east buttress capping north west face in the upper part is failing. Renewal excluding access; point open joints and the brickwork adjacent.

8.1 Tower north east buttress
8.1 Tower walling

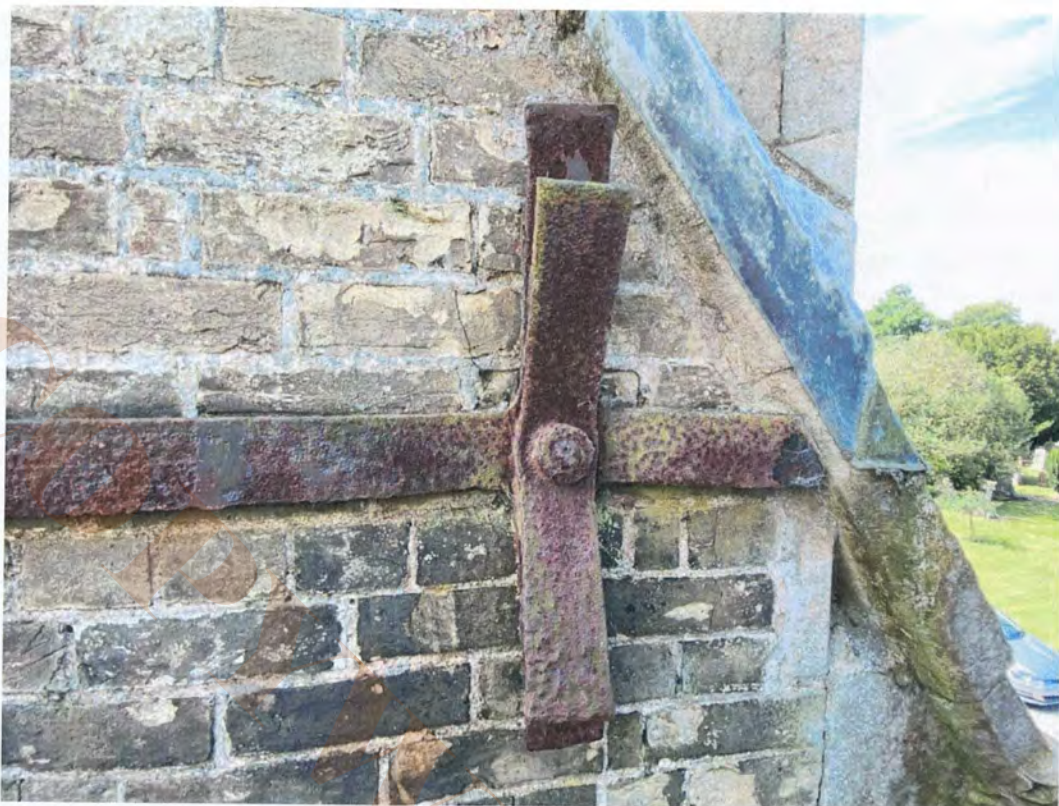
8.2 There are iron bands on the north and south faces connected to iron rods which run through the tower. The centre rod is let into the floor at this level and is visible; the two end rods are set into the walls and are rusting, causing damage to the internal brickwork. The rods and bands should be renewed, subject to a structural engineer's advice.

8.2, 8.3 Tower north elevation ironwork

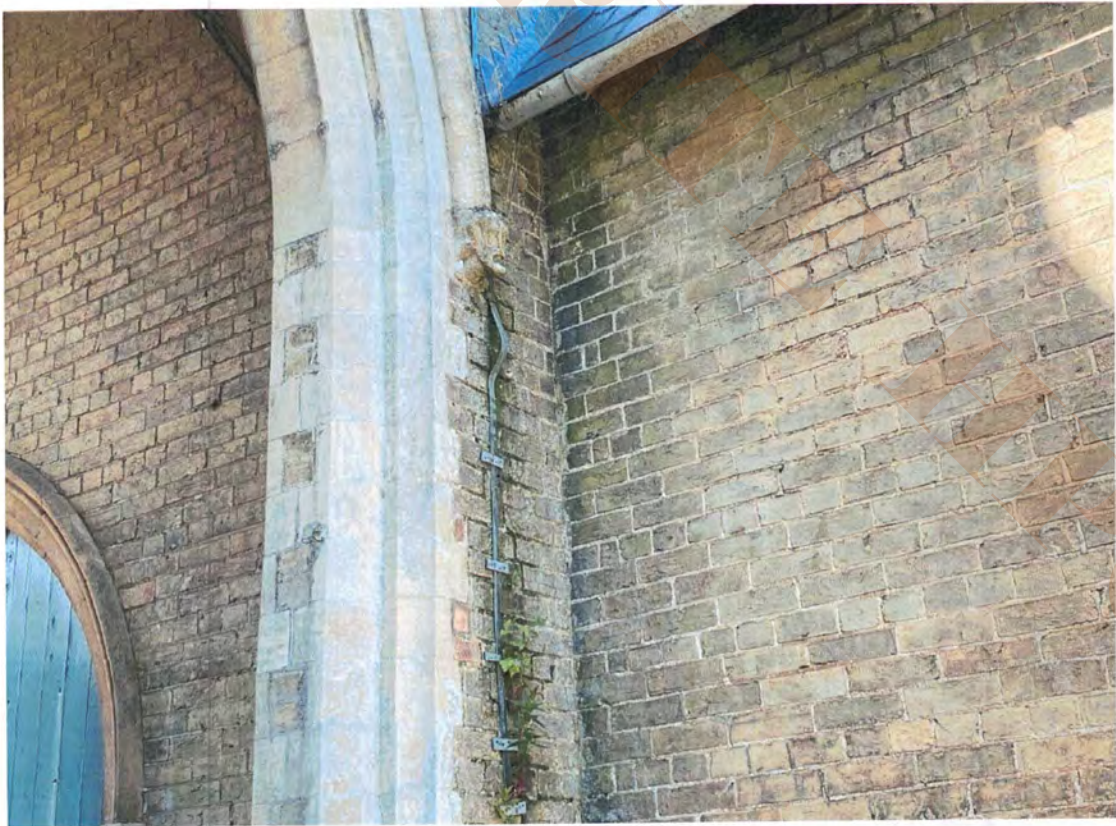
8.8 Tower east elevation north side brickwork

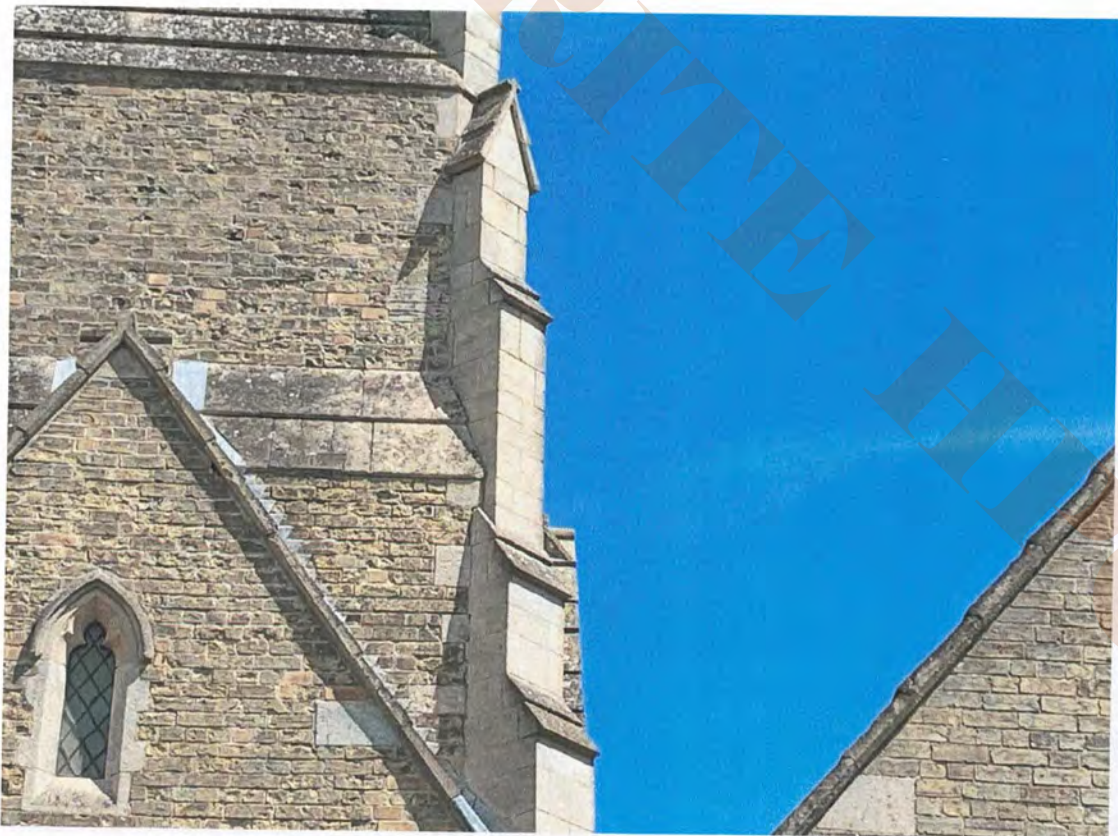
8.13 Tower west elevation triangular panels

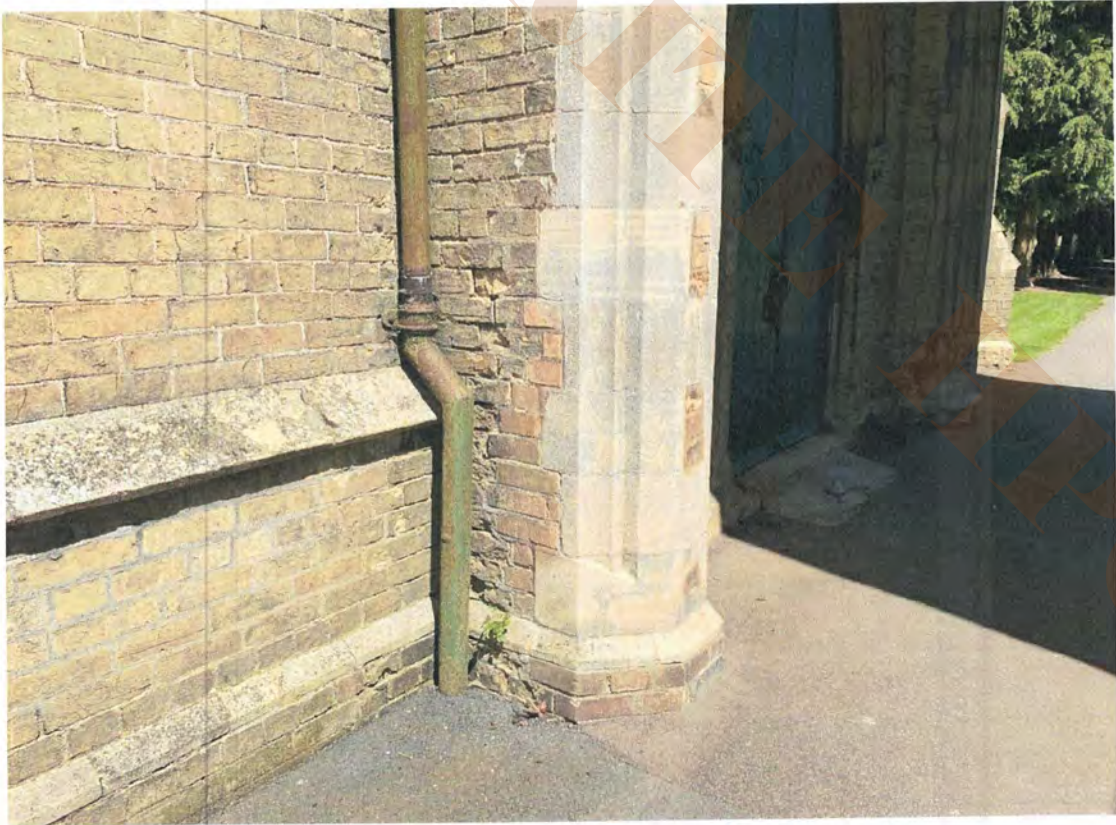
8.16 West elevation north pier

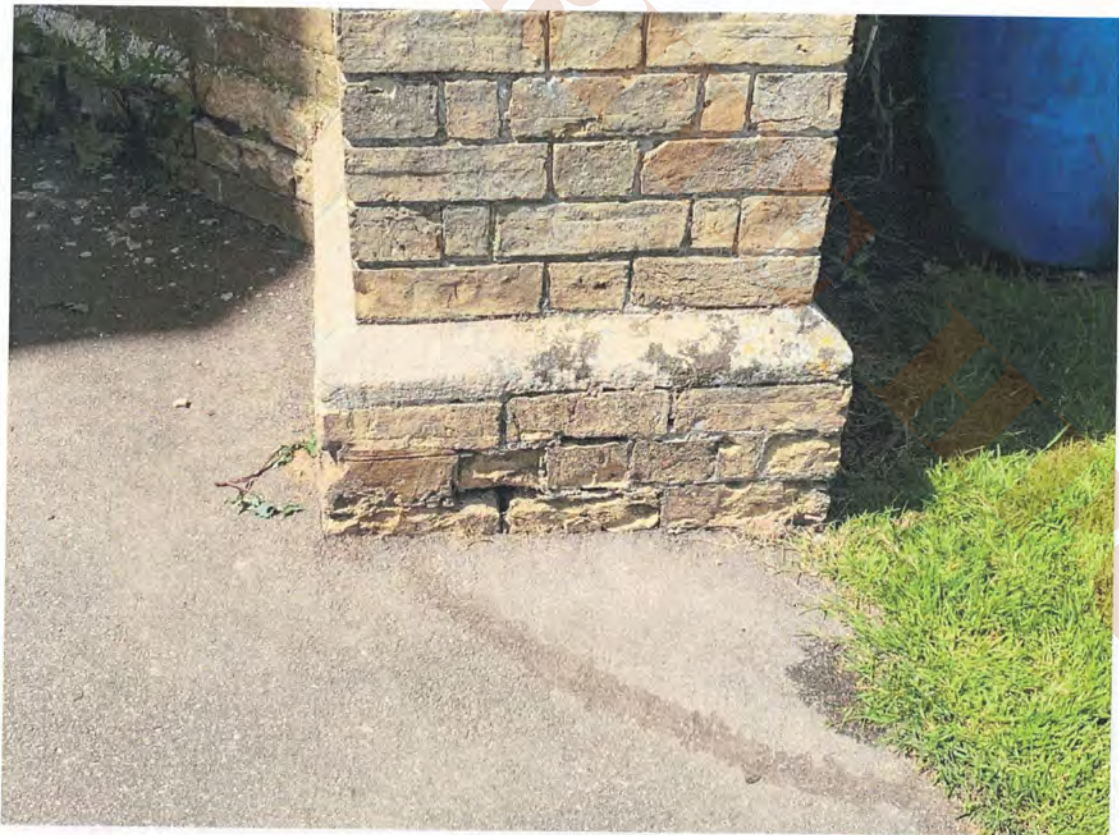
8.20 North chapel south east buttress

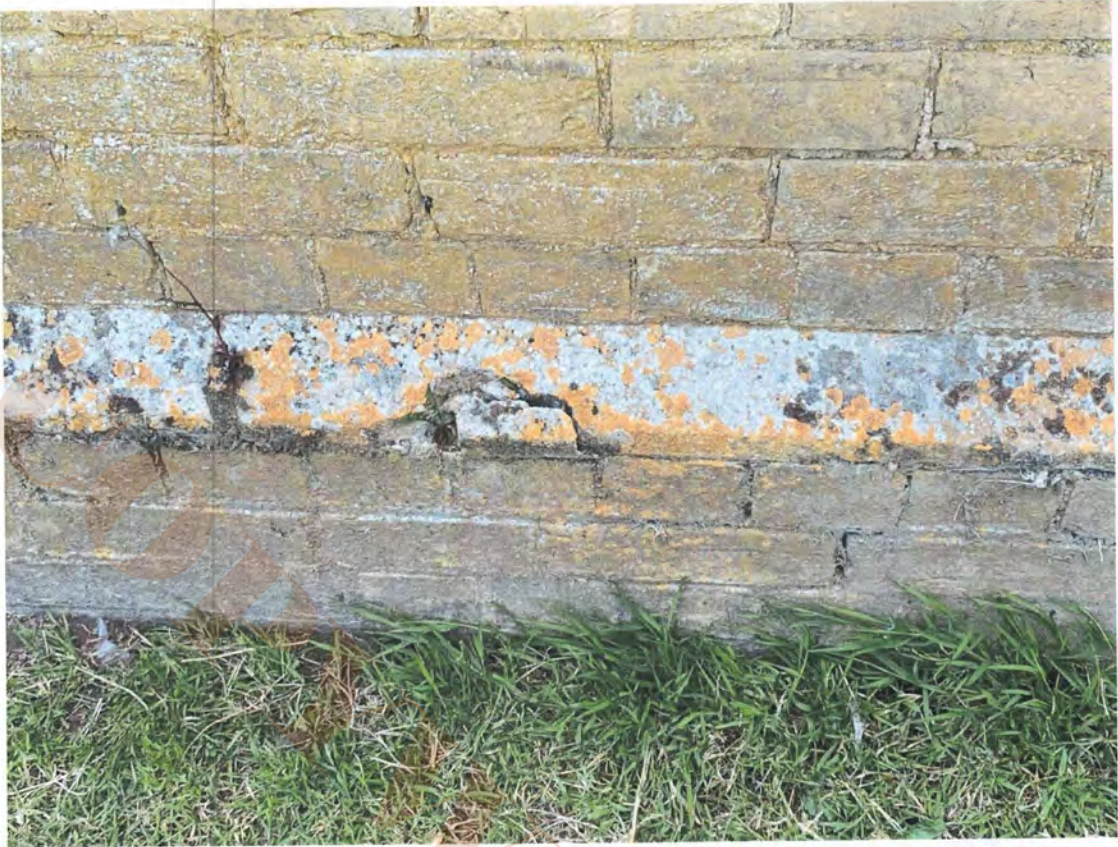
8.21 North chapel east plinth offset

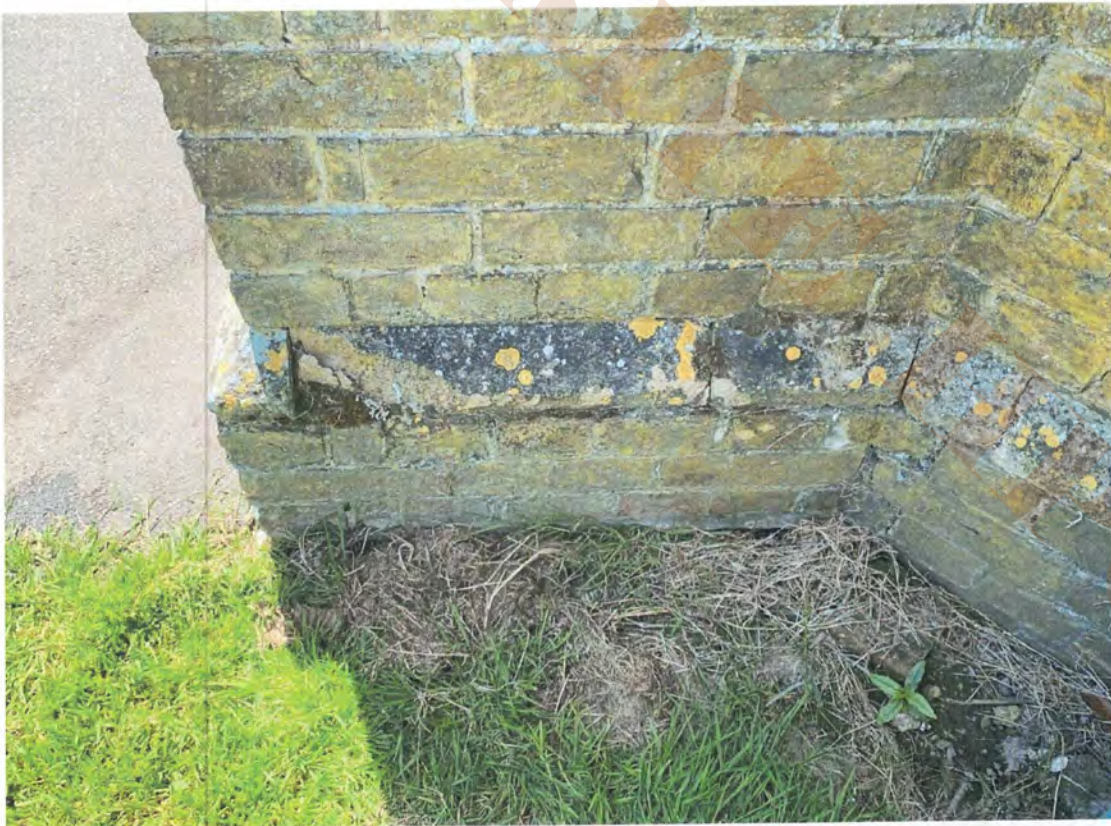
8.21 North chapel south west buttress plinth offset

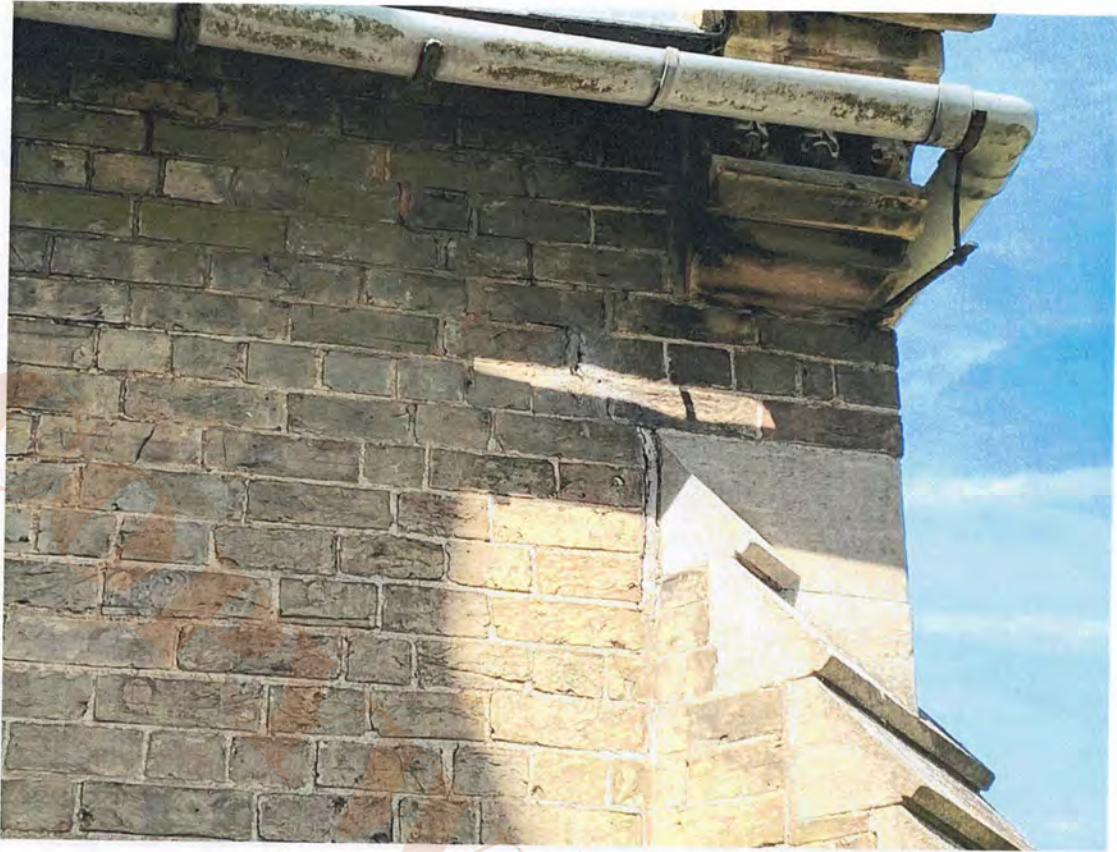
8.22 North chapel south elevation east of tower

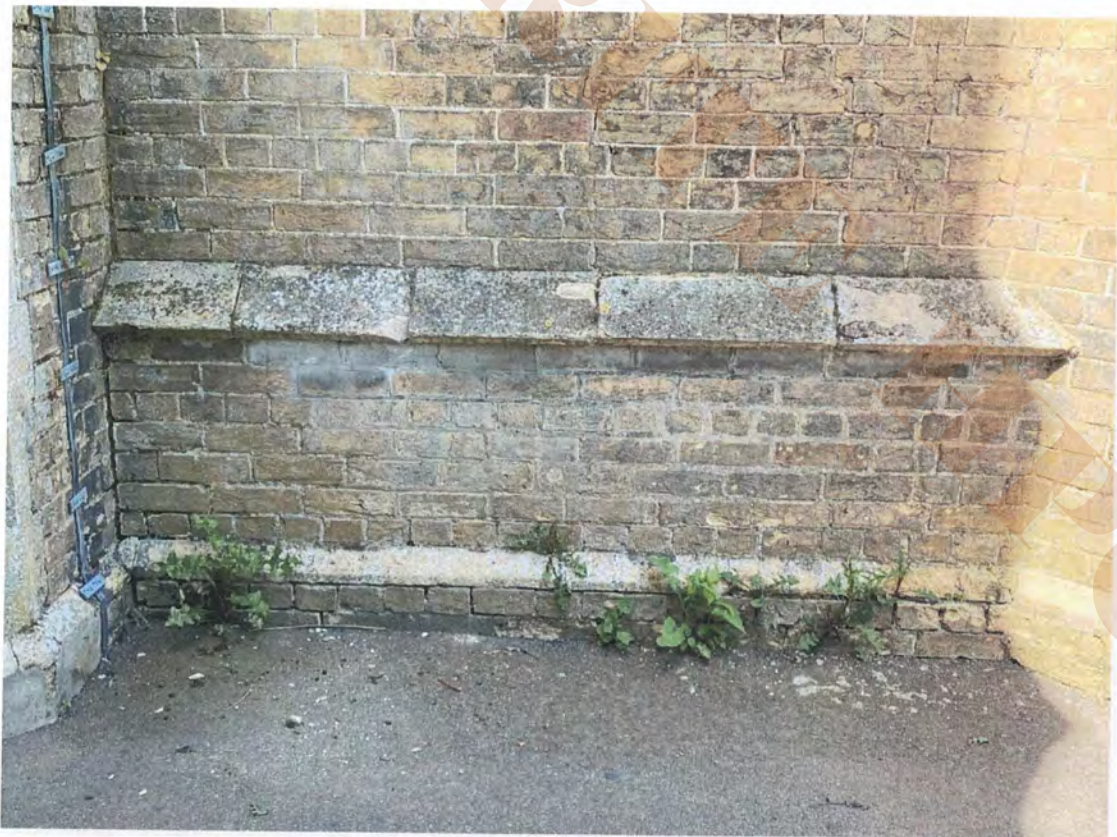
8.23 North chapel south elevation east of tower: plinth

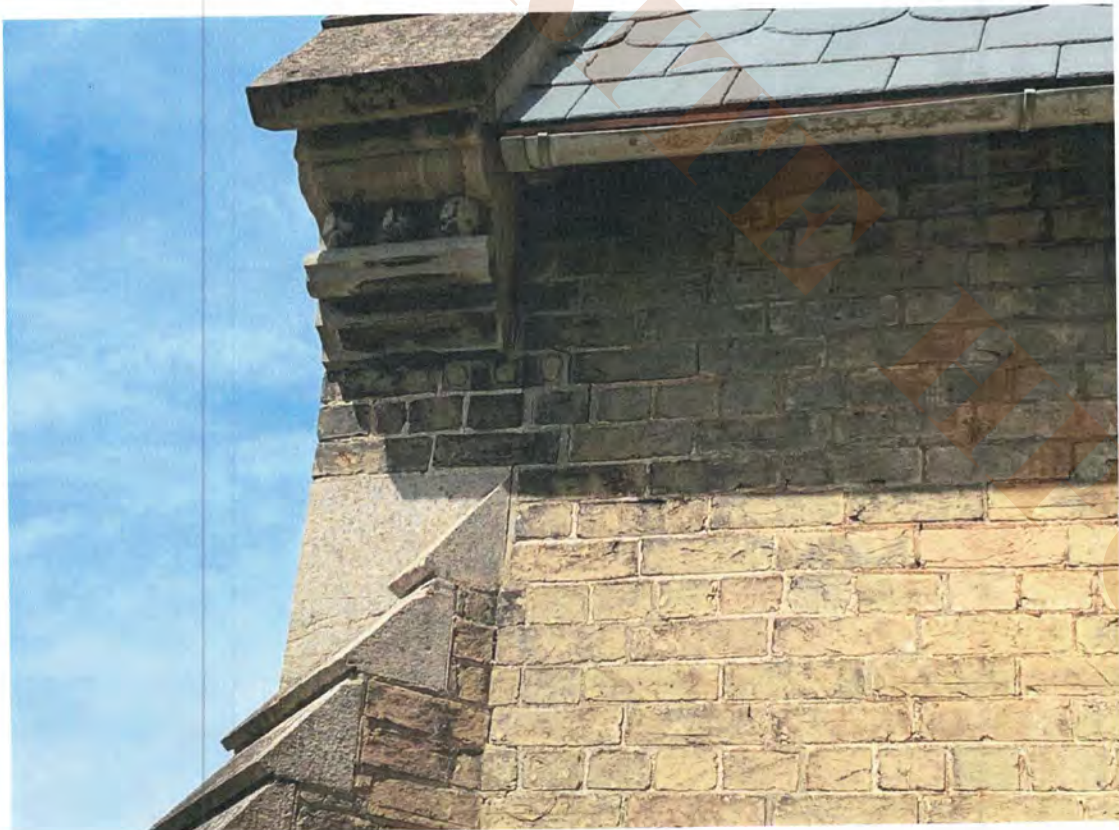
8.25 North chapel south elevation west of tower

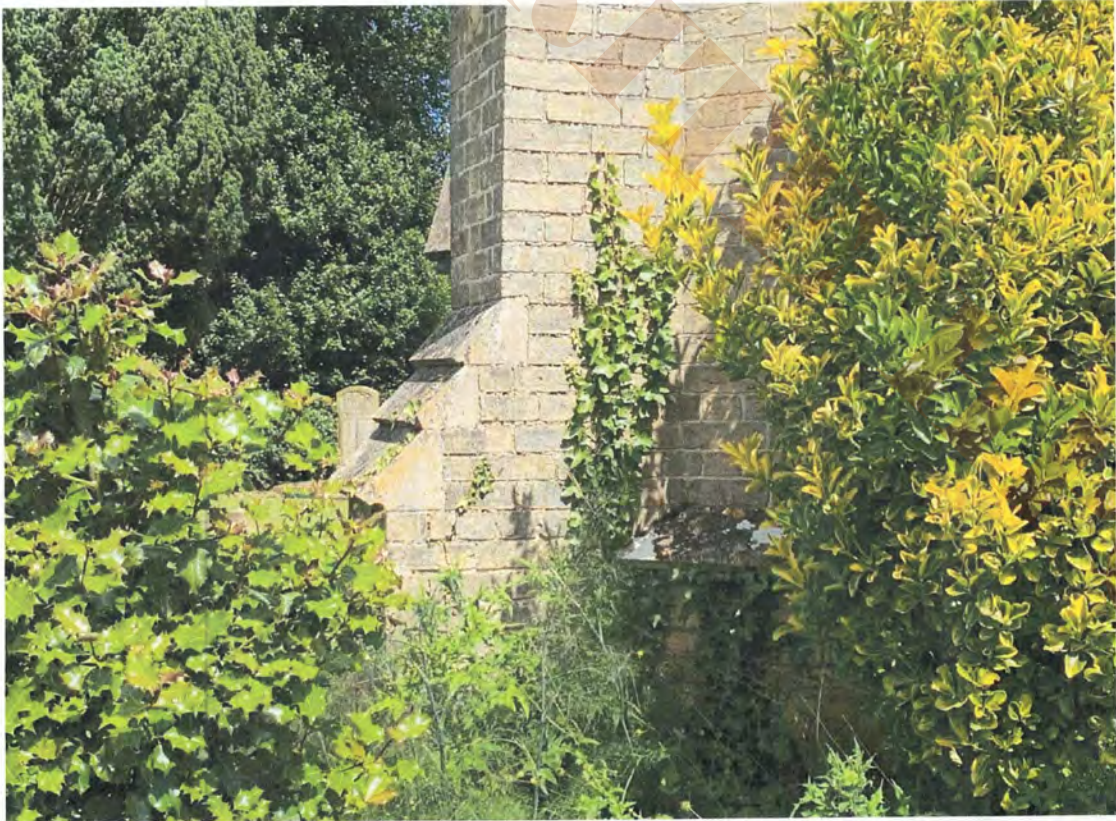
8.29 North chapel west elevation ivy

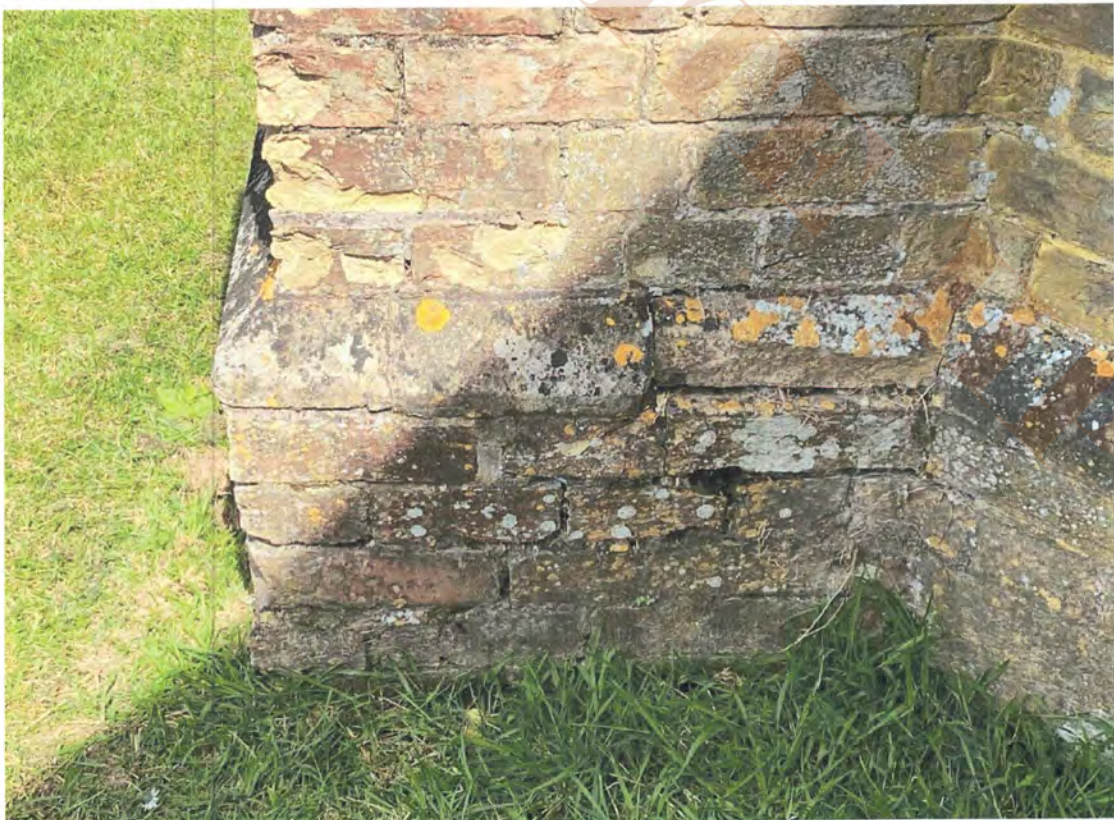
8.34 North porch north west buttress

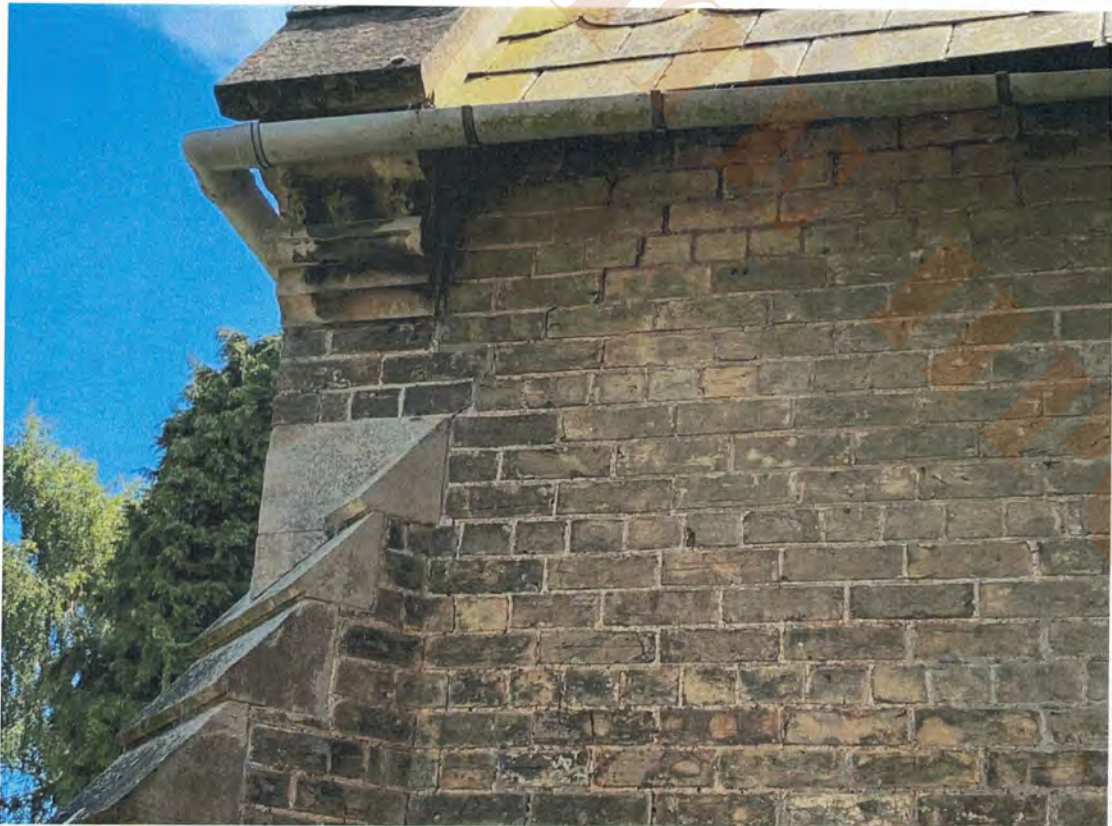
8.37 South chapel north elevation east of tower

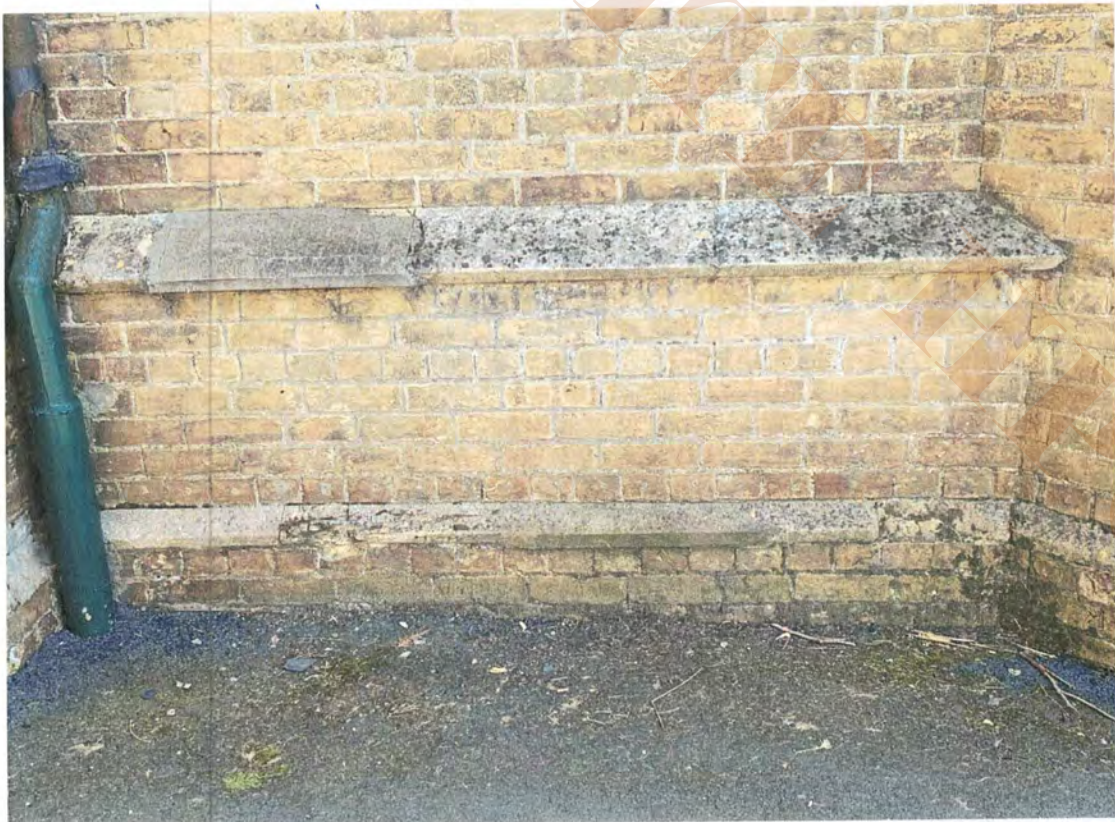
8.39 South chapel north elevation west of tower: plinth

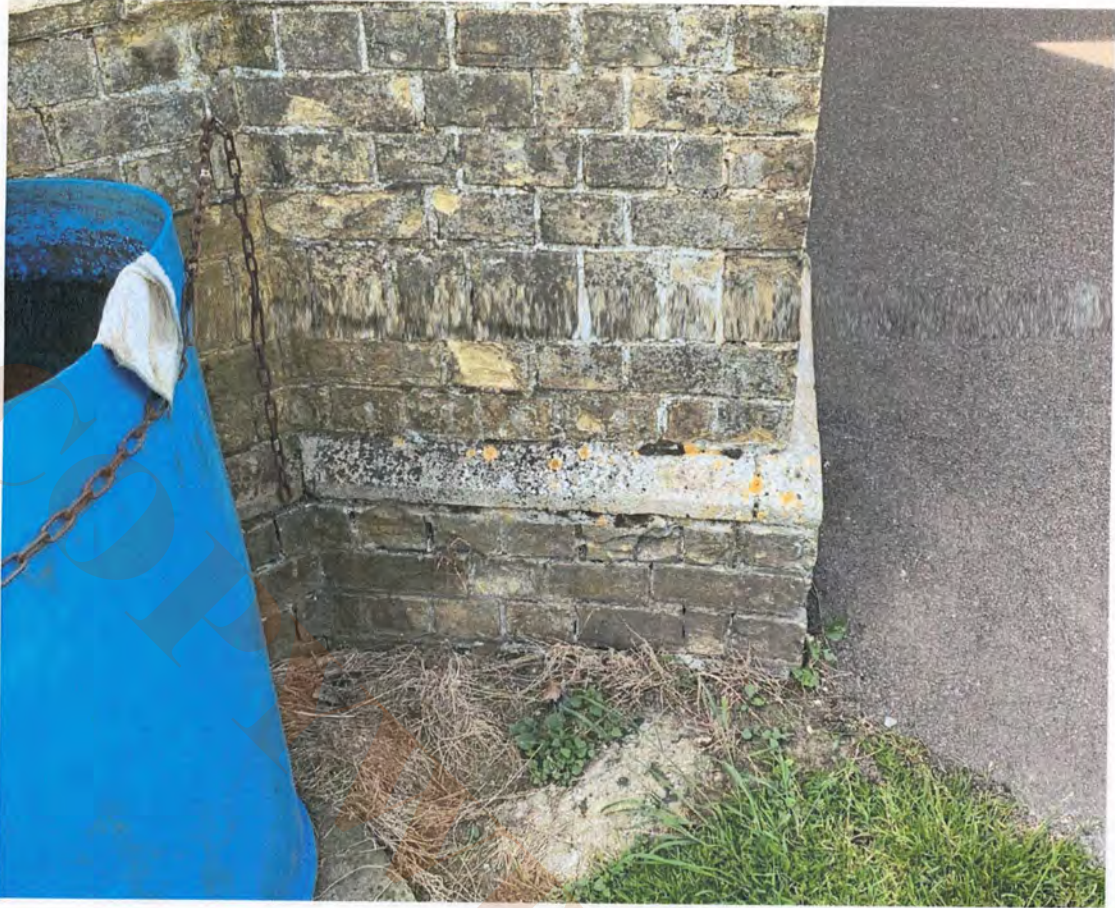
8.42 South chapel north east buttress

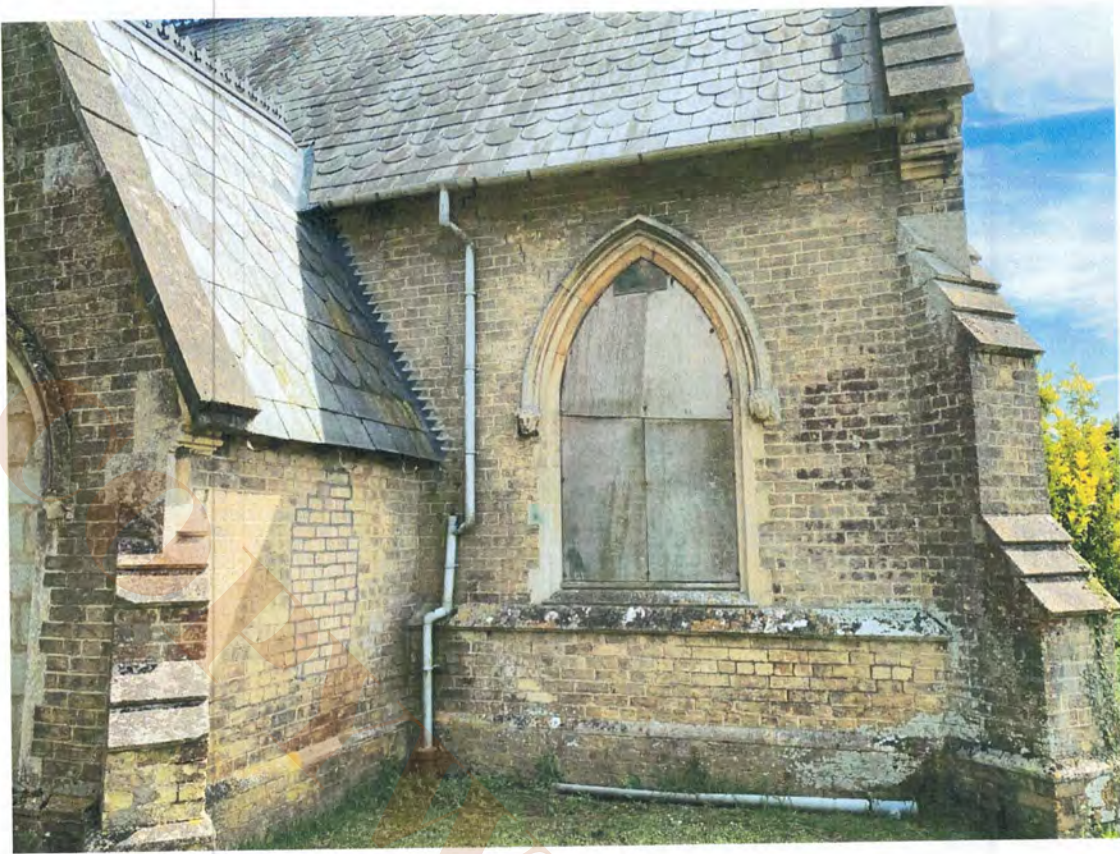
9.41 South porch south gable opening

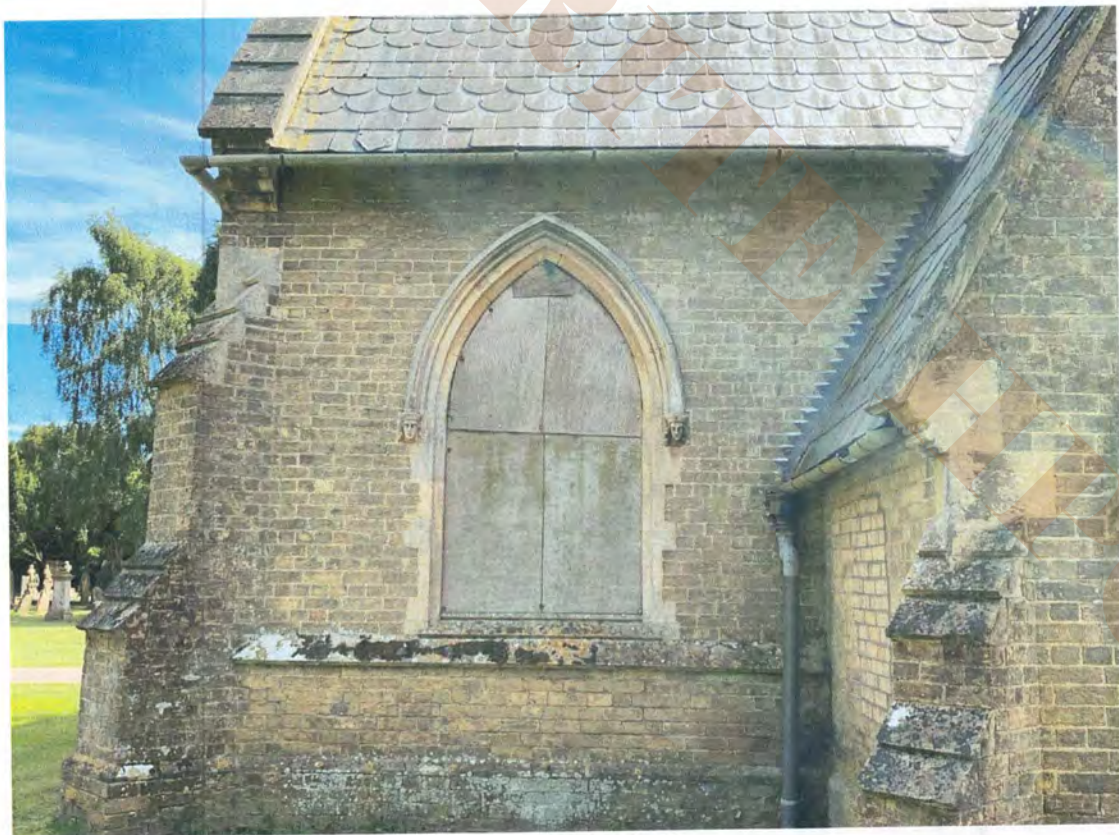
10.2 North chapel rainwater goods: west of the porch

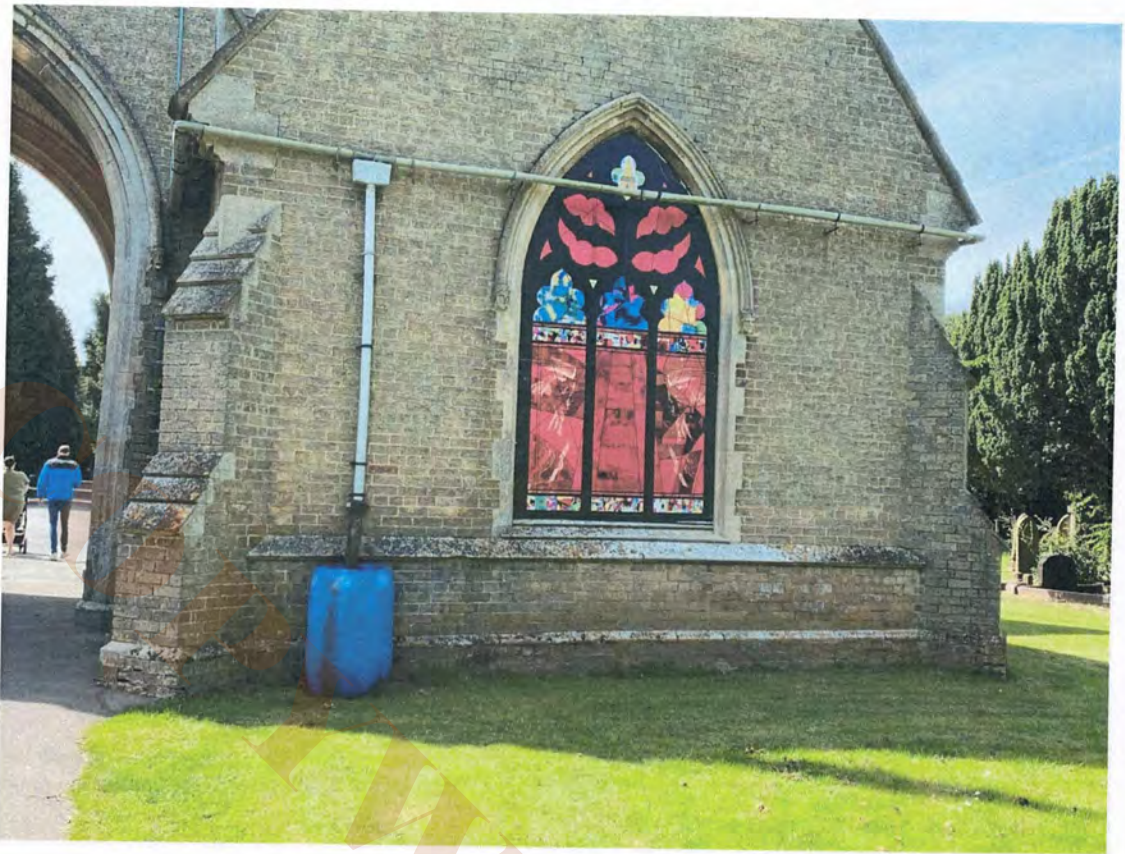
10.3 North chapel rainwater goods: east of porch

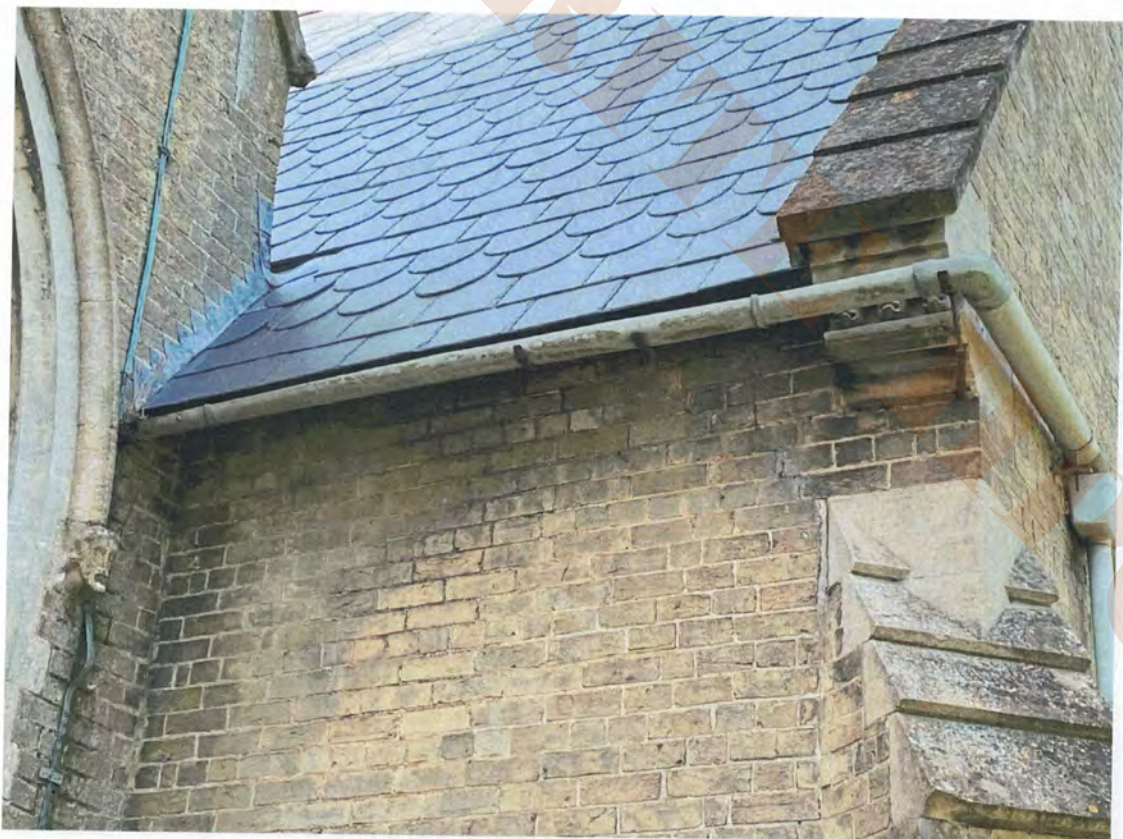
10.3 North chapel rainwater goods on east elevation

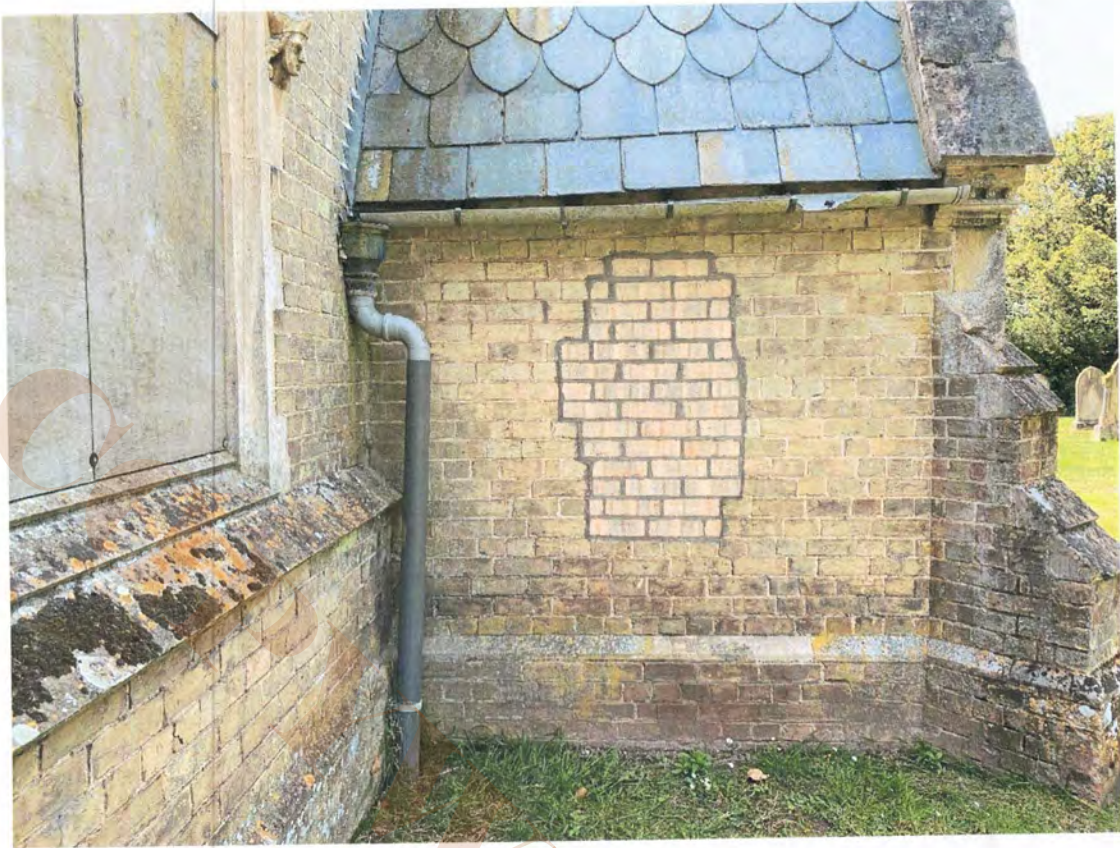
10.4 North chapel rainwater goods: south eaves east of tower

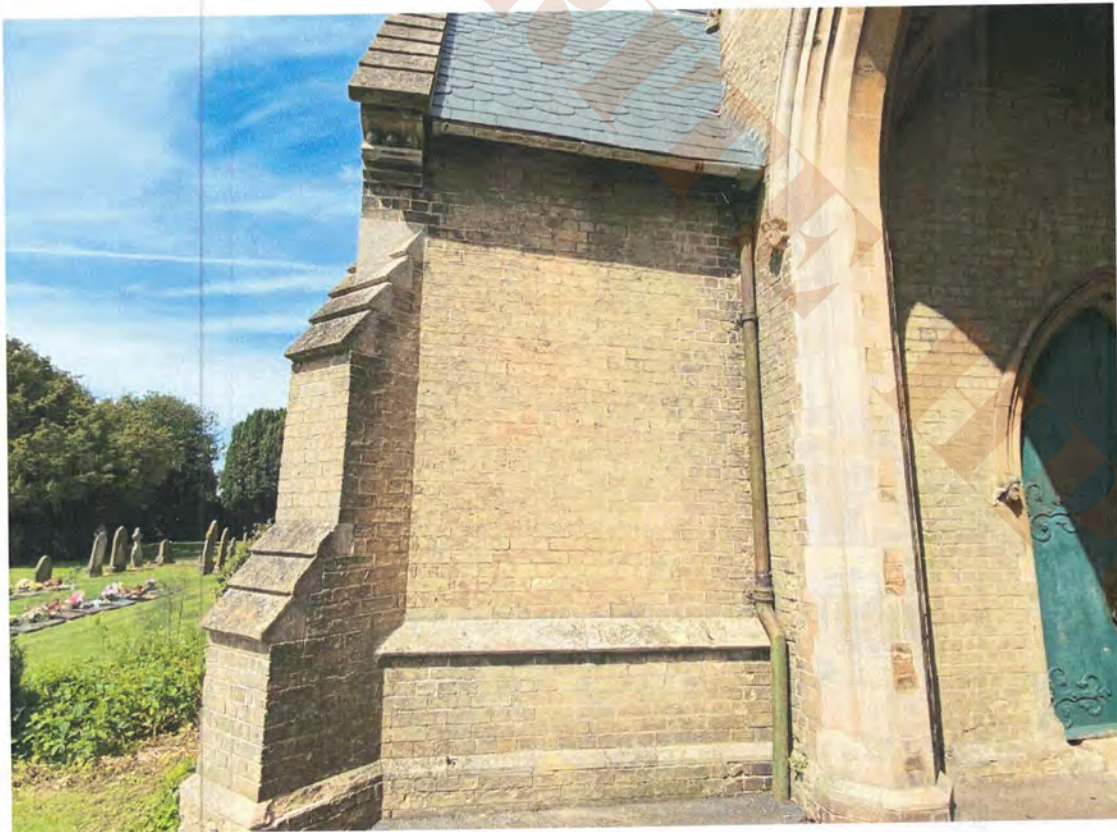
10.4 North porch west eaves

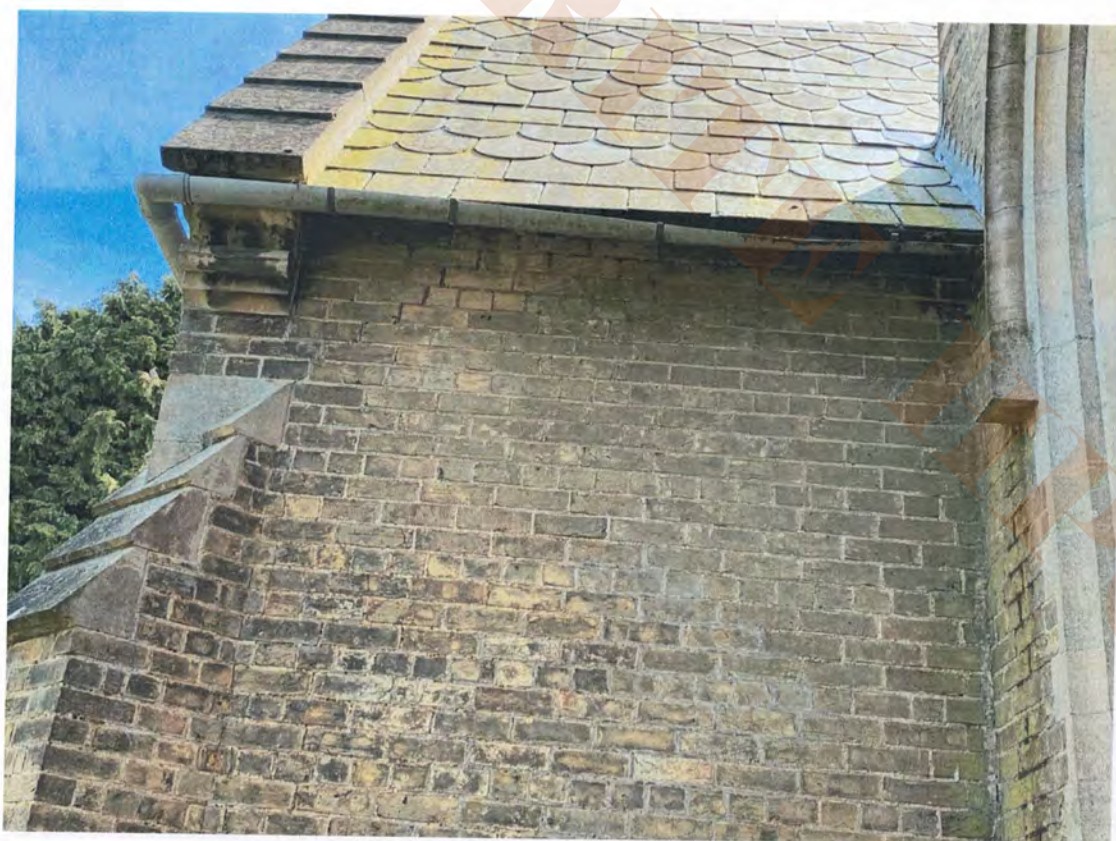
10.6 North porch east eaves
