CONDITION REPORT 2024

of
HOLBEACH CEMETERY CHAPELS

Date of inspection: 19th June 2024

**CONDITION REPORT: UPDATED 2024
HOLBEACH CEMETERY CHAPELS**

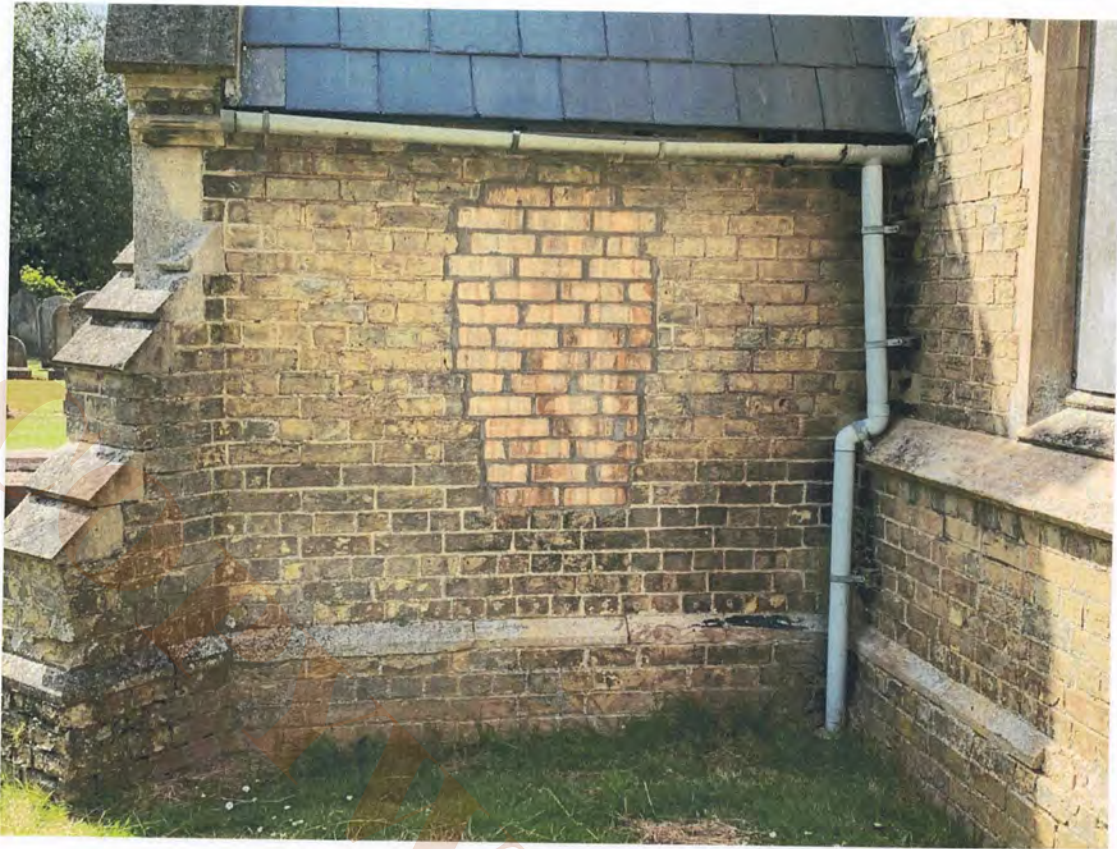
10.11 South chapel south rainwater goods west of porch

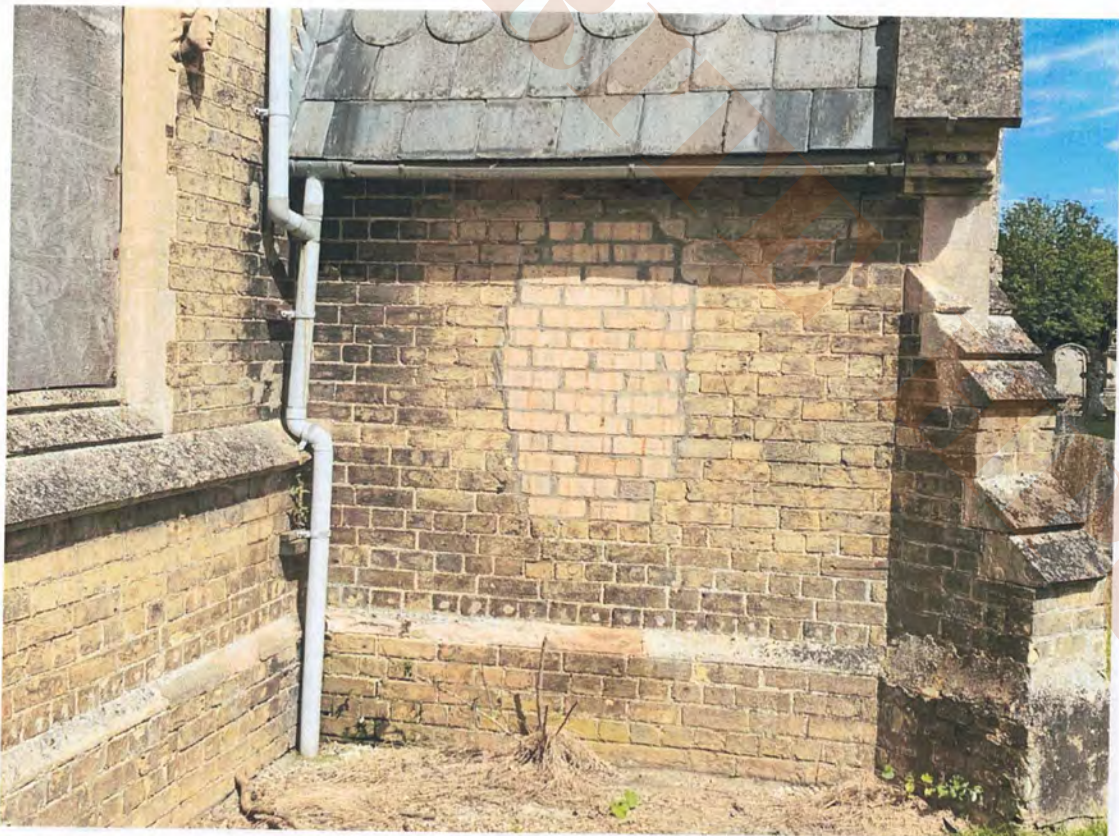
10.12 South porch rainwater goods east eaves

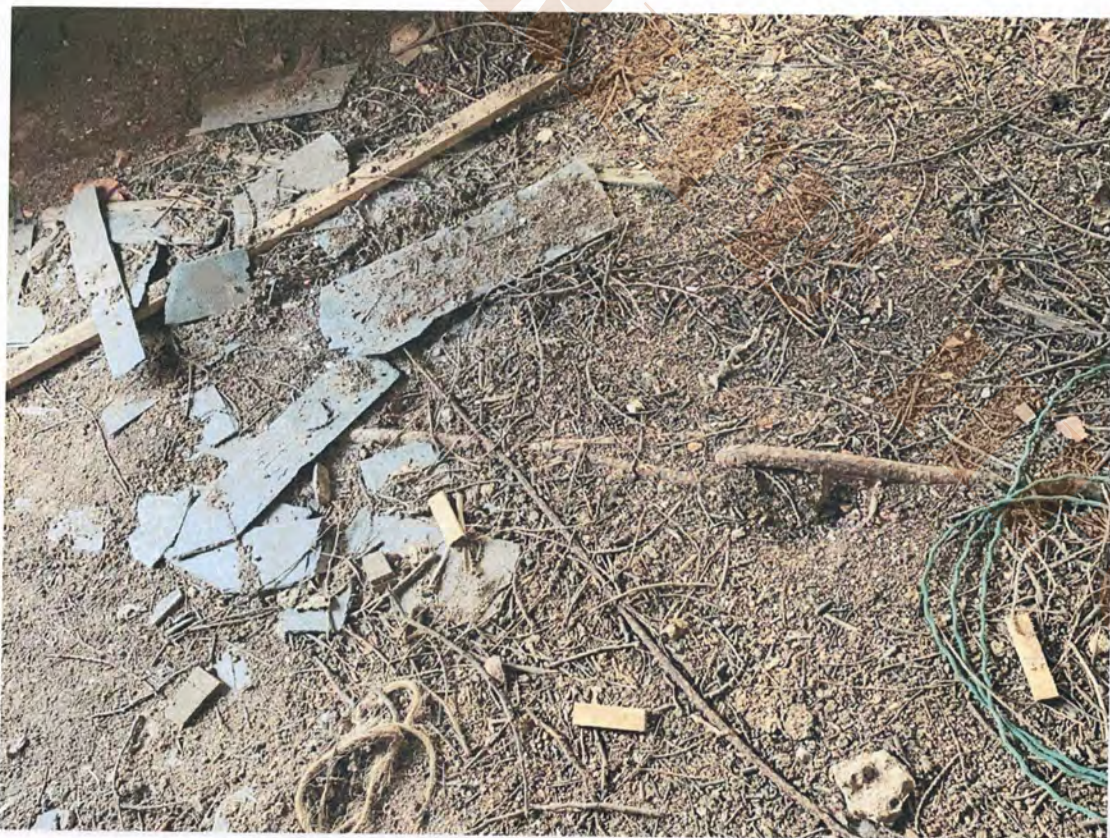
11.4 Tower lower chamber interior

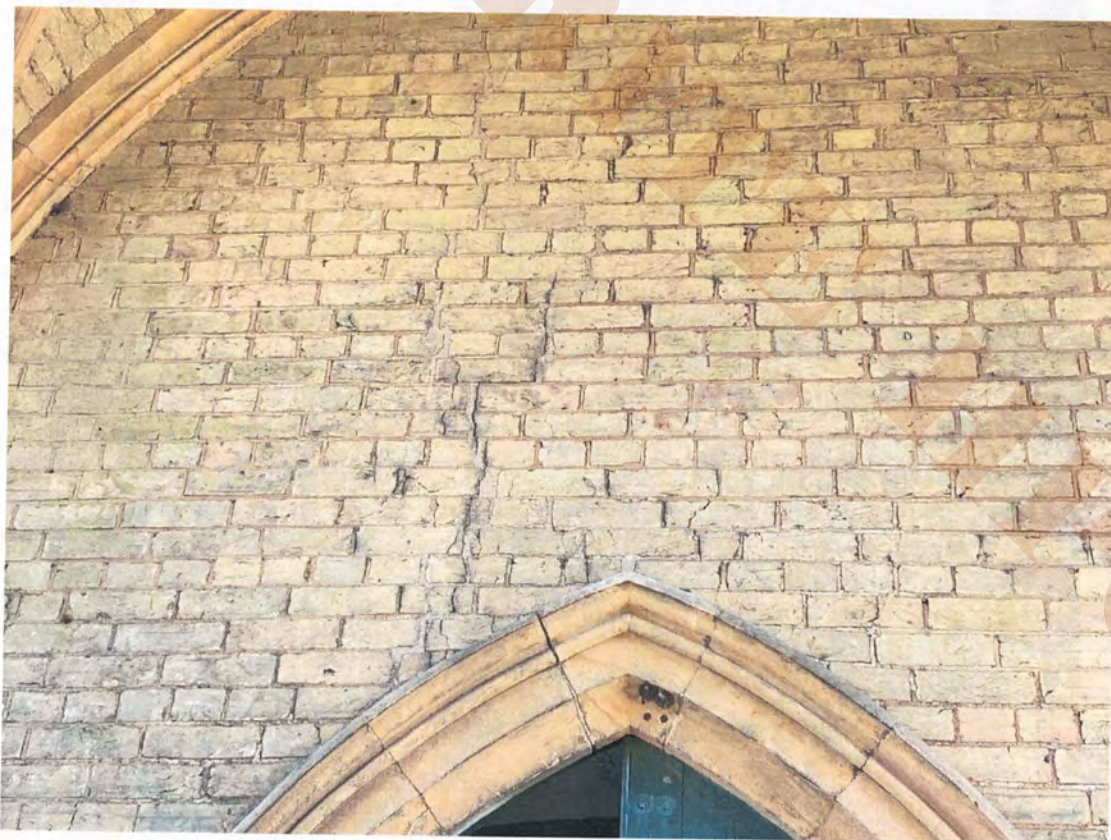
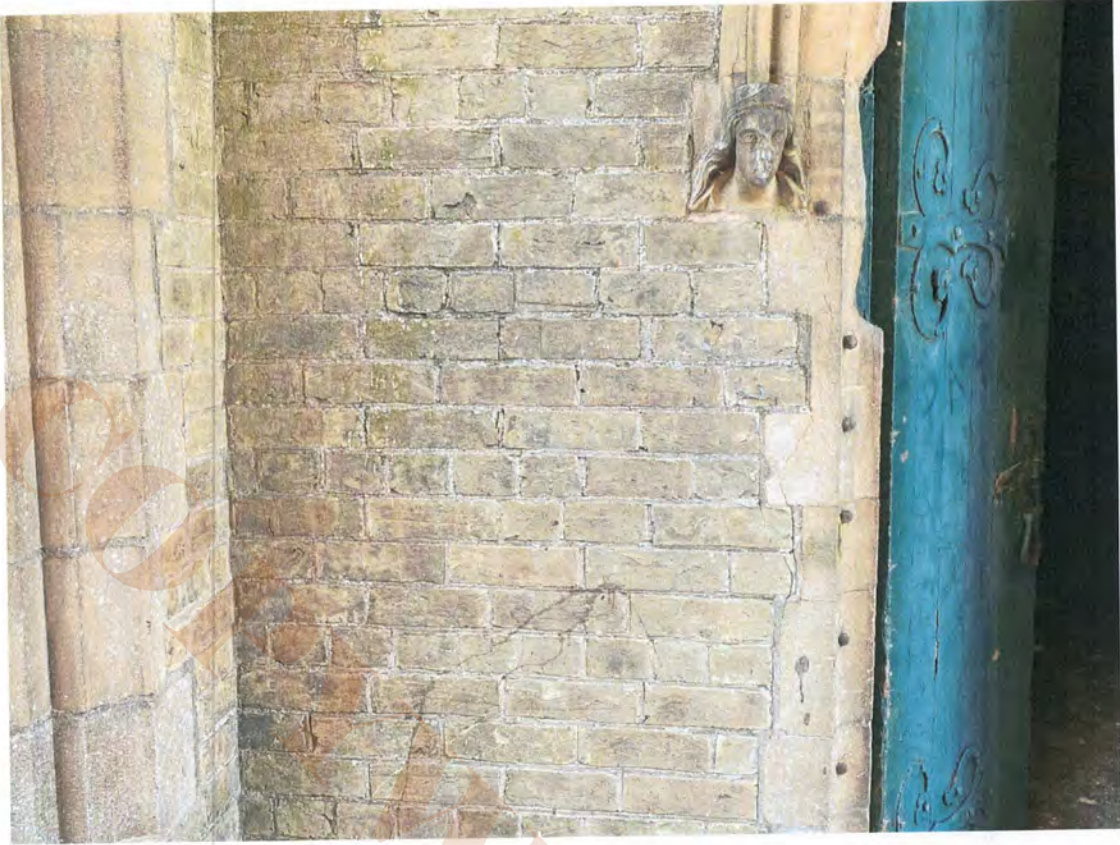
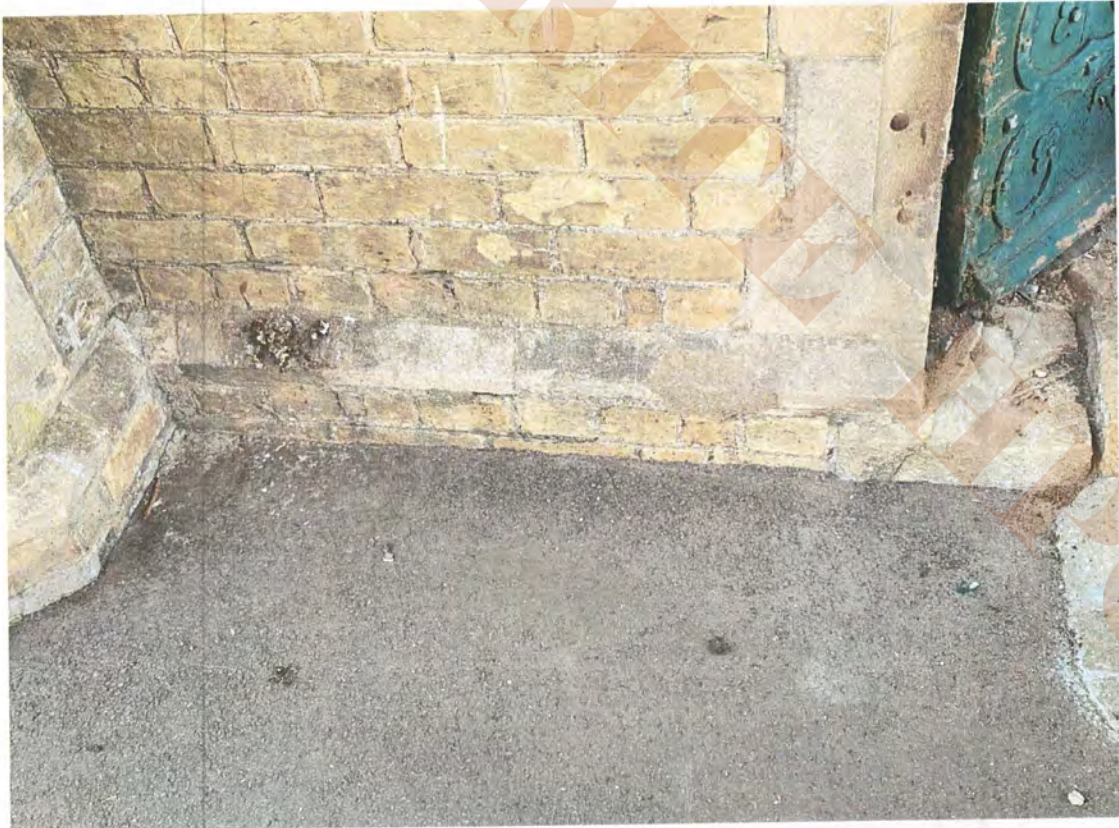
11.9 Carriageway north wall east

11.9 Carriageway north wall

11.9 Carriageway north wall west

- 11.7 **Carriage porch interior:** stone renewals may be needed
- 11.8 **Ground floor of the carriageway:** boot scrapers could be repainted
- 11.9 **North internal wall:** point cracking above the door head and adjacent to the stonework of the door

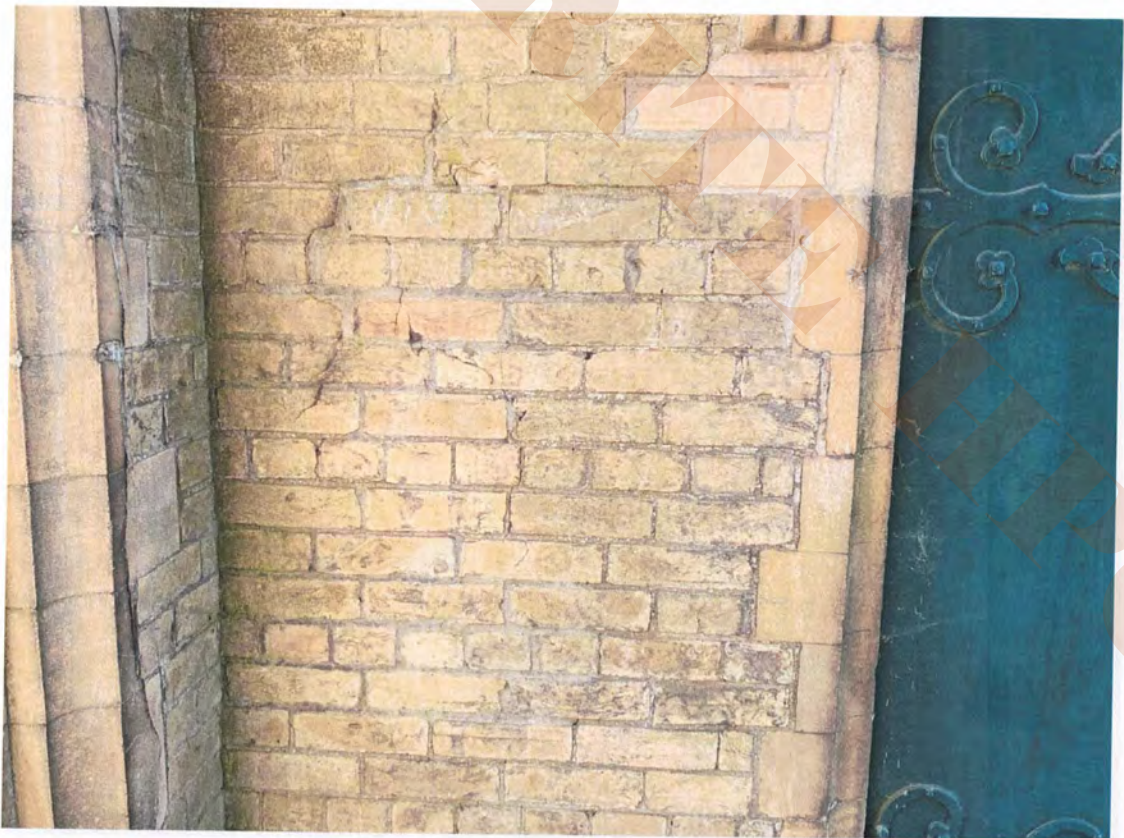
11.11, 11.12 North doorway

- 11.10 **Carriage porch north internal wall:** piece repair stonework of the plinth offset
- 11.11 **North doorway:** remove iron bolts holding the door frame and secure independently, stone renewals on the west jamb

- 11.12 **Carriage porch north door:** repaint door, some repair will be needed in association
- 11.13 **Carriage porch south internal wall:** drill and stitch. Assume iron straps, renew with stainless steel

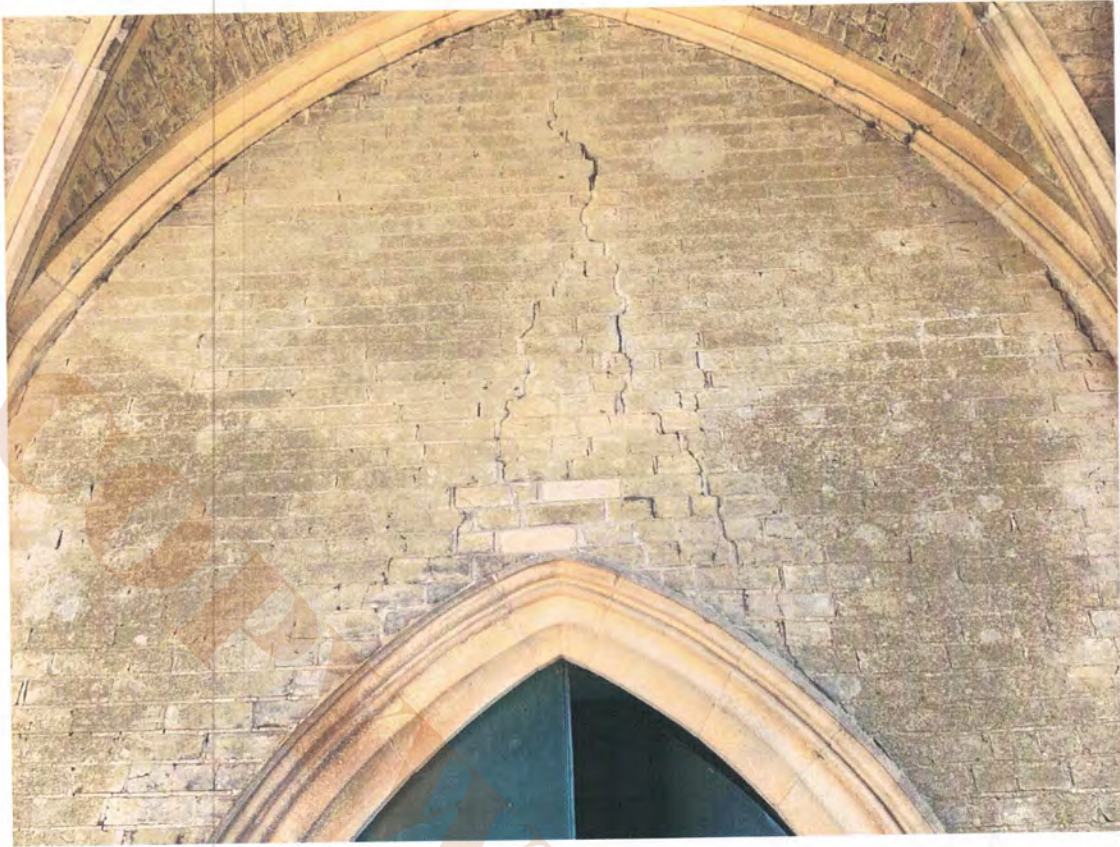
11.13 Carriageway south wall east

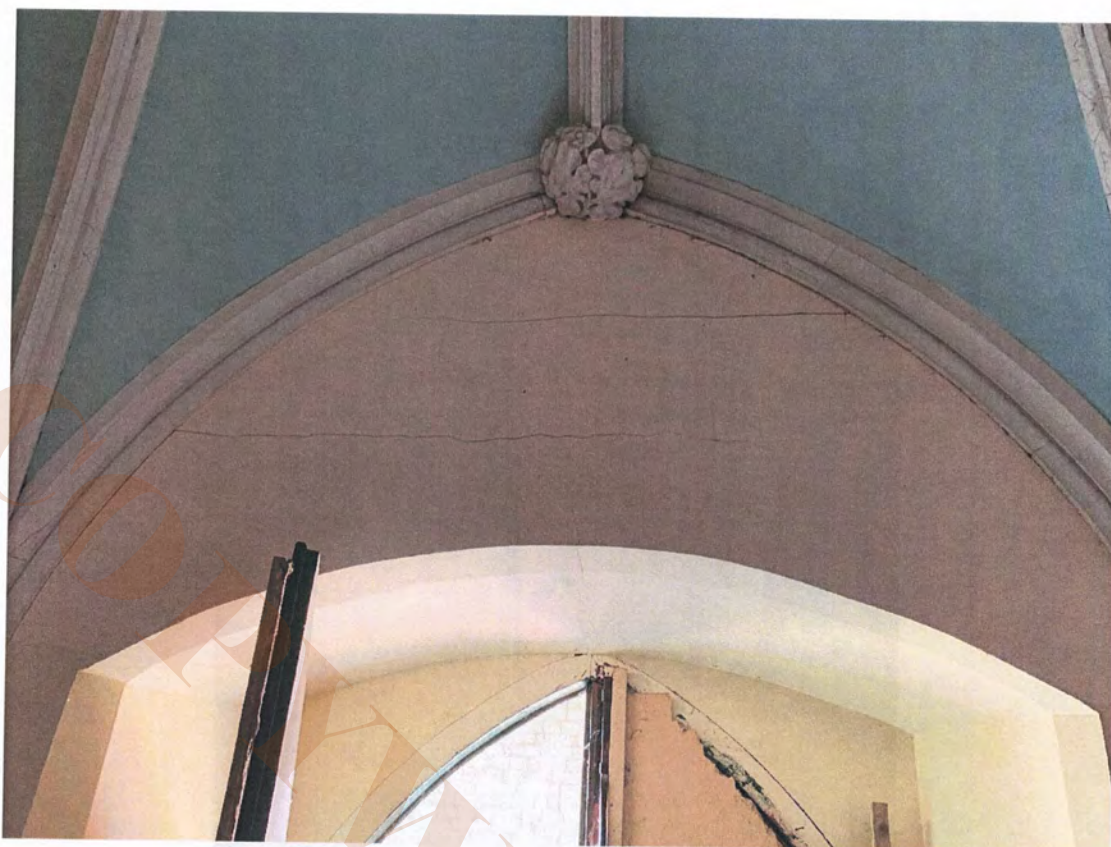
11.20 South chapel ceiling (cracking)

- 11.19 **South chapel interior:** redecorate door
- 11.20 **South chapel interior:** plaster repairs
- 11.22 **South chapel interior:** repair brickwork

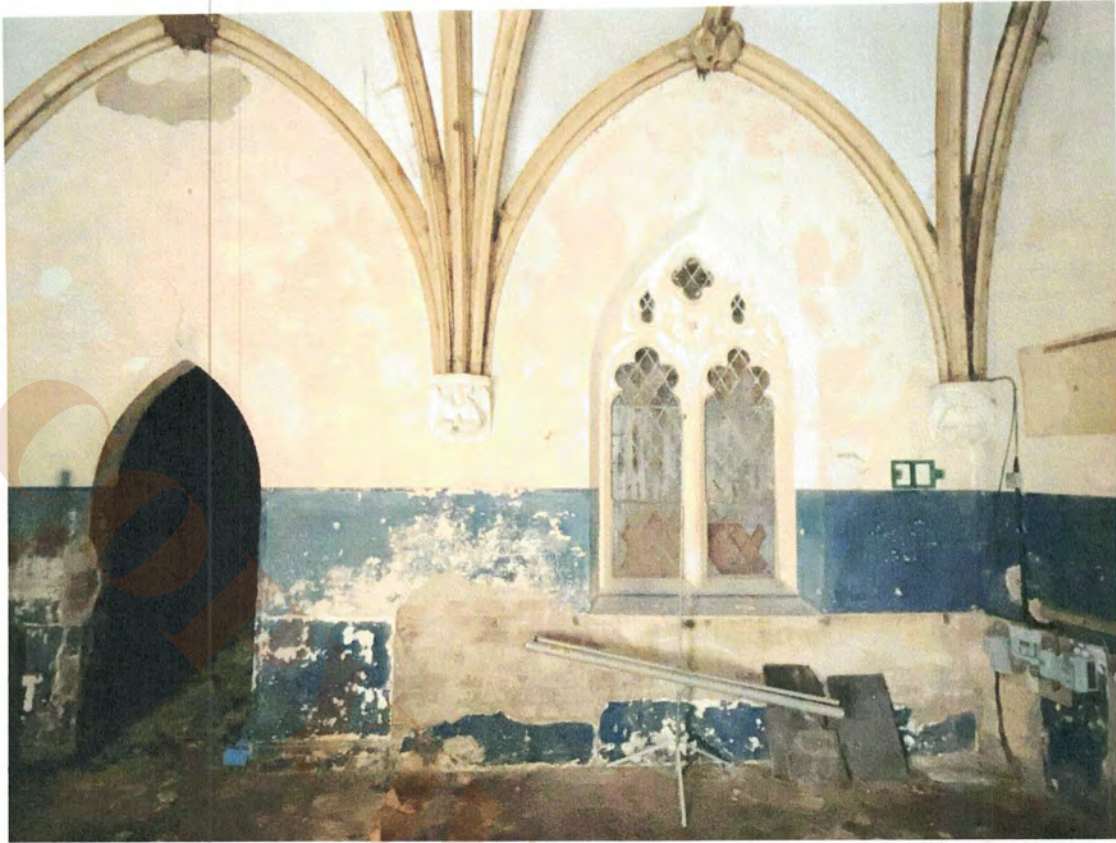
11.35 North chapel south interior

- 11.34 **North chapel interior:** renew defective plaster to the vault
- 11.35 **North chapel interior:** strip and renew plasterwork to south wall
- 11:36 **North chapel interior:** north and west wall plaster repairs. Redecorate generally

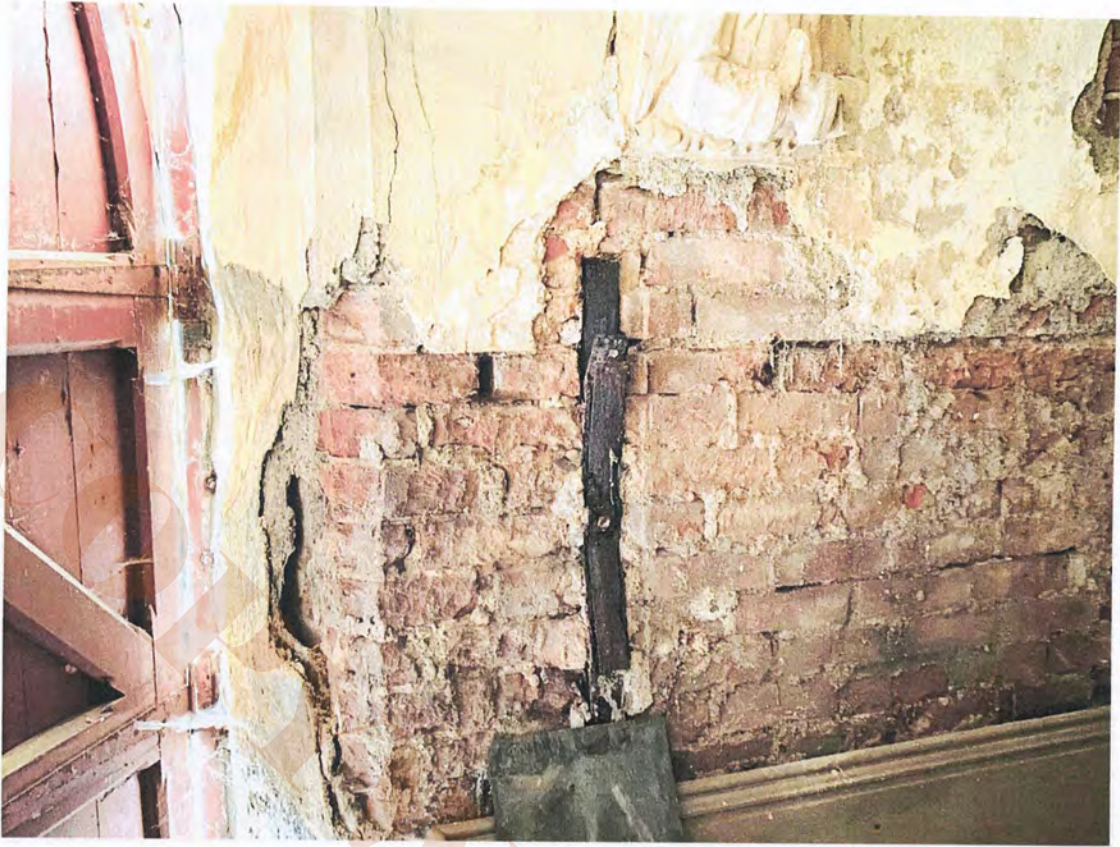
11.36 North chapel north interior
