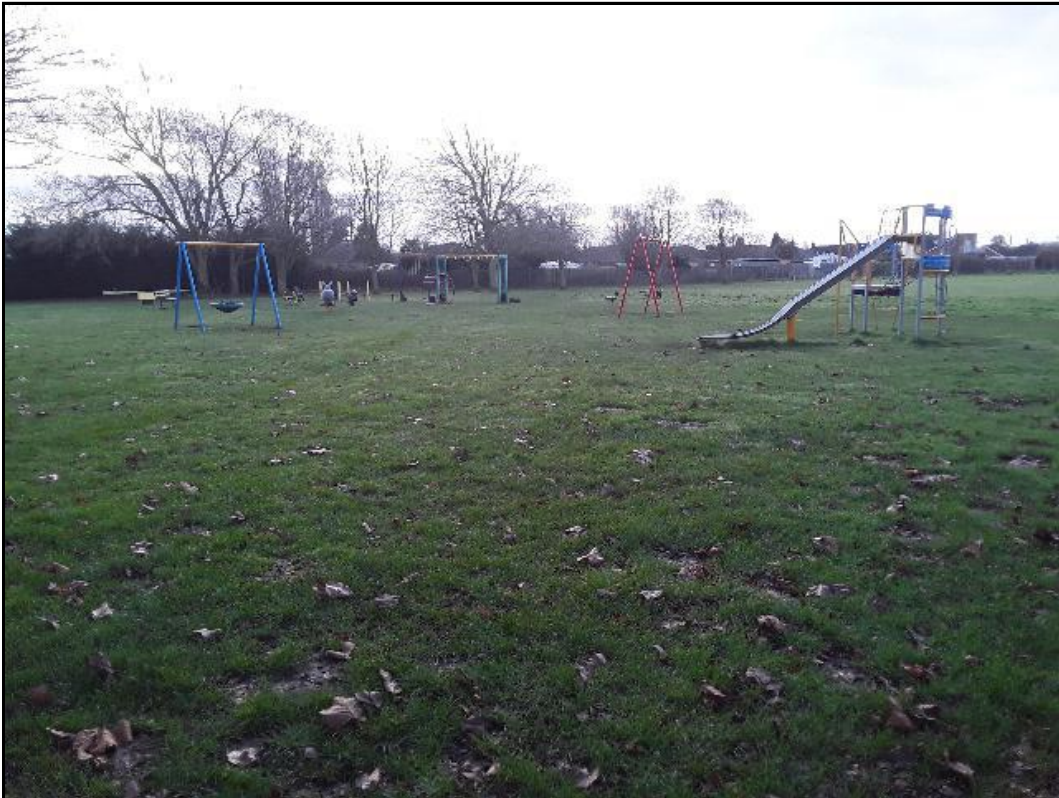
Risk Assessment: 8 Low Risk

The site is partially overlooked by properties in the local community

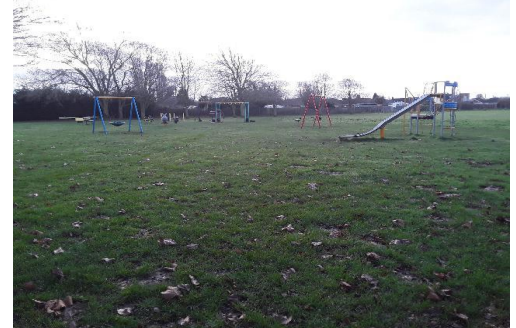
i 8 - Low Risk

Item: Site General
Manufacturer: Owner/Operator
Surface Type: N/A
Item Quantity: 1
Equipment Compliance: N/A
Surface Area Compliance: N/A

Total Findings: 2

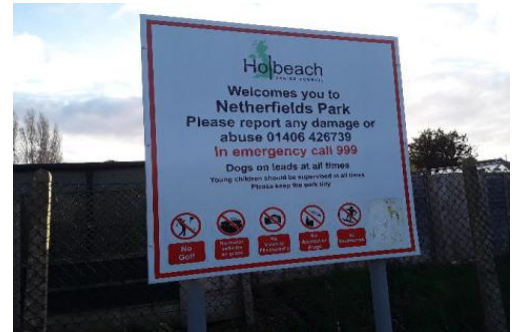
i 5 - Very Low Risk

Item: Sign
Manufacturer: Not Identified
Surface Type: Grass
Item Quantity: 1
Equipment Compliance: N/A
Surface Area Compliance: N/A

Total Findings: 1

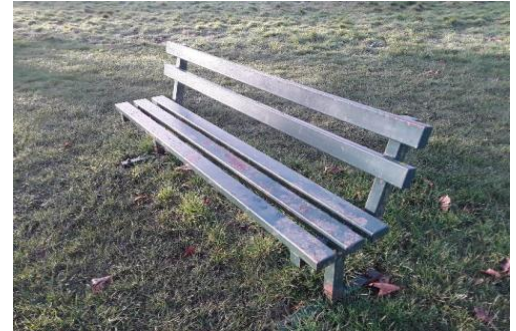
i 6 - Low Risk

Item: Bench
Manufacturer: Wicksteed Playgrounds
Surface Type: Grass
Item Quantity: 2
Equipment Compliance: N/A
Surface Area Compliance: N/A

Total Findings: 1

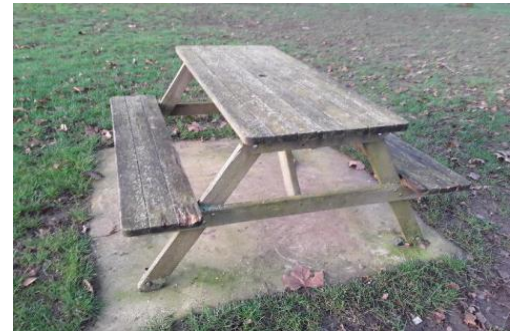
Item: Picnic Table
Manufacturer: Not Identified
Surface Type: Concrete
Item Quantity: 1
Equipment Compliance: N/A
Surface Area Compliance: N/A

There is minor rot in the timber - Monitor for any further deterioration and replace as required

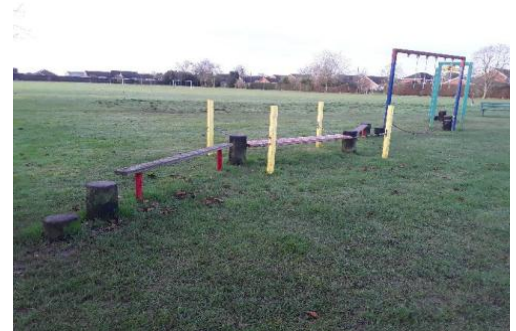
Item: Activity Trail
Manufacturer: Not Identified
Surface Type: Grass
Item Quantity: 1
Equipment Compliance: Yes
Surface Area Compliance: Yes
Life Expectancy: 5 -10 Years
Total Findings: 7

There are projecting bolt thread(s) present - Remove excess thread length and deburr or provide cap

There is/are bolt cap covers missing or damaged on the item - Replace missing or damaged bolt cap covers

The fixings have corroded - Replace all corroded fixings

The paintwork on this item has been damaged or worn exposing the metal underneath which is rusting / corroding - Treat affected areas and repaint

The item has a missing grab chain - Replace the missing chain

The connecting lugs are showing signs of wear - Monitor for any further deterioration and repair as required

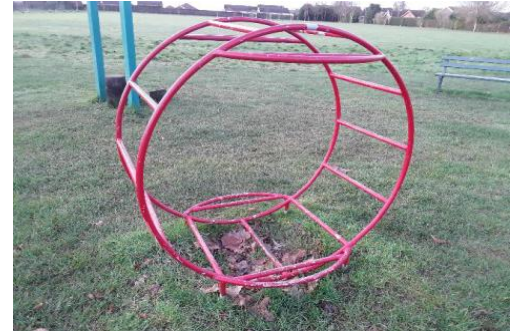
Item: Climbing Frame
Manufacturer: Wicksteed Playgrounds
Surface Type: Grass
Item Quantity: 1
Equipment Compliance: No
Surface Area Compliance: Yes
Life Expectancy: 5 -10 Years
Total Findings: 3

There are falls in excess of 600mm between adjacent components on the structure, in contravention of the recommendations set out in BS EN 1176 Part 1; 4.2.8.4 - Monitor - No action given the risk assessment

The item fails to meet the requirements of BS EN 1176 Part 1 4.2.7.2 for head and neck entrapment in the framework - Monitor - No action given the risk assessment

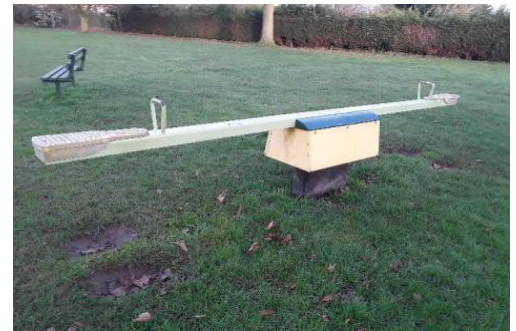
Item: See Saw
Manufacturer: Wicksteed Playgrounds
Surface Type: Grass
Item Quantity: 1
Equipment Compliance: Yes
Surface Area Compliance: Yes
Life Expectancy: 5 -10 Years
Total Findings: 4

The area around the item has eroded creating trip hazards and may become slippery when wet - Reinstate eroded area

There is surface corrosion / rust present on the item - Consider treating the item

There is or are fixings missing on the item - Replace all missing fixings

The item is slightly loose in its foundations - Monitor for any further deterioration and repair as required

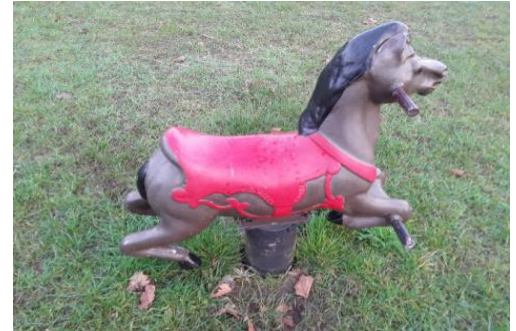
Item: Spring Horse
Manufacturer: Wicksteed Playgrounds
Surface Type: Grass
Item Quantity: 1
Equipment Compliance: No
Surface Area Compliance: Yes
Life Expectancy: 5 -10 Years
Total Findings: 4

The end of handgrips and/or footrests have a cross section of less than 15cm² and fail to meet the requirements of BS EN 1176 Part 6 - Monitor - No action given the risk assessment

The handgrips / footrests are damaged or missing - Replace the handgrips / footrests

The spring cover is damaged - Monitor and replace the cover if required

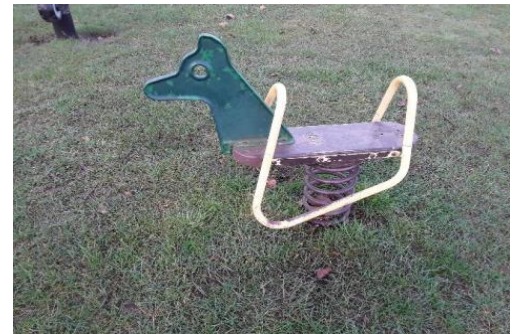
Item: Spring Horse
Manufacturer: Ausplay
Surface Type: Grass
Item Quantity: 1
Equipment Compliance: Yes
Surface Area Compliance: Yes
Life Expectancy: 3 - 5 Years
Total Findings: 3

There is surface corrosion / rust present on the item - Consider treating the item

The paintwork on the spring has been damaged or worn exposing the metal underneath which is rusting - Treat any rusting components and repaint

The item has missing component(s) - Consider replacing missing components

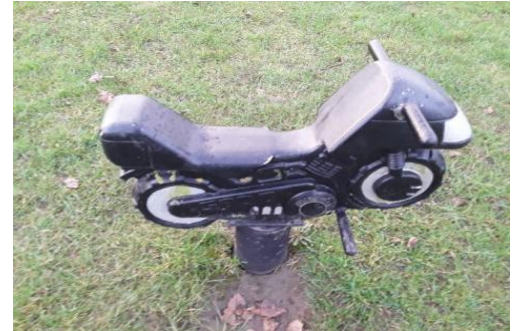
Item: Spring Bike
Manufacturer: Wicksteed Playgrounds
Surface Type: Grass
Item Quantity: 1
Equipment Compliance: No
Surface Area Compliance: Yes
Life Expectancy: 5 -10 Years
Total Findings: 4

The end of handgrips and/or footrests have a cross section of less than 15cm² and fail to meet the requirements of BS EN 1176 Part 6 - Monitor - No action given the risk assessment

The spring cover is damaged - Monitor and replace the cover if required

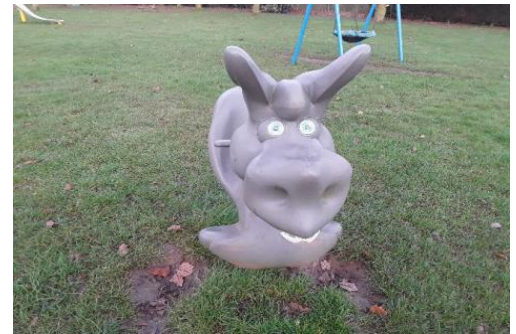
Item: Spring Donkey
Manufacturer: Wicksteed Playgrounds
Surface Type: Grass
Item Quantity: 1
Equipment Compliance: Yes
Surface Area Compliance: Yes
Life Expectancy: 5 -10 Years
Total Findings: 2

The paintwork on the spring has been damaged or worn exposing the metal underneath which is rusting - Treat any rusting components and repaint

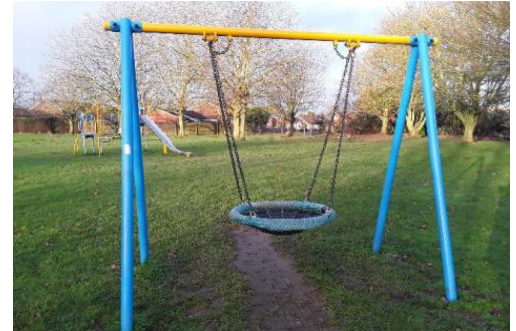
Item: Basket Swing - Type 1
Manufacturer: Wicksteed Playgrounds
Surface Type: Grass Matrix Tiles
Item Quantity: 1
Equipment Compliance: Yes
Surface Area Compliance: Yes
Life Expectancy: 5 -10 Years
Total Findings: 3

There is/are bolt cap covers missing or damaged on the item - Replace missing or damaged bolt cap covers

The chain openings are in excess of the 8.6mm as recommended by BS EN 1176 - Monitor - No action given the risk assessment

The ropes/nets are worn/damaged in places - Monitor for any further deterioration and repair or replace as required

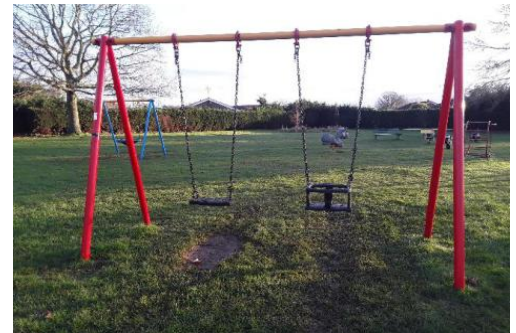
Item: 1 Bay Mixed Seat, 1 Cradle, 1 Flat
Manufacturer: Wicksteed Playgrounds
Surface Type: Grass Matrix Tiles
Item Quantity: 1
Equipment Compliance: Yes
Surface Area Compliance: Yes
Life Expectancy: 5 -10 Years
Total Findings: 1

There is redundant gaffa tape on the leg - Remove the tape

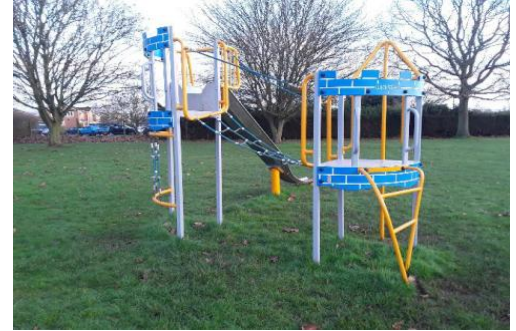
Item: Multi Play (Junior)
Manufacturer: Wicksteed Playgrounds
Surface Type: Grass Matrix Tiles
Item Quantity: 1
Equipment Compliance: No
Surface Area Compliance: Yes
Life Expectancy: 5 -10 Years
Total Findings: 2

There is/are end caps missing creating finger entrapment/s in the end openings and the item fails to meet the requirements of BS EN 1176 Part 1 4.2.7.6 Entrapment of fingers - Replace the missing end caps

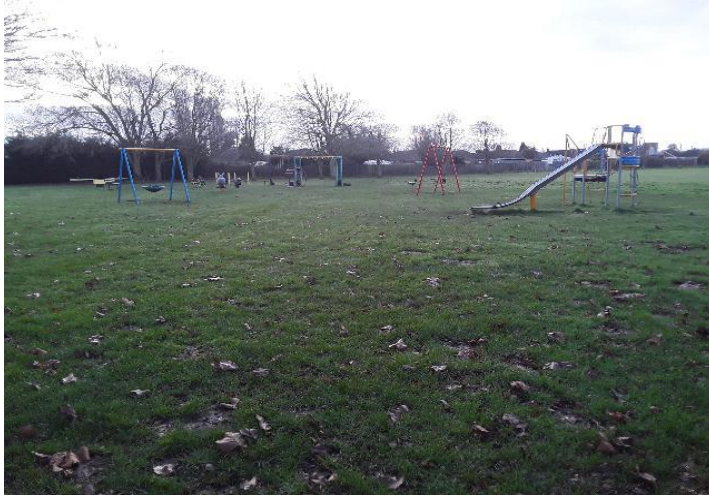
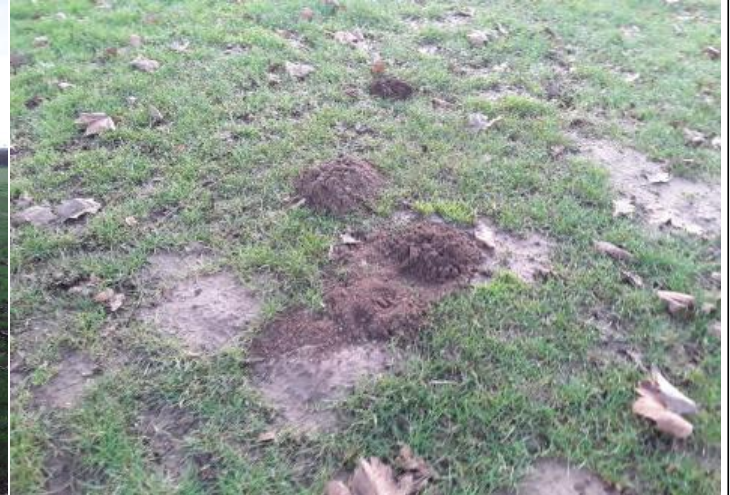
Item: Ancillary Items - Site General
Manufacturer: Owner/Operator

Finding: There are a number of molehills within the area and these may present unforeseen hazards for users

Action: Remove moles by appropriate means, reinstate surfaces to level and maintain the area

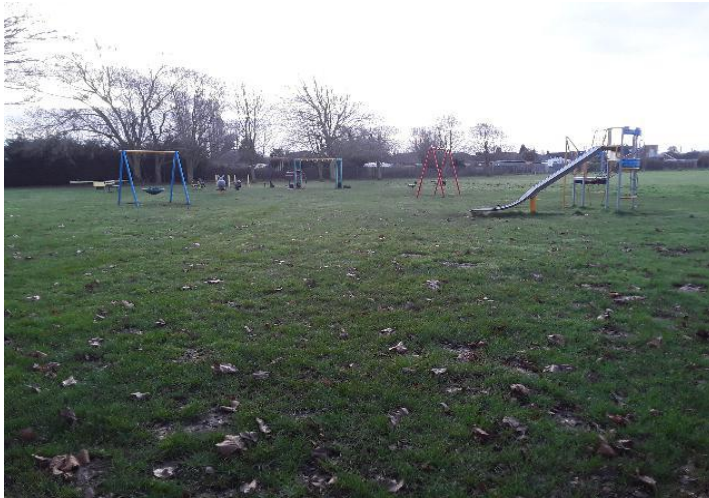
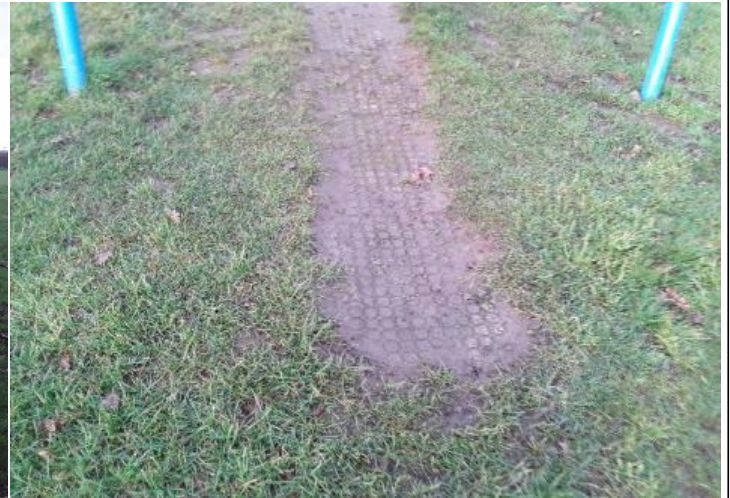
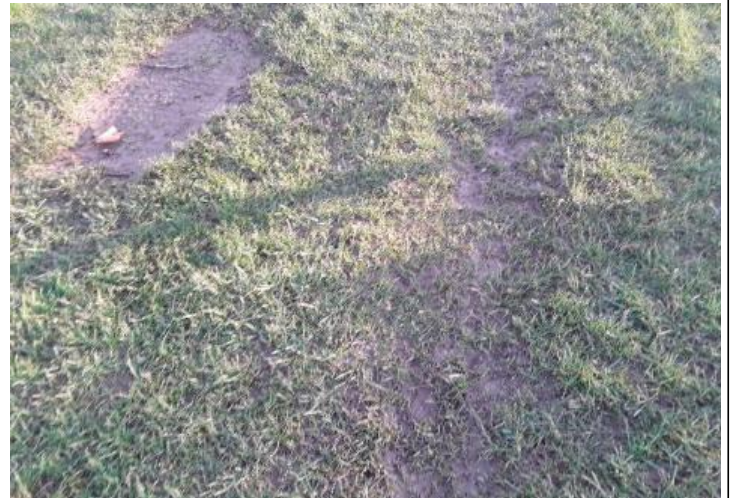
Item: Ancillary Items - Site General
Manufacturer: Owner/Operator

Finding: The grass mats are silted up, the soil is compacted and the area will become very slippery when the soil is wet. **Action:** Reinstate as required

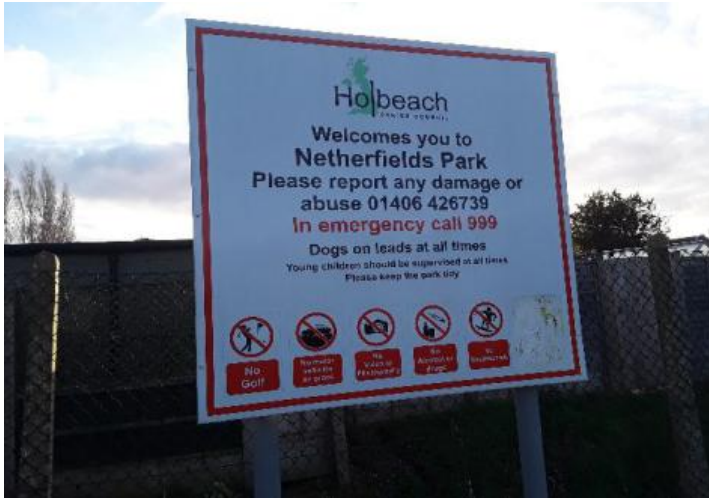
Item: Ancillary Items - Sign
Manufacturer: Not Identified

Finding: BS EN 1176 Part 7 recommends that signage shall include the site address
Action: Provide additional information

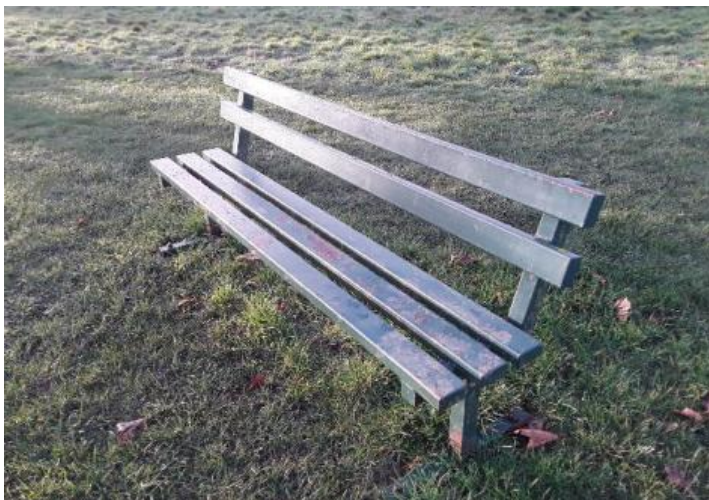
Item: Ancillary Items - Bench
Manufacturer: Wicksteed Playgrounds

Finding: The paintwork on this item has been damaged or worn exposing the metal underneath which is rusting / corroding
Action: Treat affected areas and repaint

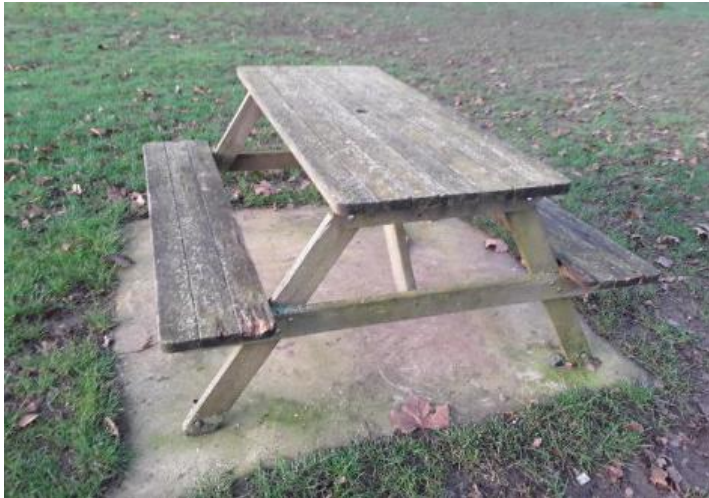
Item: Ancillary Items - Picnic Table
Manufacturer: Not Identified

Finding: There is minor rot in the timber

Action: Monitor for any further deterioration and replace as required

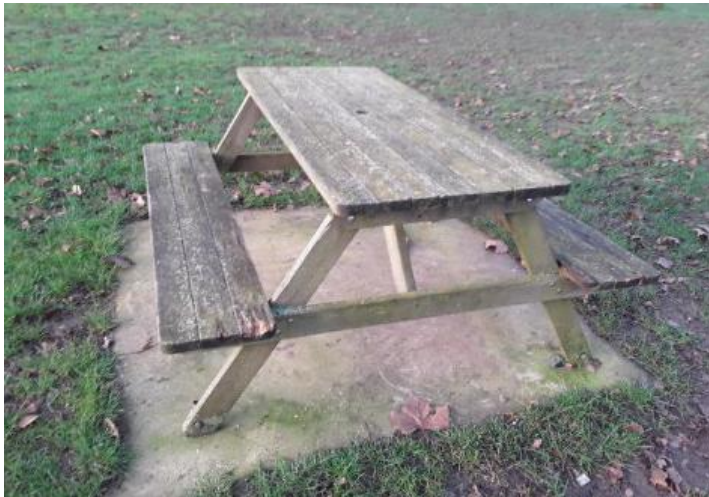
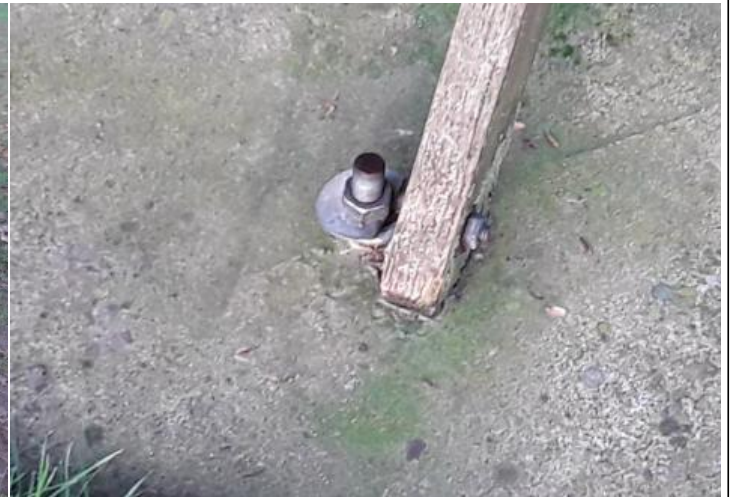
Item: Ancillary Items - Picnic Table
Manufacturer: Not Identified

Finding: There are projecting bolt thread(s) present

Action: Remove excess thread length and deburr or provide cap

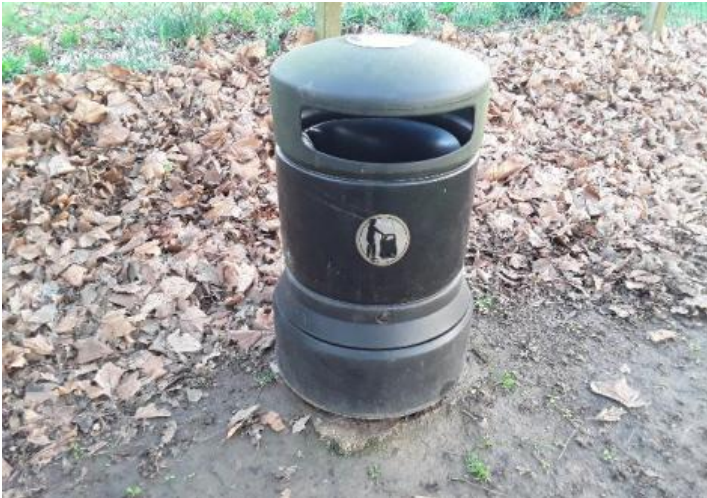
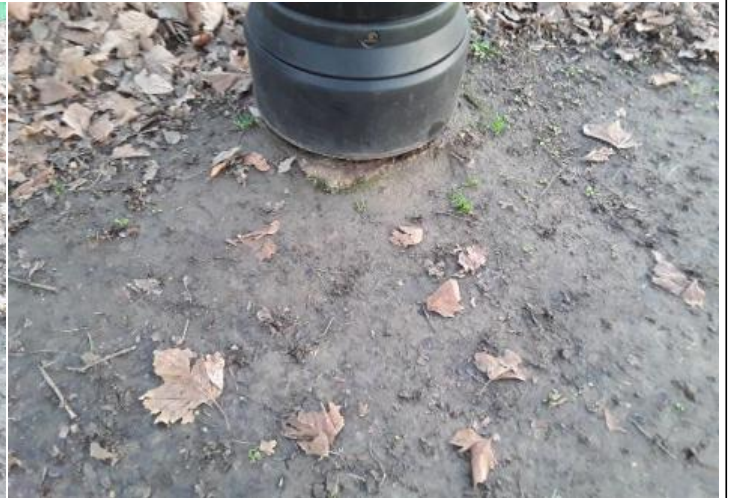
Item: Ancillary Items - Litter Bin
Manufacturer: Not Identified

Finding: The area around the item has eroded and may become slippery

Action: Reinstate eroded area

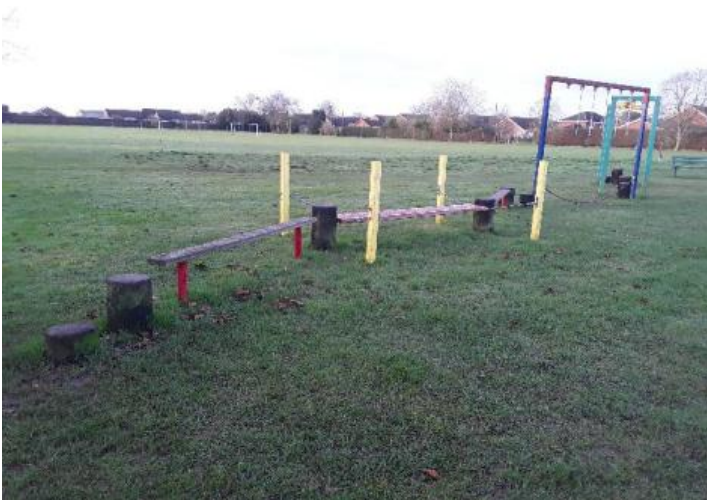
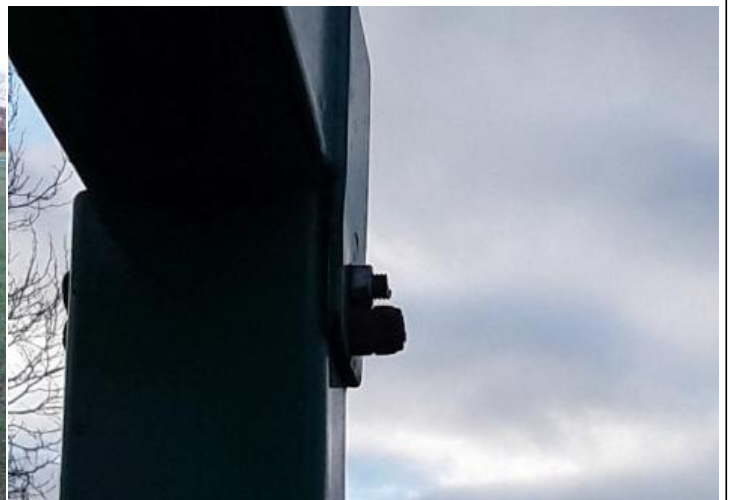
Item: Activity Equipment - Activity Trail
Manufacturer: Not Identified

Finding: There are projecting bolt thread(s) present

Action: Remove excess thread length and deburr or provide cap

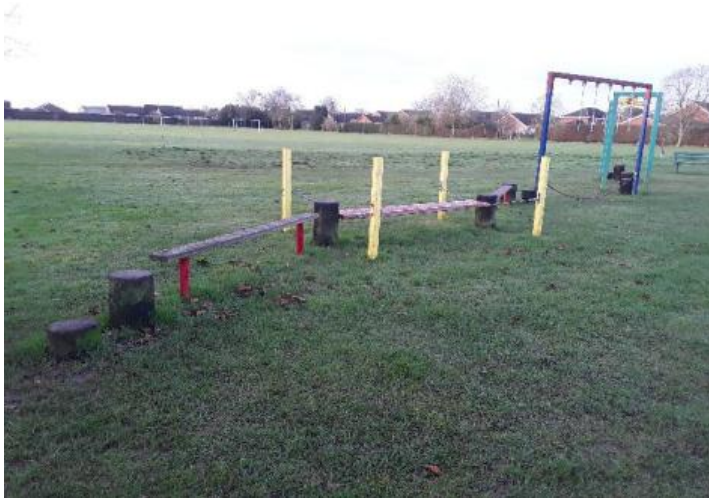
Item: Activity Equipment - Activity Trail
Manufacturer: Not Identified

Finding: There is/are bolt cap covers missing or damaged on the item

Action: Replace missing or damaged bolt cap covers

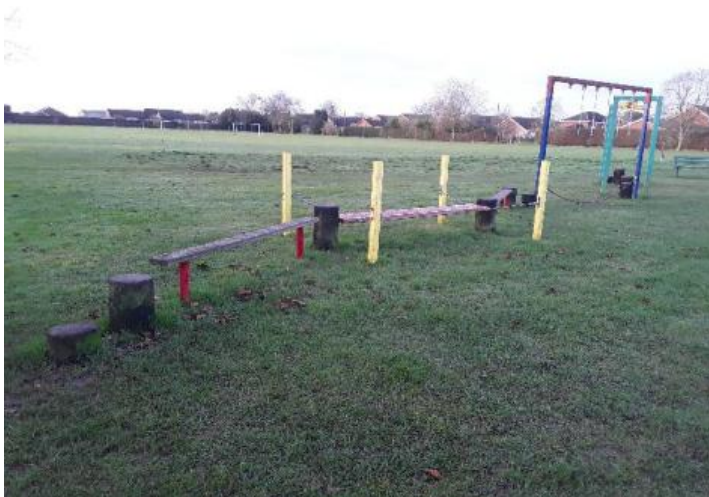
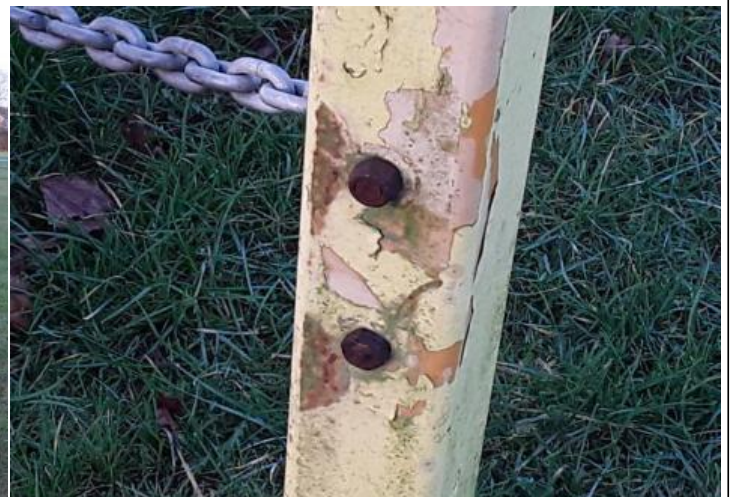
Item: Activity Equipment - Activity Trail
Manufacturer: Not Identified

Finding: The fixings have corroded

Action: Replace all corroded fixings

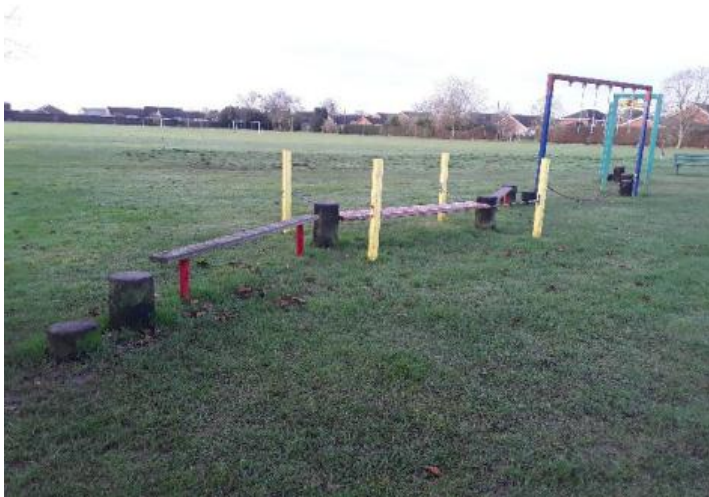
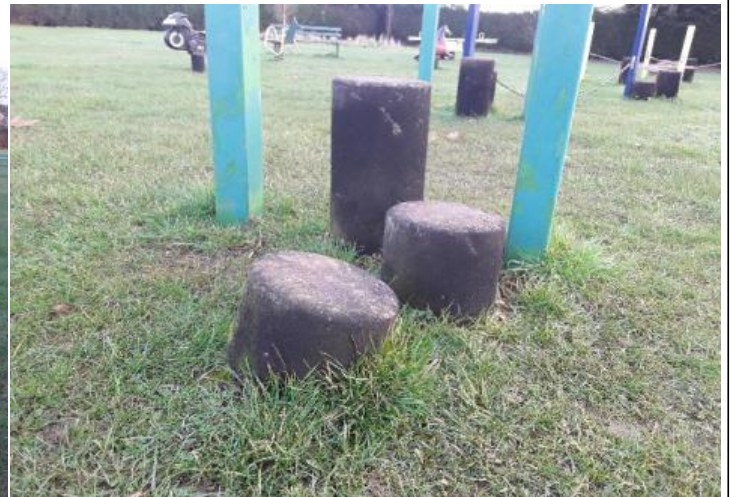
Item: Activity Equipment - Activity Trail
Manufacturer: Not Identified

Finding: One stepping post is out of plumb

Action: Reset the stepping post

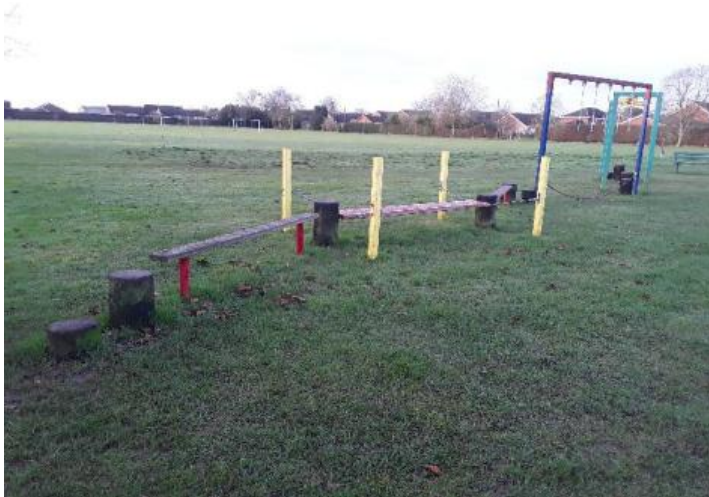
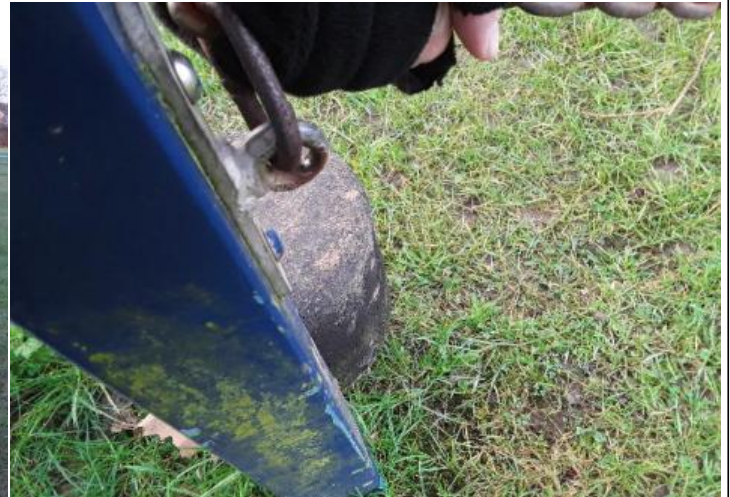
Item: Activity Equipment - Activity Trail
Manufacturer: Not Identified

Finding: The connecting lugs are showing signs of wear

Action: Monitor for any further deterioration and repair as required

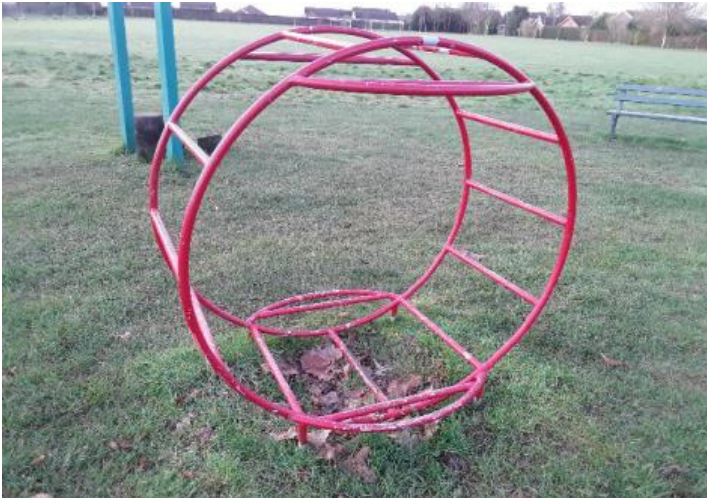
Item: Activity Equipment - Climbing Frame
Manufacturer: Wicksteed Playgrounds

Finding: There are falls in excess of 600mm between adjacent components on the structure, in contravention of the recommendations set out in BS EN 1176 Part 1; 4.2.8.4

Action: Monitor - No action given the risk assessment

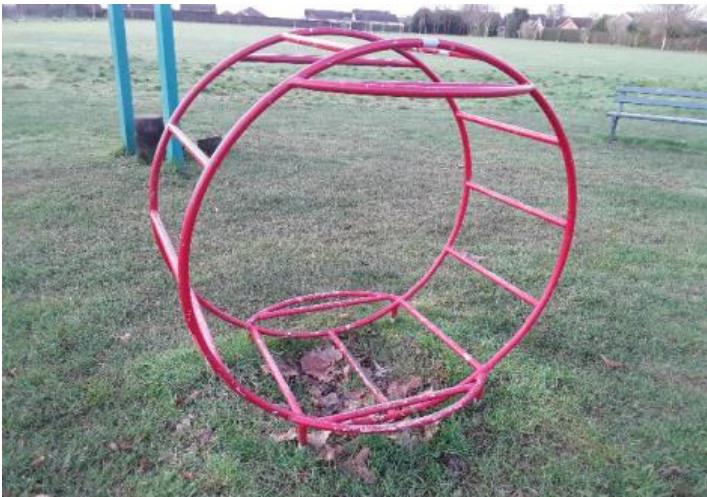
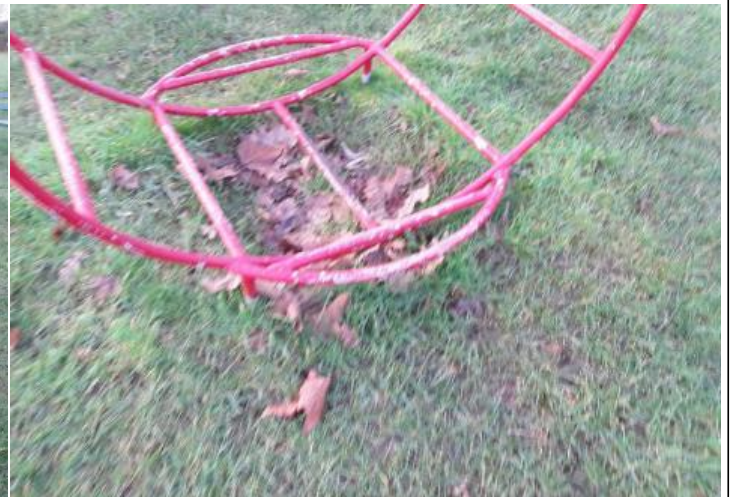
Item: Activity Equipment - Climbing Frame
Manufacturer: Wicksteed Playgrounds

Finding: The paint is flaking off the metalwork

Action: Rub down and re-paint

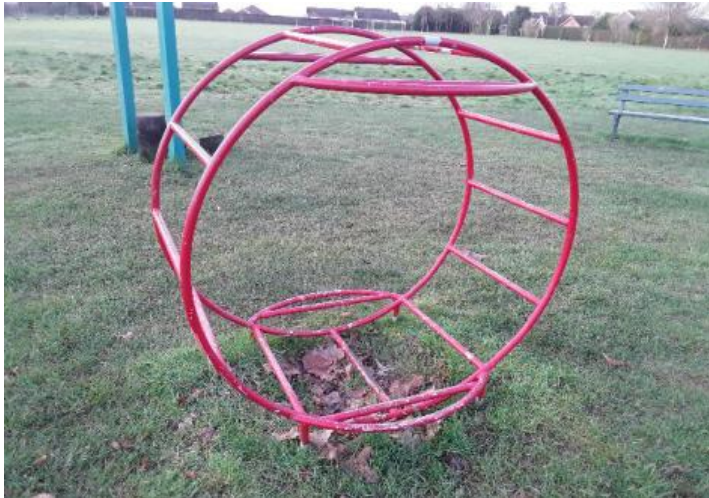
Item: Activity Equipment - Climbing Frame
Manufacturer: Wicksteed Playgrounds

Finding: The item fails to meet the requirements of BS EN 1176 Part 1 4.2.7.2 for head and neck entrapment in the framework

Action: Monitor - No action given the risk assessment

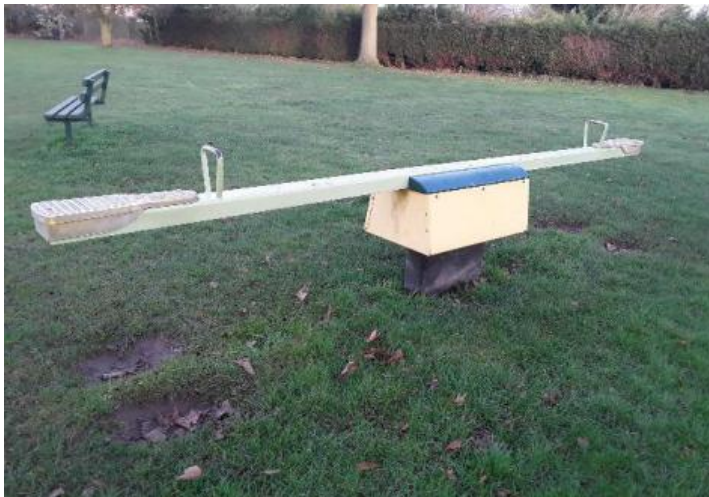
Item: Rocking Equipment - See Saw
Manufacturer: Wicksteed Playgrounds

Finding: The area around the item has eroded creating trip hazards and may become slippery when wet

Action: Reinstate eroded area

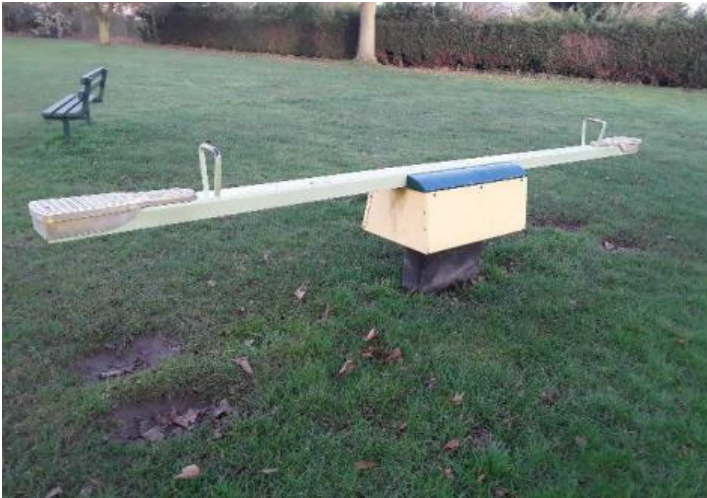
Item: Rocking Equipment - See Saw
Manufacturer: Wicksteed Playgrounds

Finding: There is surface corrosion / rust present on the item

Action: Consider treating the item

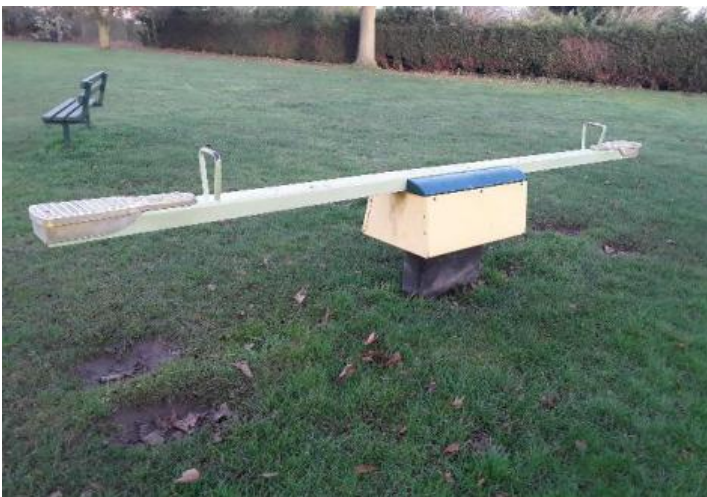
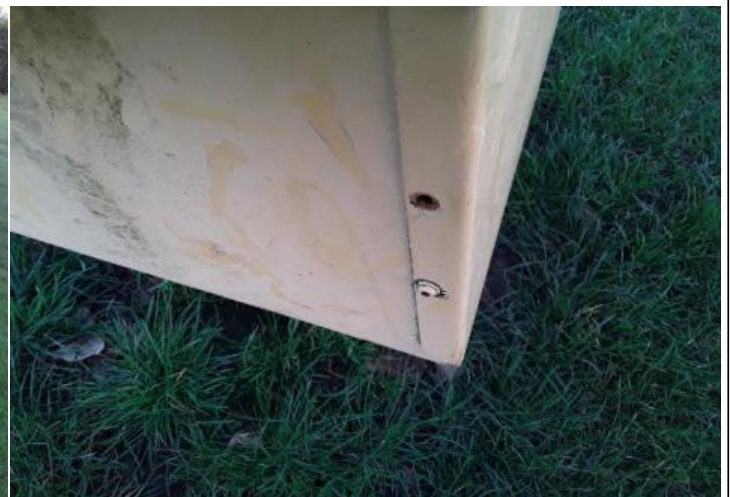
Item: Rocking Equipment - See Saw
Manufacturer: Wicksteed Playgrounds

Finding: There is or are fixings missing on the item

Action: Replace all missing fixings

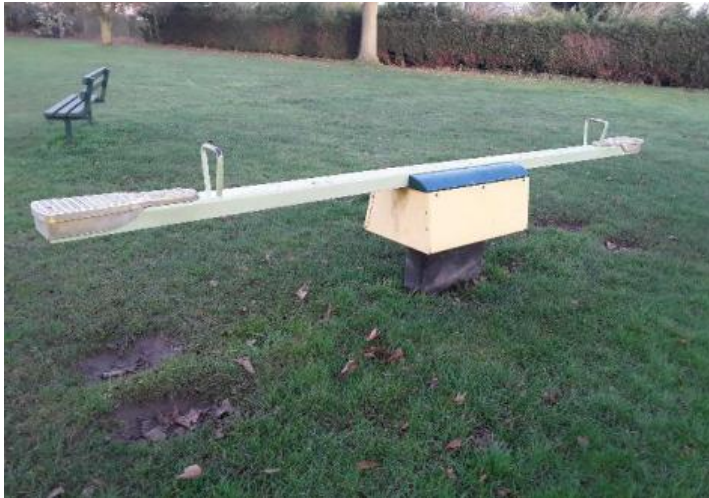
Item: Rocking Equipment - See Saw
Manufacturer: Wicksteed Playgrounds

Finding: The item is slightly loose in its foundations

Action: Monitor for any further deterioration and repair as required

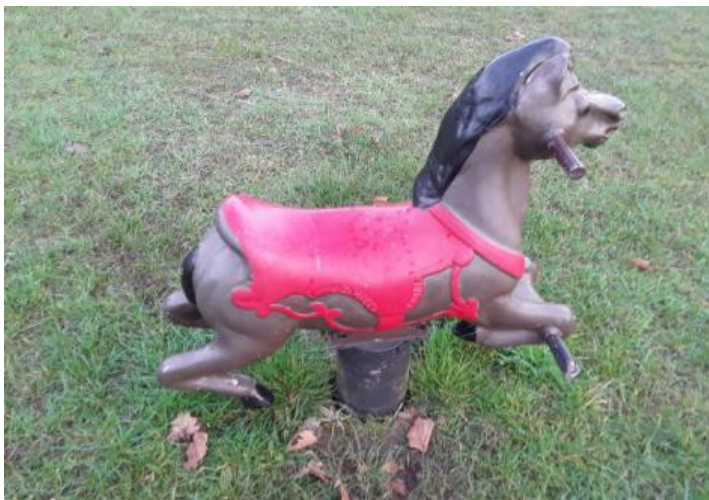
Item: Rocking Equipment - Spring Horse
Manufacturer: Wicksteed Playgrounds

Finding: The end of handgrips and/or footrests have a cross section of less than 15cm² and fail to meet the requirements of BS EN 1176 Part 6

Action: Monitor - No action given the risk assessment

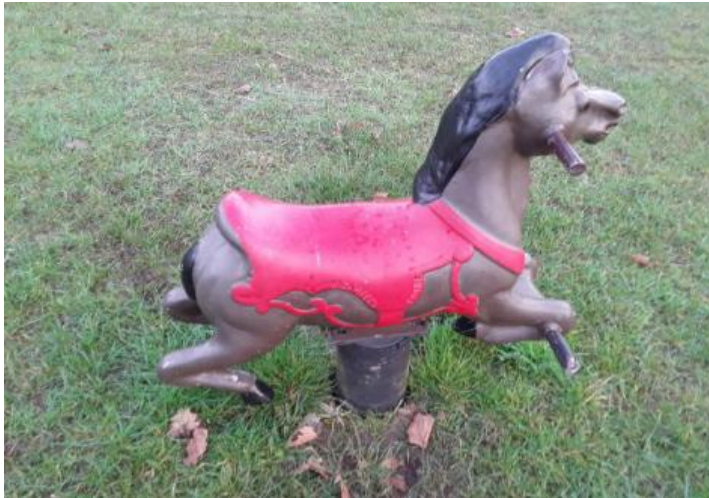
Item: Rocking Equipment - Spring Horse
Manufacturer: Wicksteed Playgrounds

Finding: The handgrips / footrests are damaged or missing **Action:** Replace the handgrips / footrests

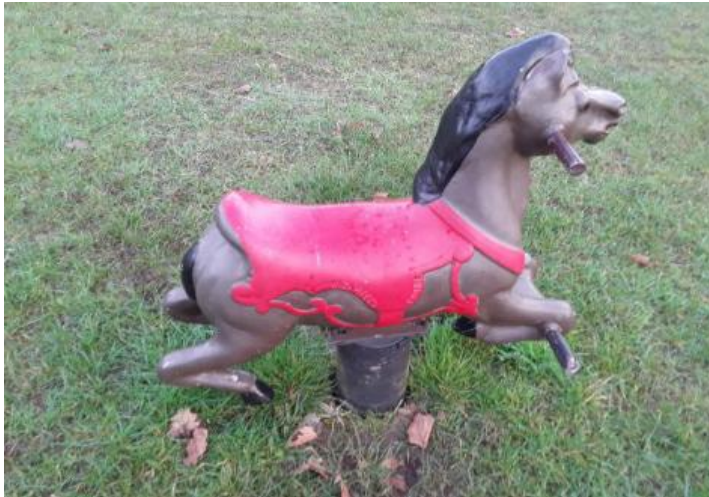
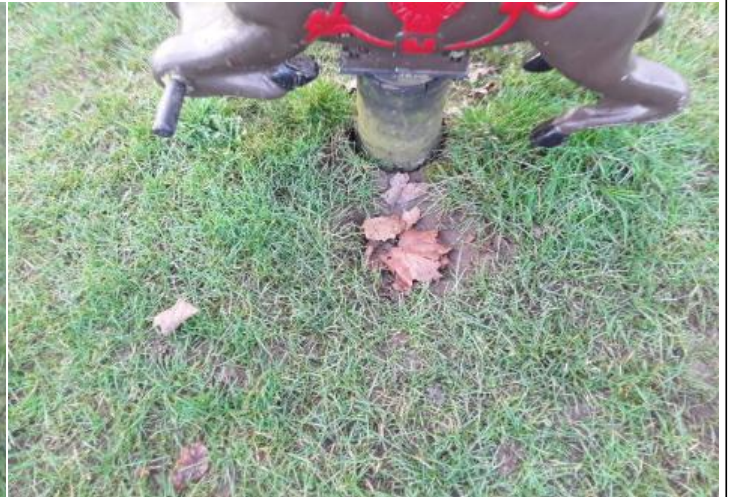
Item: Rocking Equipment - Spring Horse
Manufacturer: Wicksteed Playgrounds

Finding: The area around the item has eroded and may become slippery

Action: Reinstate eroded area

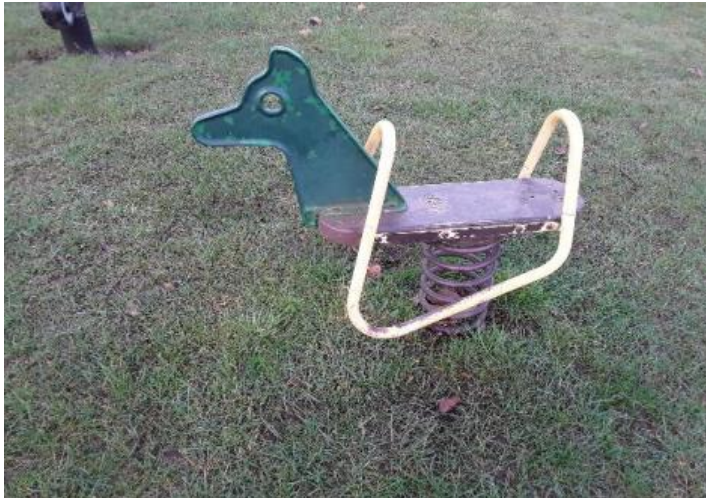
Item: Rocking Equipment - Spring Horse
Manufacturer: Ausplay

Finding: There is surface corrosion / rust present on the item

Action: Consider treating the item

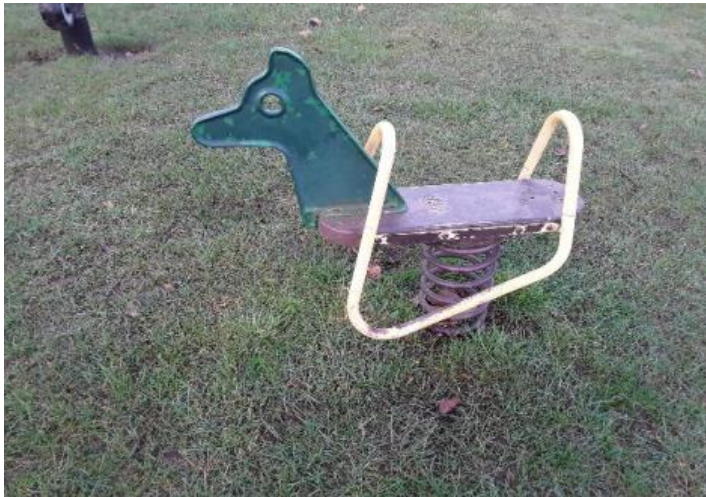
Item: Rocking Equipment - Spring Horse
Manufacturer: Ausplay

Finding: The paintwork on the spring has been damaged or worn exposing the metal underneath which is rusting

Action: Treat any rusting components and repaint

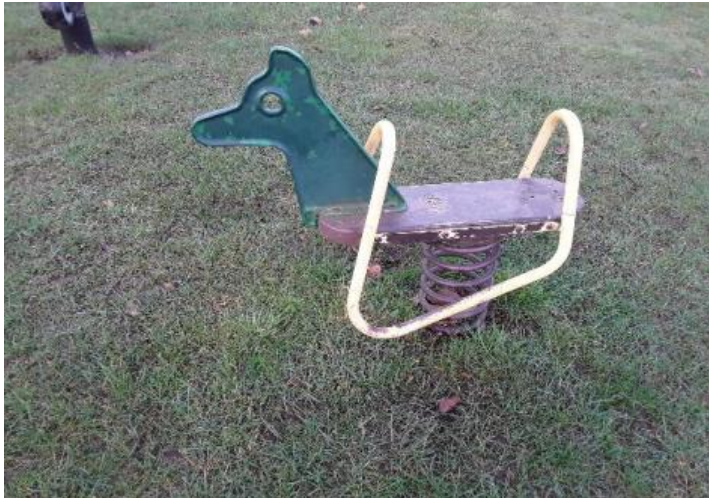
Item: Rocking Equipment - Spring Horse
Manufacturer: Ausplay

Finding: The item has missing component(s)

Action: Consider replacing missing components

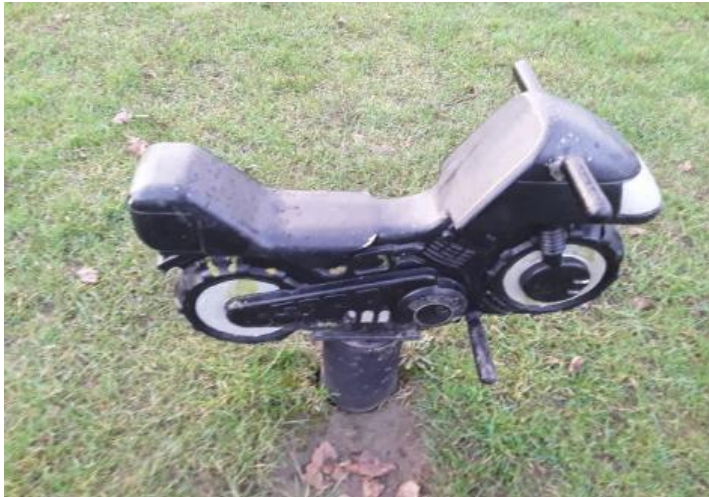
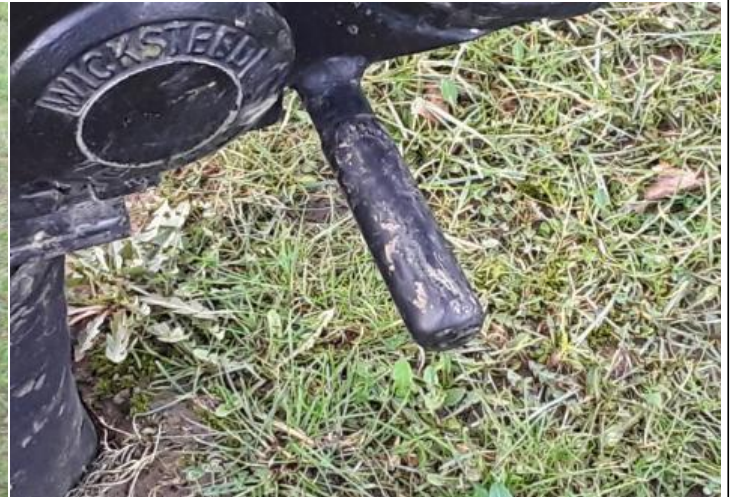
Item: Rocking Equipment - Spring Bike
Manufacturer: Wicksteed Playgrounds

Finding: The end of handgrips and/or footrests have a cross section of less than 15cm² and fail to meet the requirements of BS EN 1176 Part 6

Action: Monitor - No action given the risk assessment

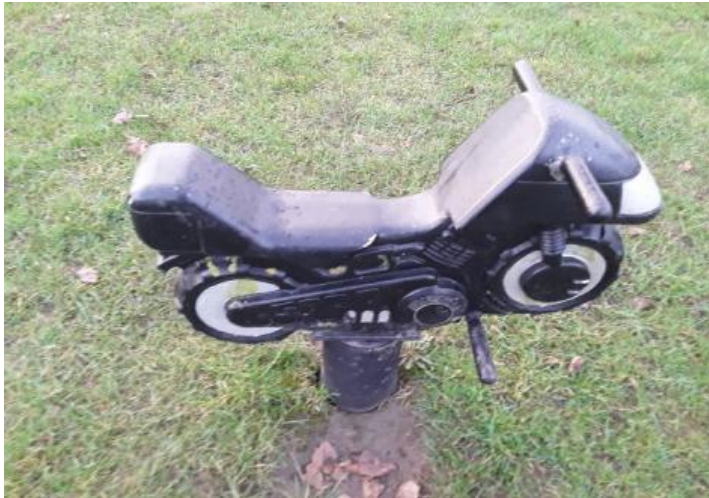
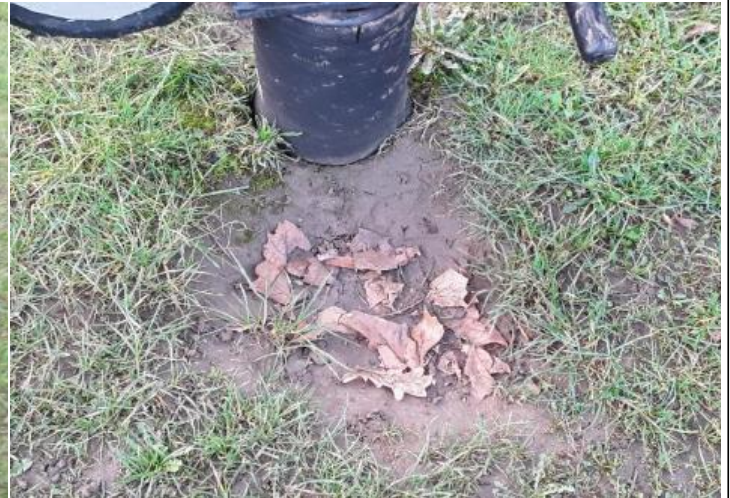
Item: Rocking Equipment - Spring Bike
Manufacturer: Wicksteed Playgrounds

Finding: The area around the item has eroded and may become slippery

Action: Reinststate eroded area

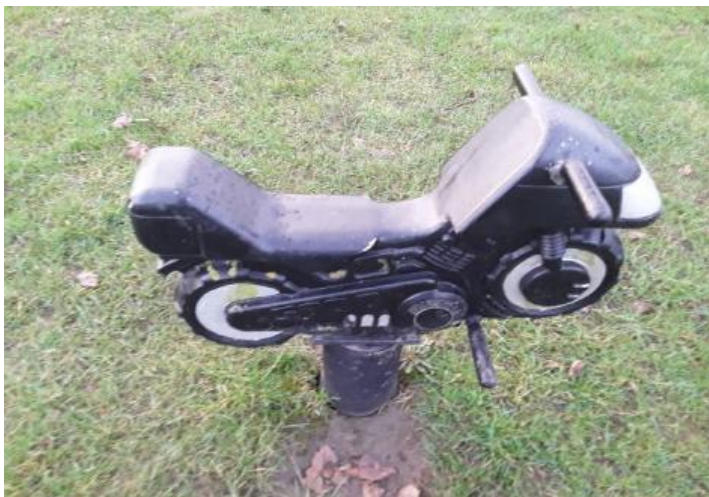
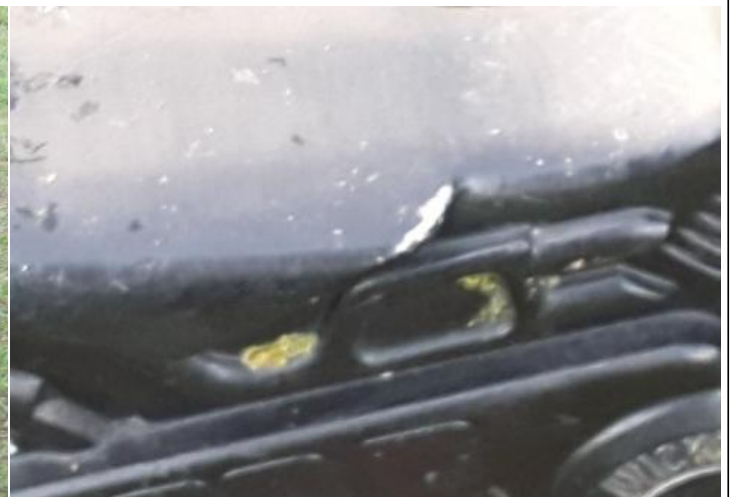
Item: Rocking Equipment - Spring Bike
Manufacturer: Wicksteed Playgrounds

Finding: The paint is flaking off the metalwork

Action: Rub down and re-paint

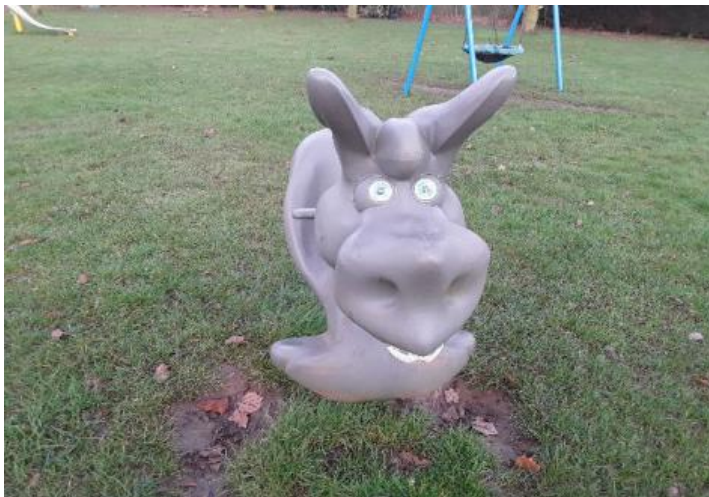
Item: Rocking Equipment - Spring Donkey
Manufacturer: Wicksteed Playgrounds

Finding: The paintwork on the spring has been damaged or worn exposing the metal underneath which is rusting

Action: Treat any rusting components and repaint

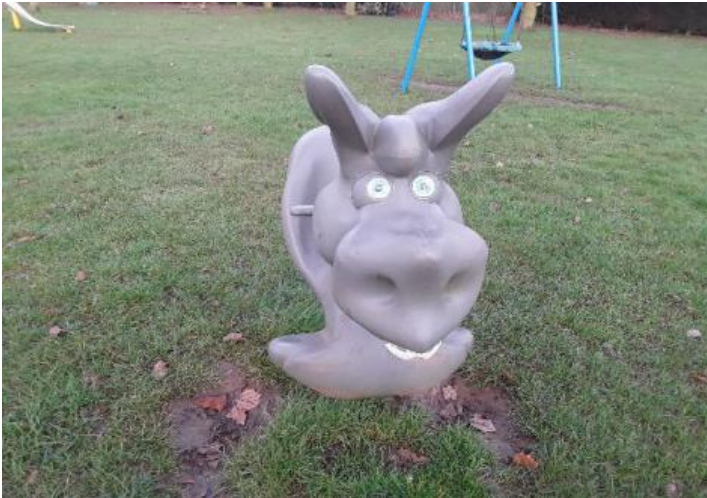
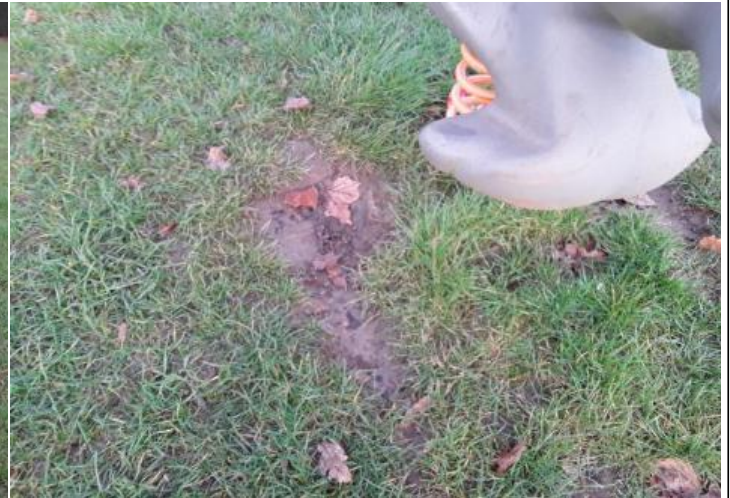
Item: Rocking Equipment - Spring Donkey
Manufacturer: Wicksteed Playgrounds

Finding: The area around the item has eroded and may become slippery

Action: Reinststate eroded area
