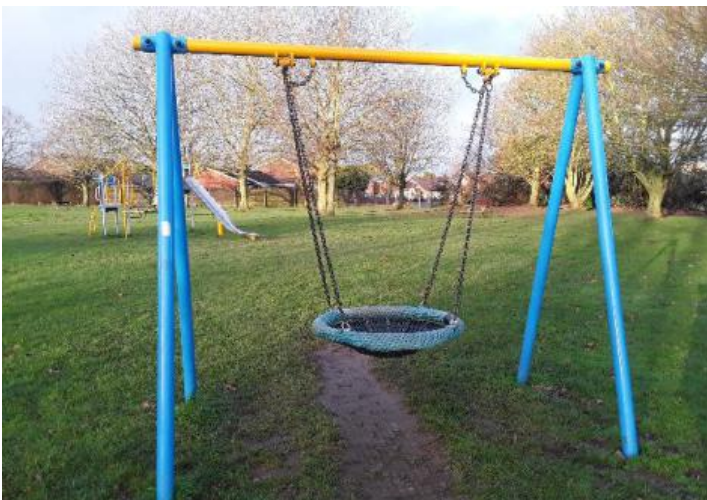
Item: Swings - Basket Swing - Type 1
Manufacturer: Wicksteed Playgrounds

Finding: There is/are bolt cap covers missing or damaged on the item

Action: Replace missing or damaged bolt cap covers

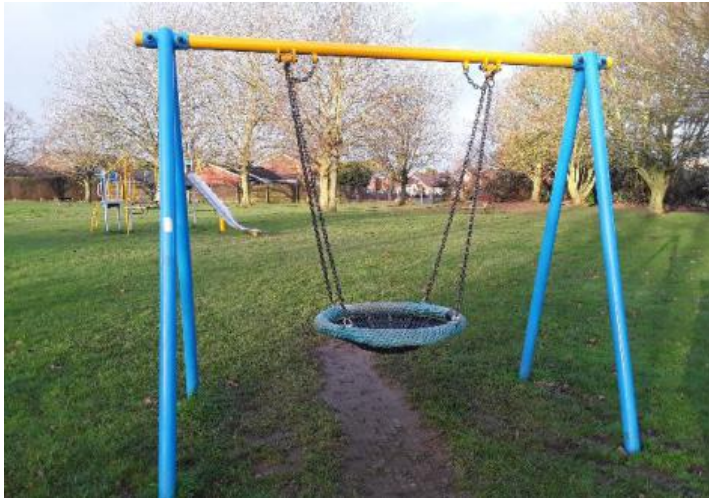
Item: Swings - Basket Swing - Type 1
Manufacturer: Wicksteed Playgrounds

Finding: The chain openings are in excess of the 8.6mm as recommended by BS EN 1176
Action: Monitor - No action given the risk assessment

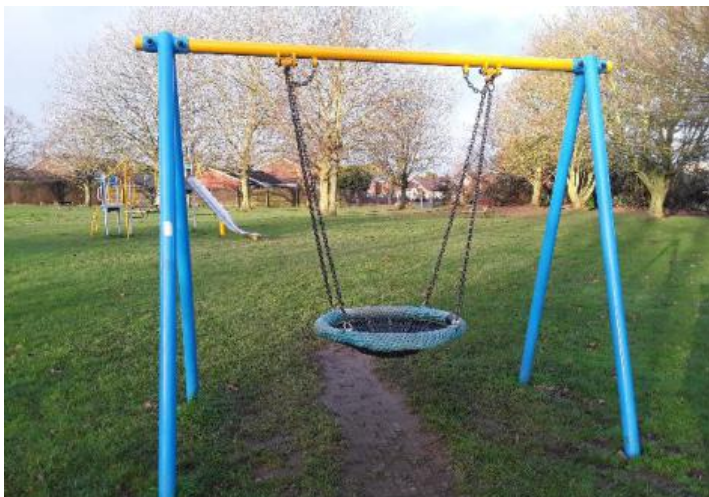
Item: Swings - Basket Swing - Type 1
Manufacturer: Wicksteed Playgrounds

Finding: The ropes/nets are worn/damaged in places
Action: Monitor for any further deterioration and repair or replace as required

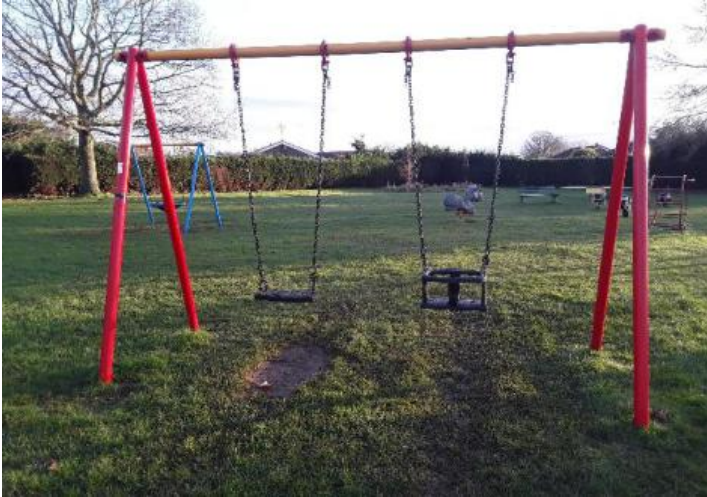
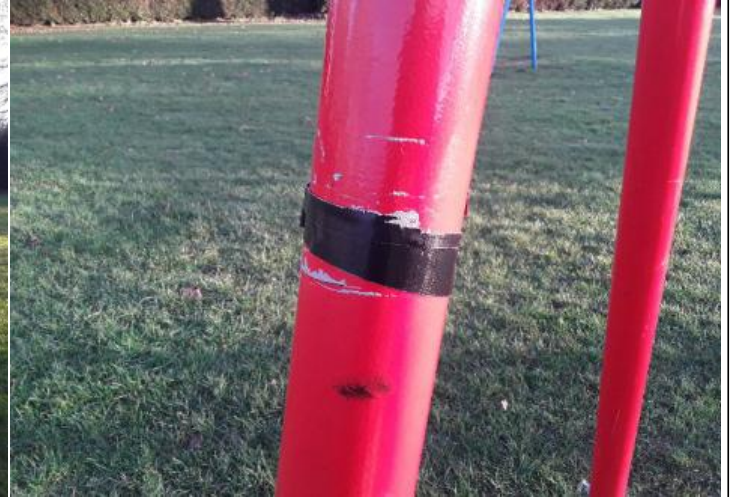
i 6 - Low Risk (Finding 1)**Item:** Swings - 1 Bay Mixed Seat, 1 Cradle, 1 Flat**Manufacturer:** Wicksteed Playgrounds**Risk Level:** L - Low Risk**Surface:** Grass Matrix Tiles

**Finding:** There is redundant gaffa tape on the leg**Action:** Remove the tape

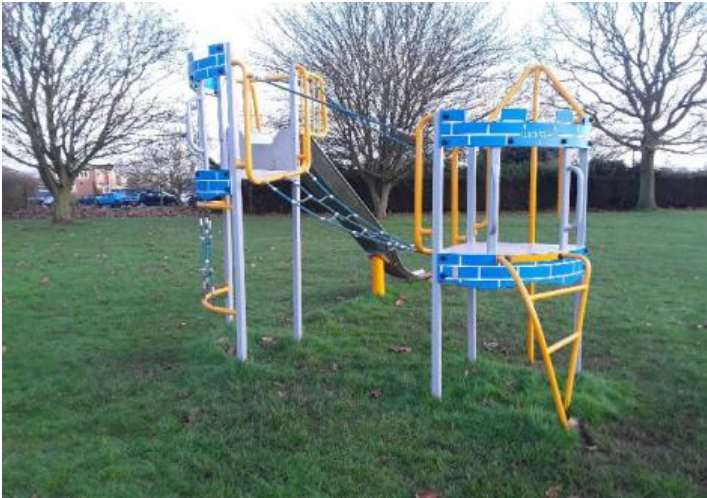
Item: Activity Equipment - Multi Play (Junior)
Manufacturer: Wicksteed Playgrounds

Finding: There is/are end caps missing creating finger entrapment/s in the end openings and the item fails to meet the requirements of BS EN 1176 Part 1 4.2.7.6 Entrapment of fingers

Action: Replace the missing end caps

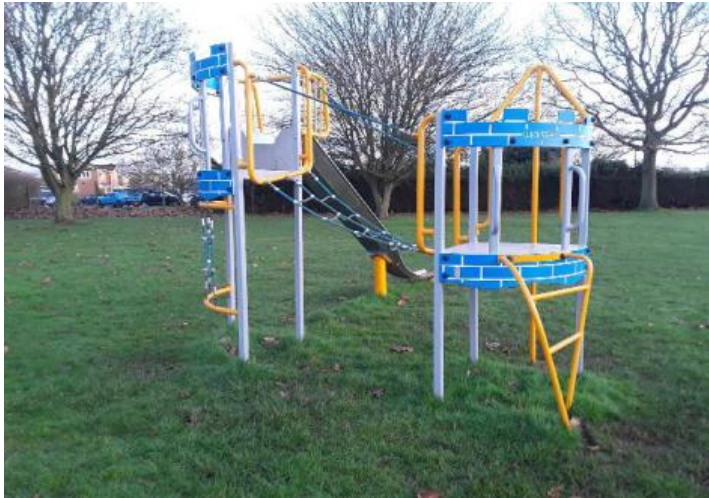
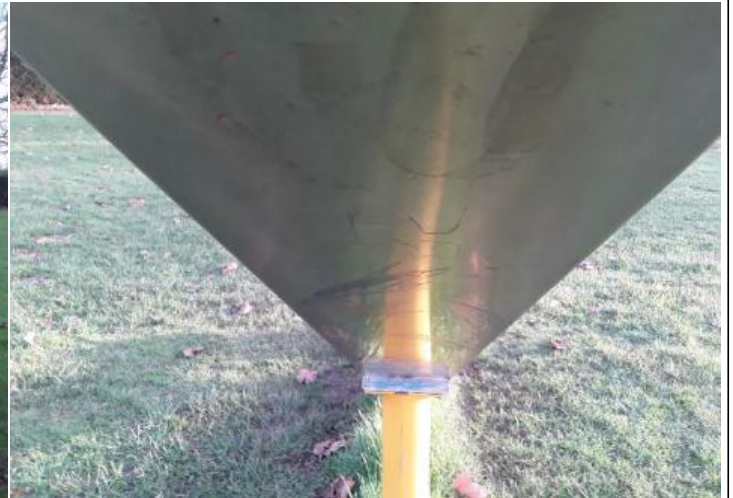
Item: Activity Equipment - Multi Play (Junior)
Manufacturer: Wicksteed Playgrounds

Finding: There is some graffiti present

Action: Remove the graffiti

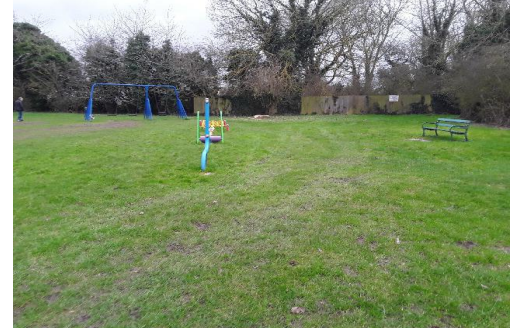
Item: Site General
Manufacturer: Owner/Operator
Surface Type: N/A
Item Quantity: 1
Equipment Compliance: N/A
Surface Area Compliance: N/A

There is a large loose concrete foundation adjacent to the play area - Remove the concrete

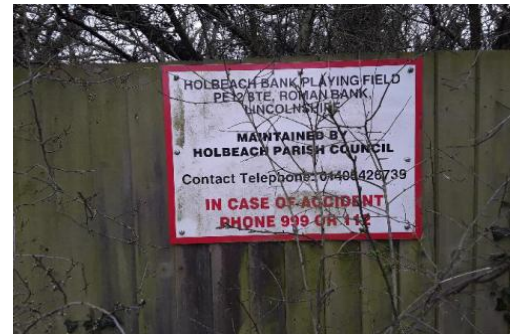
Item: Sign
Manufacturer: Not Identified
Surface Type: N/A
Item Quantity: 1
Equipment Compliance: N/A
Surface Area Compliance: N/A

BS EN 1176 Part 7 recommends that signage shall include the contact details of owner / operator for reporting maintenance issues - Provide additional information

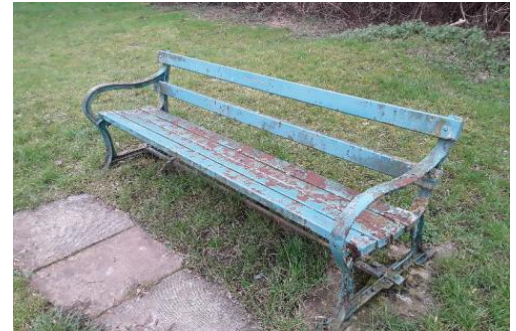
Item: Bench
Manufacturer: Not Identified
Surface Type: Paving Slabs
Item Quantity: 1
Equipment Compliance: N/A
Surface Area Compliance: N/A

The paintwork on this item has been damaged or worn exposing the metal underneath which is rusting / corroding - Treat affected areas and repaint

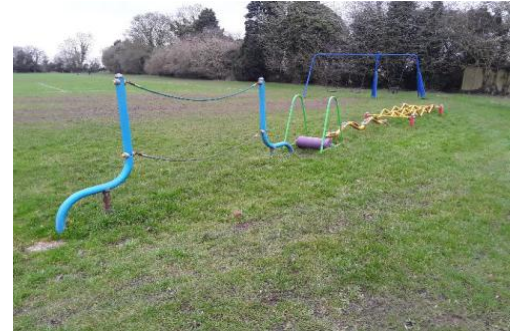
Item: Activity Trail
Manufacturer: Wicksteed Playgrounds
Surface Type: Grass
Item Quantity: 1
Equipment Compliance: No
Surface Area Compliance: Yes
Life Expectancy: 5 -10 Years
Total Findings: 11

The foundations are exposed - Reinststate surrounding surfaces to cover the foundations

The paintwork on this item has been damaged or worn exposing the metal underneath which is rusting / corroding - Treat affected areas and repaint

There is/are inserts missing - Replace missing inserts

There is/are bolt cap covers missing or damaged on the item - Replace missing or damaged bolt cap covers

The connecting lugs are showing signs of wear - Monitor for any further deterioration and repair as required

The chain links are worn and require renewing - Replace worn chains

There is minor damage to the foot treads - Monitor and replace if required

There is some notable evidence of chain wear - Monitor for any further deterioration and replace when 40% worn

The ropes/nets are worn/damaged in places - Monitor for any further deterioration and repair or replace as required

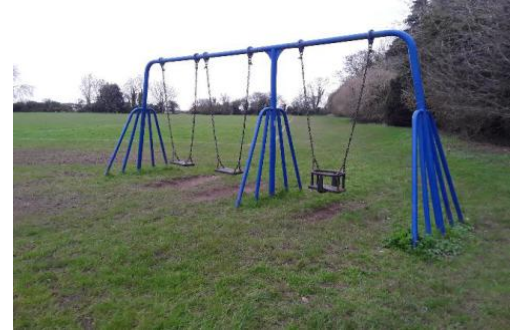
Item: 2 Bay 2 Flat 1 Cradle Seat
Manufacturer: Wicksteed Playgrounds
Surface Type: Grass
Item Quantity: 1
Equipment Compliance: No
Surface Area Compliance: Yes
Life Expectancy: 5 -10 Years
Total Findings: 3

The surfacing is severely damaged exposing compacted soil underneath - Reinstate to provide a uniform surface and repair damaged areas of surfacing

The chain openings are in excess of the 8.6mm as recommended by BS EN 1176 - Monitor - No action given the risk assessment

There is some notable evidence of chain wear - Monitor for any further deterioration and replace when 40% worn

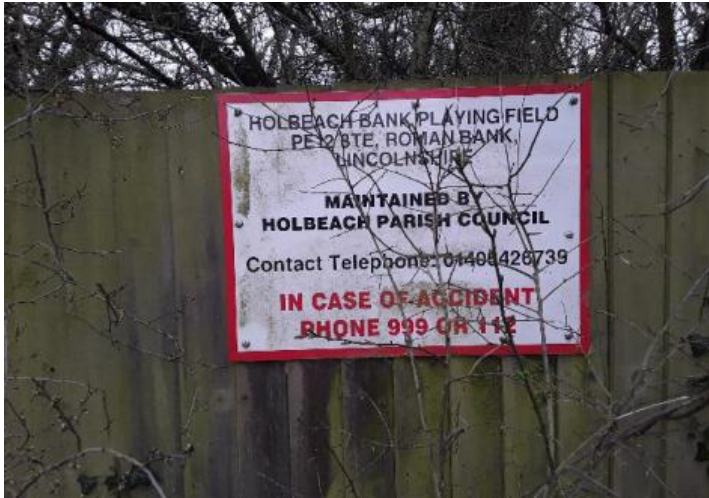
Item: Ancillary Items - Sign
Manufacturer: Not Identified

Finding: BS EN 1176 Part 7 recommends that signage shall include the contact details of owner / operator for reporting maintenance issues
Action: Provide additional information

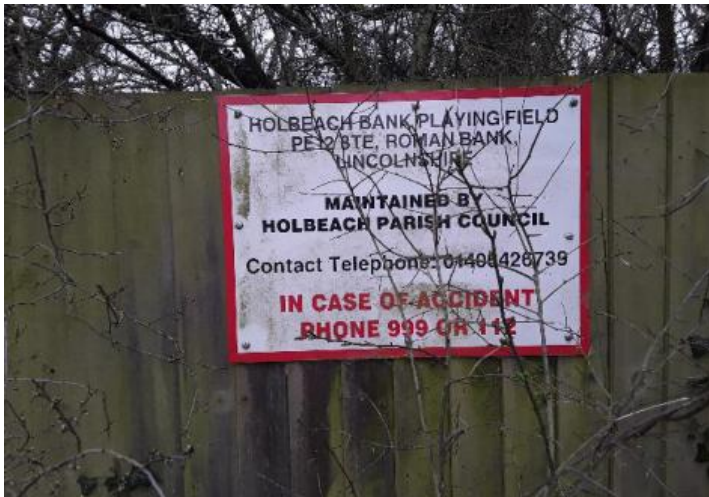
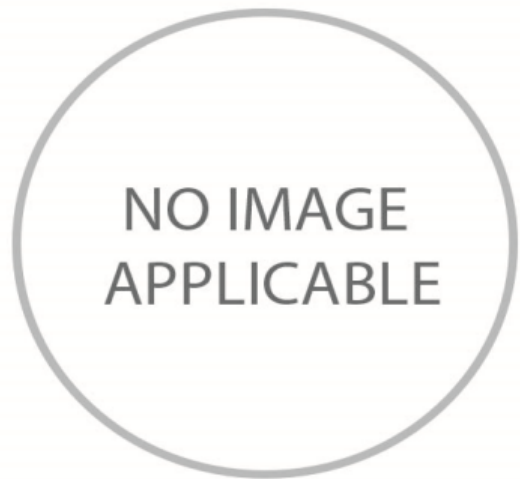
Item: Ancillary Items - Sign
Manufacturer: Not Identified

Finding: The adjacent foliage is overhanging the sign
Action: Cut back and maintain

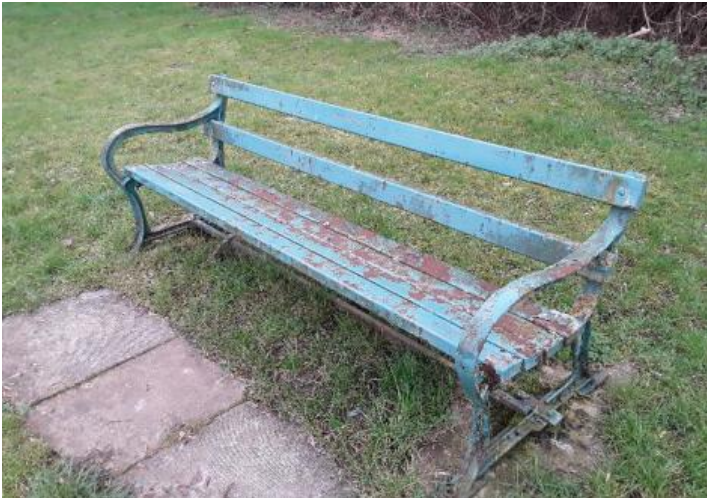
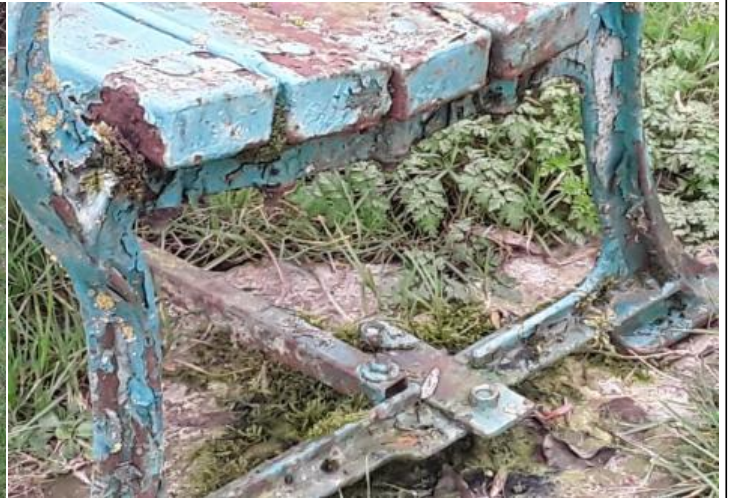
Item: Ancillary Items - Bench
Manufacturer: Not Identified

Finding: There are projecting bolt thread(s) present

Action: Remove excess thread length and deburr or provide cap

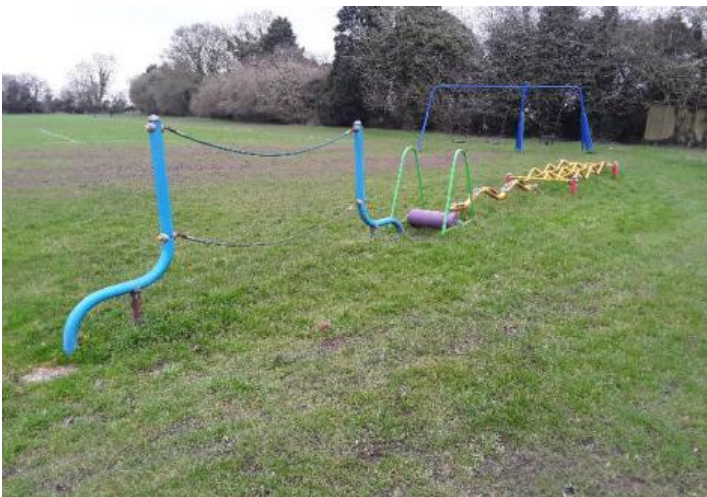
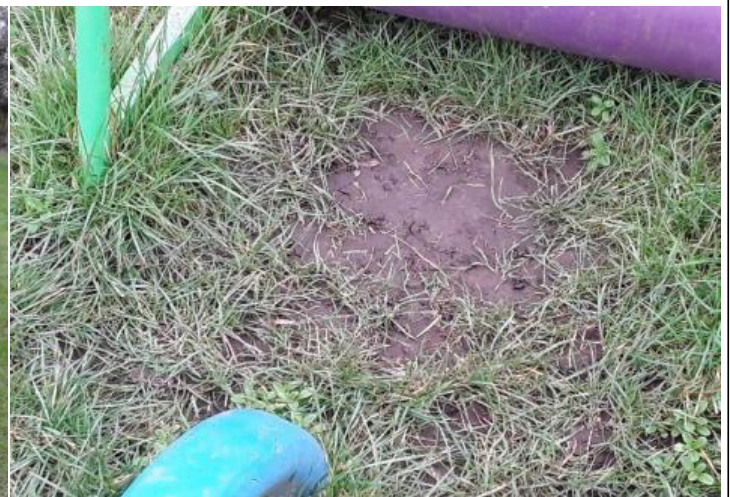
Finding: The area around the item has eroded and may become slippery

Action: Reinstate eroded area

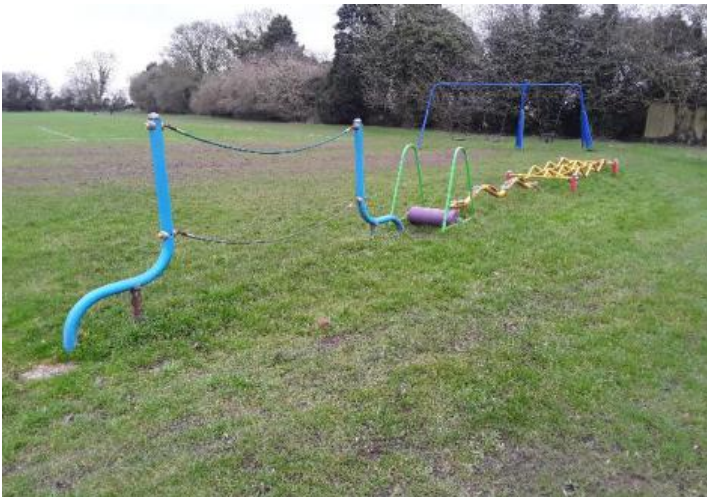
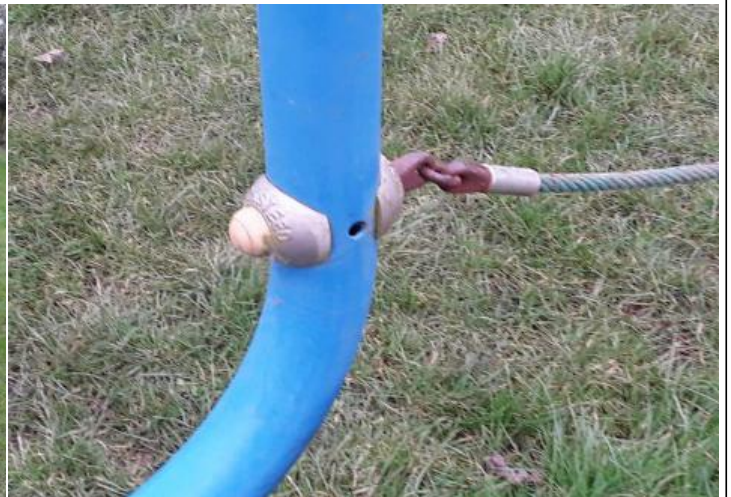
Finding: There is/are inserts missing

Action: Replace missing inserts

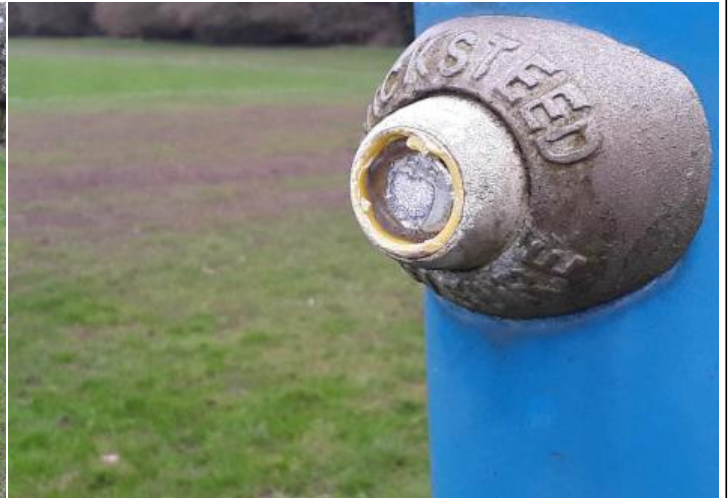
Finding: There is/are bolt cap covers missing or damaged on the item

Action: Replace missing or damaged bolt cap covers

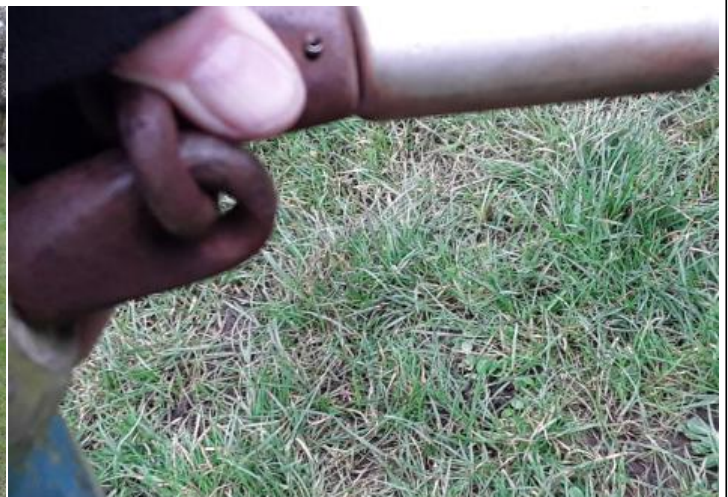
Finding: The connecting lugs are showing signs of wear

Action: Monitor for any further deterioration and repair as required

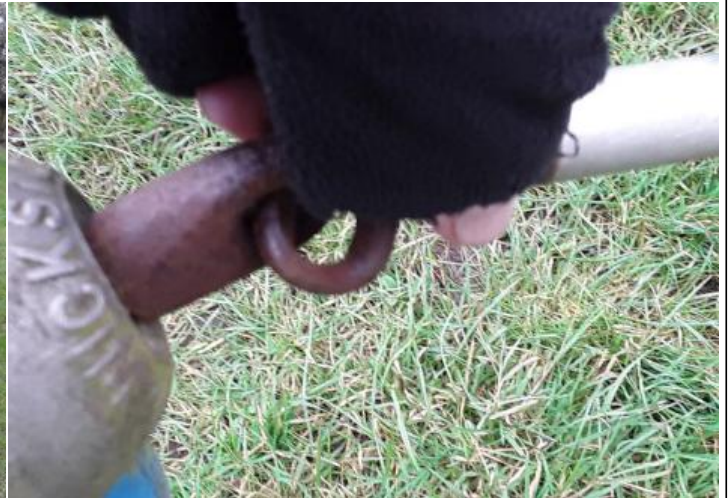
Finding: The chain links are worn and require renewing

Action: Replace worn chains

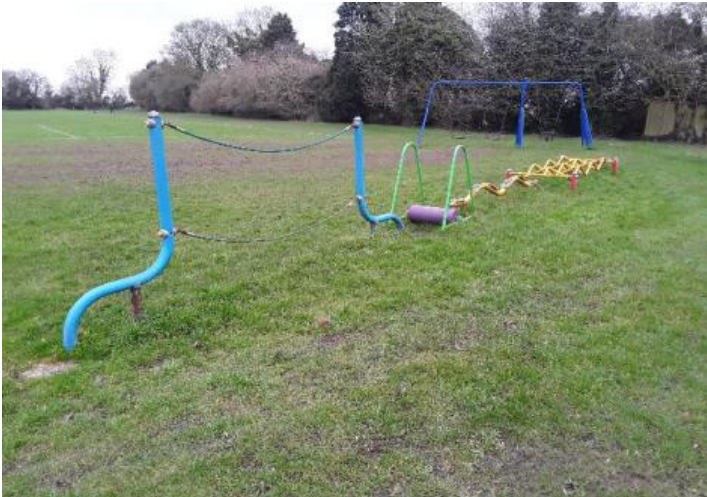
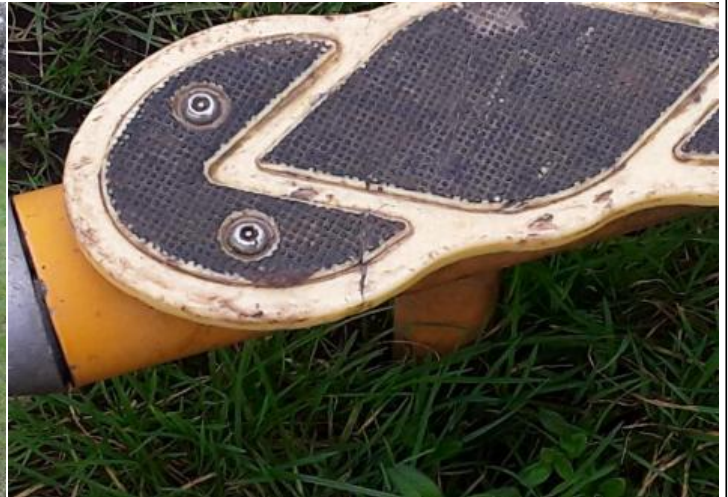
Finding: There is minor damage to the foot treads

Action: Monitor and replace if required

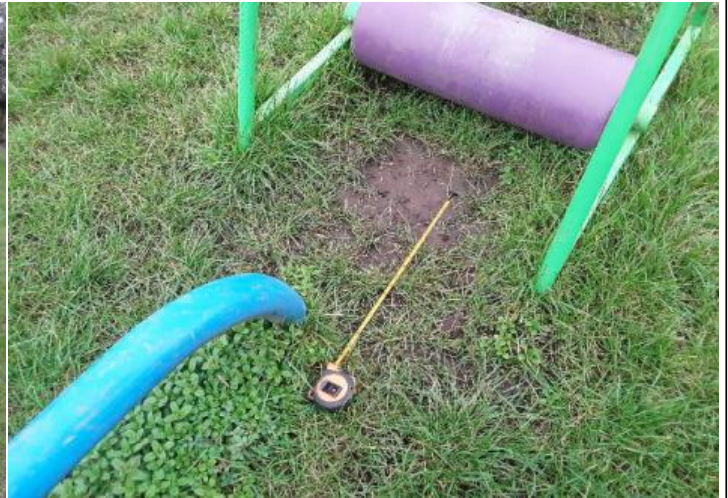
Finding: The step between the items is quite large and users may not be able to complete the step without touching ground, the items could therefore be considered to be within the falling space of each other, however the intention of the play activity continuity is easily apparent and foreseeable to the user

Action: Monitor - No action given the risk assessment

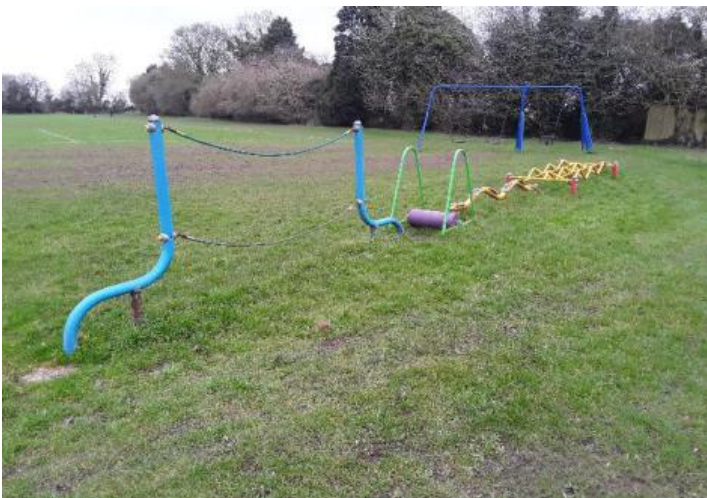
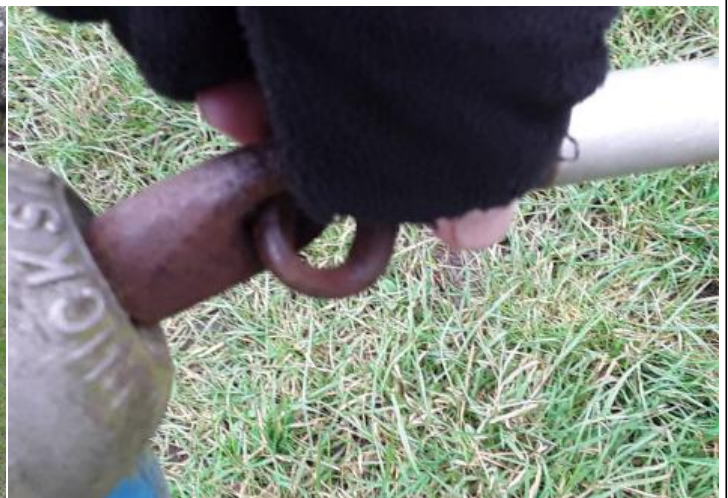
Finding: There is some notable evidence of chain wear

Action: Monitor for any further deterioration and replace when 40% worn

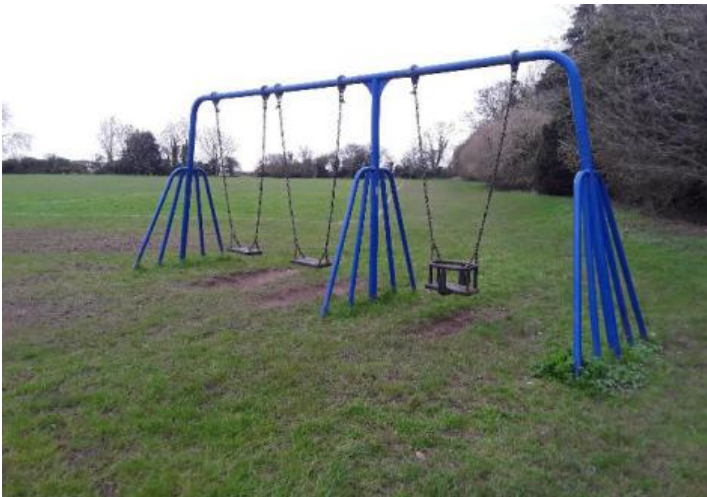
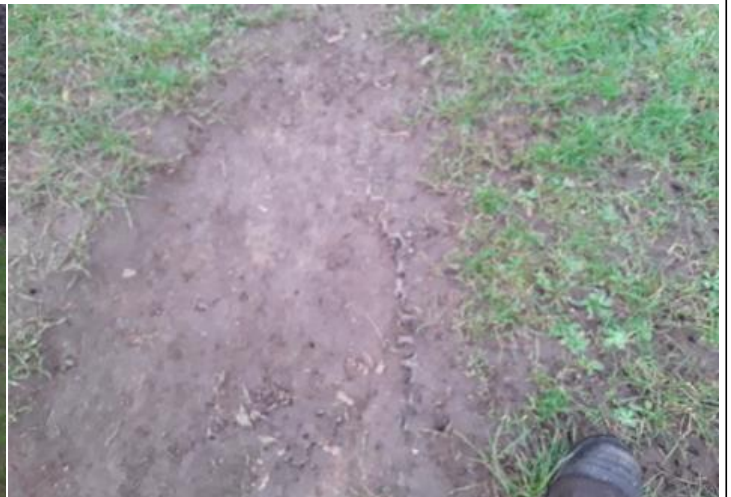
Finding: The surfacing is severely damaged exposing compacted soil underneath

Action: Reinststate to provide a uniform surface and repair damaged areas of surfacing

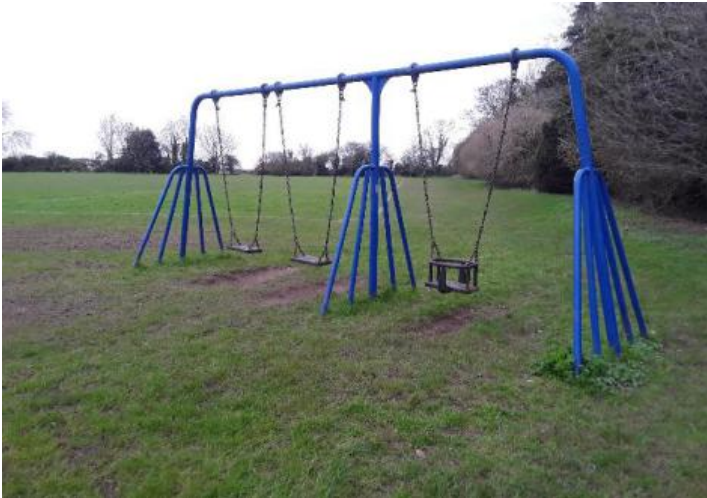
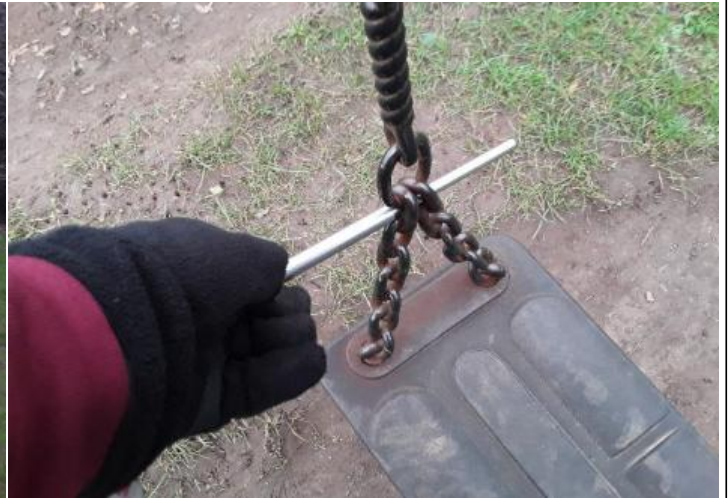
Finding: The chain openings are in excess of the 8.6mm as recommended by BS EN 1176 **Action:** Monitor - No action given the risk assessment

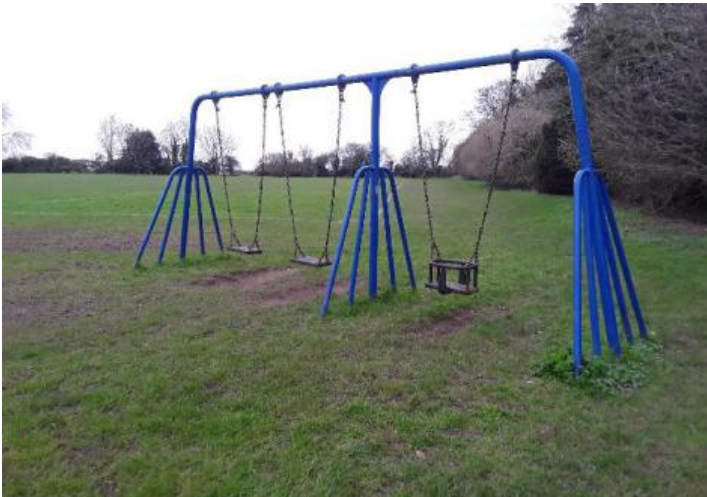
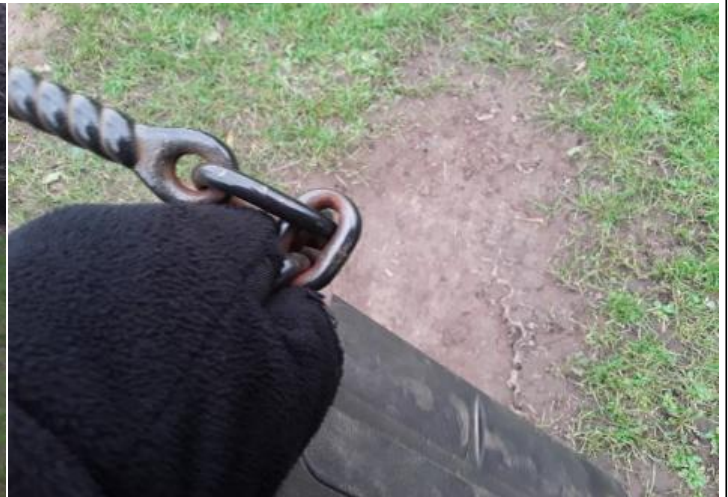
Finding: There is some notable evidence of chain wear **Action:** Monitor for any further deterioration and replace when 40% worn

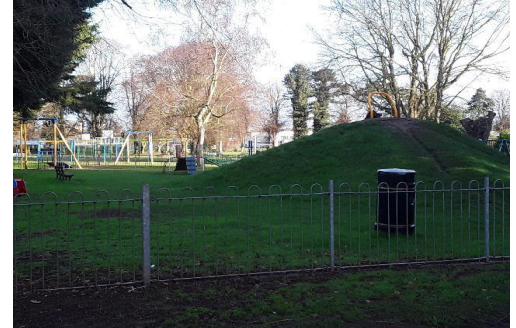
The grass mats are silted up, the soil is compacted and the area will become very slippery when the soil is wet. - Reinstate as required

The surface has eroded in some areas and may be slippery in wet conditions - Reinstate the surface

There are holes in the surface adjacent to the fitness equipment that may cause users to trip or roll ankles - Infill to provide a sound reasonably level surface.

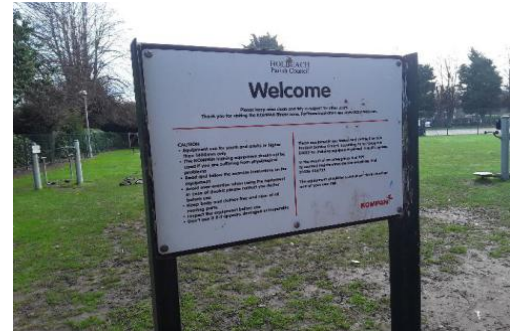
It is recommended that signage, with information including the site address, contact information for maintenance issues and emergency contact details are provided for the playground facility - Provide in accordance with the recommendations

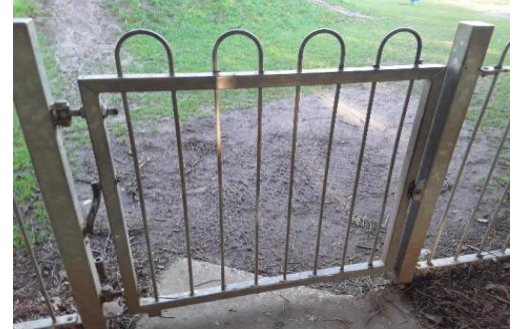
There are trip hazards present over the concrete base under the gate - Remove trip hazard

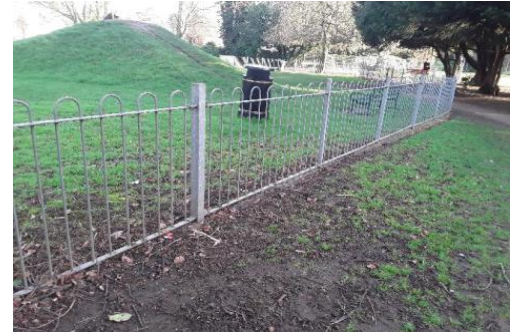
There is minor damage to the fence sections - Monitor for any further deterioration and repair as required

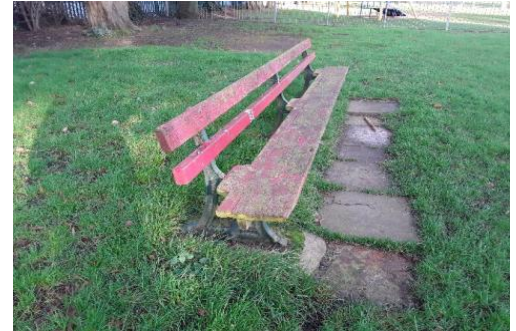
There is minor vandalism damage to the bench - Monitor and repair if required

There are trip hazards present over the displaced pavings - Remove trip hazard

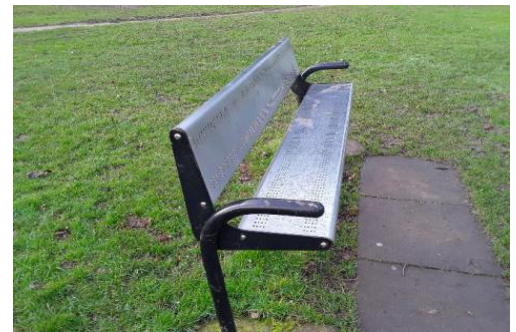
The paintwork on this item has been damaged or worn exposing the metal underneath which is rusting / corroding - Treat affected areas and repaint

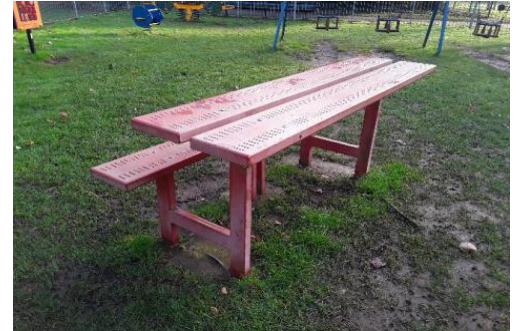
There is/are inserts missing - Replace missing inserts

The surface has eroded and the foundations are exposed - Reinstate surrounding surfaces to cover the foundations

There is surface corrosion / rust present on the item - Consider treating the item

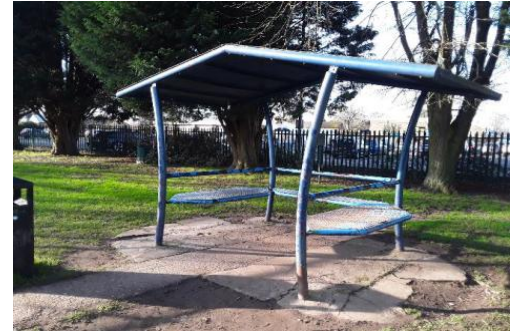
The area around the item has eroded creating trip hazards and may become slippery when wet - Reinstate eroded area

The paintwork on this item has been damaged or worn exposing the metal underneath which is rusting / corroding - Treat affected areas and repaint

There is minor damage to the concrete surface - Monitor for any further deterioration and repair as required

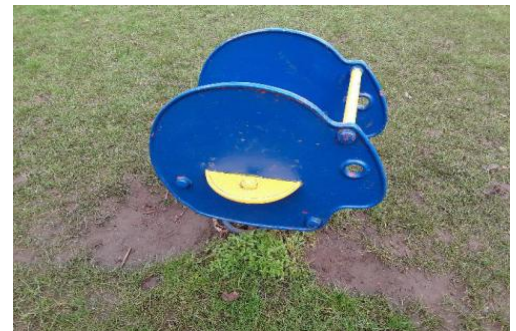
The grass has eroded within the impact area of the equipment and may not provide the necessary impact attenuating properties for the equipment fall height; the surface may also be slippery in wet weather - Reinstate the grass or provide an all weather surface

There is surface corrosion / rust present on the item - Consider treating the item

The spring clamps are loose - Tighten all loose fixings

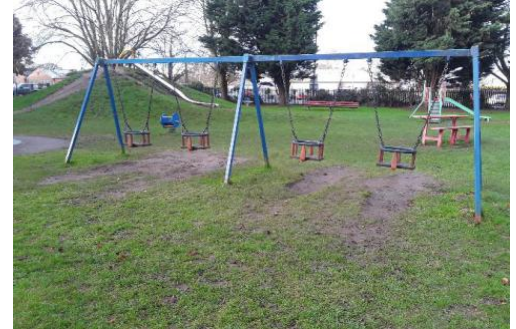
The chain openings are in excess of the 8.6mm as recommended by BS EN 1176 - Monitor - No action given the risk assessment

The bushes are showing signs of wear - Monitor for any further deterioration and replace as required

The paintwork on this item has been damaged or worn exposing the metal underneath which is rusting / corroding - Treat affected areas and repaint

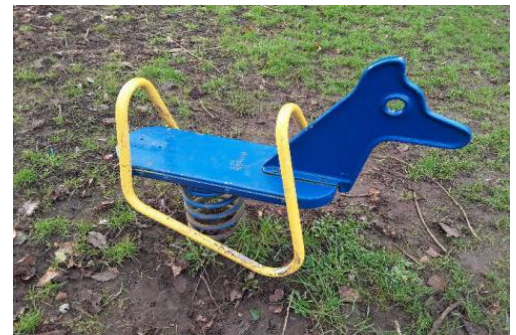
There is surface corrosion / rust present on the item - Consider treating the item

The item has missing component(s) - Consider replacing missing components

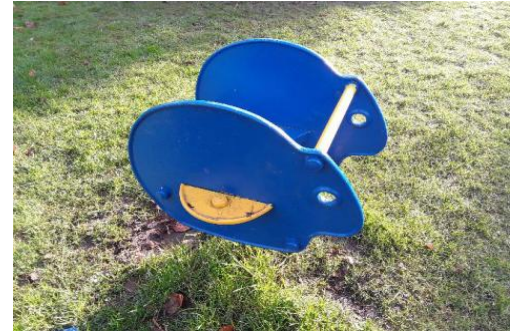
The paintwork on the spring has been damaged or worn exposing the metal underneath which is rusting - Treat any rusting components and repaint

The spring clamps are loose - Tighten all loose fixings

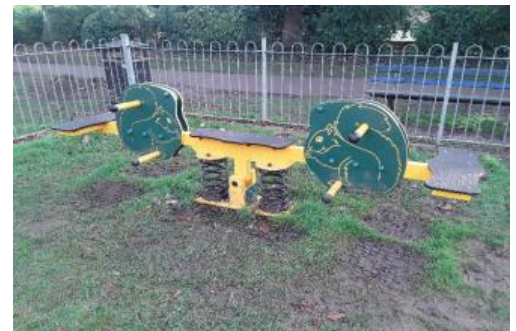
This item is satisfactory - no work required -

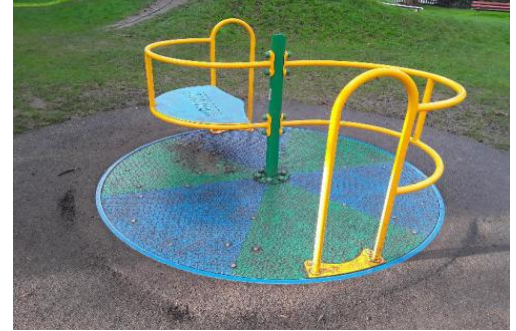
The surfacing is severely damaged - Repair damaged areas of surfacing

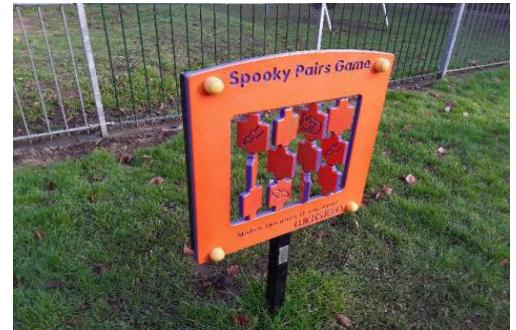
The area around the item has eroded and may become slippery - Reinstate eroded area

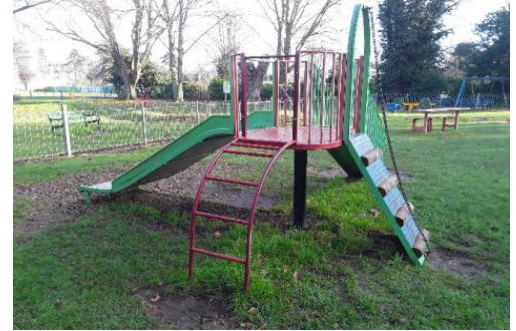
Item: Multi Play (Junior)
Manufacturer: Wicksteed Playgrounds
Surface Type: Grass Matrix Tiles
Item Quantity: 1
Equipment Compliance: No
Surface Area Compliance: Yes
Life Expectancy: 5 -10 Years
Total Findings: 8

There is surface corrosion / rust present on the item - Consider treating the item

The loosefill surfacing has displaced from under or around the slide run out - Regulate surface levels and maintain

The edges of the grass mat surface are raised / lifting above the surrounding surface in front of the slide run out - Secure edges of grass mats as per the API Code of Practice to remove trip hazards

There is/are bolt cap covers missing or damaged on the item - Replace missing or damaged bolt cap covers

The weld(s) on this slide braces have failed - Repair item

There are a number of dents in the slide surface - Monitor for any further deterioration and repair as required

The chain openings are in excess of 8.6mm and do not meet the recommendations of BS EN 1176 Part 1 - Monitor - No action given the risk assessment

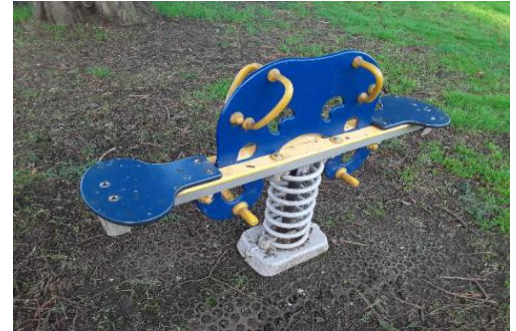
Item: Spring Octopus
Manufacturer: Wicksteed Playgrounds
Surface Type: Grass Matrix Tiles
Item Quantity: 1
Equipment Compliance: No
Surface Area Compliance: Yes
Life Expectancy: 5 -10 Years
Total Findings: 2

The surface has subsided in some areas - Repair as required to provide a uniform surface

The end of handgrips and/or footrests have a cross section of less than 15cm² and fail to meet the requirements of BS EN 1176 Part 6 - Monitor - No action given the risk assessment

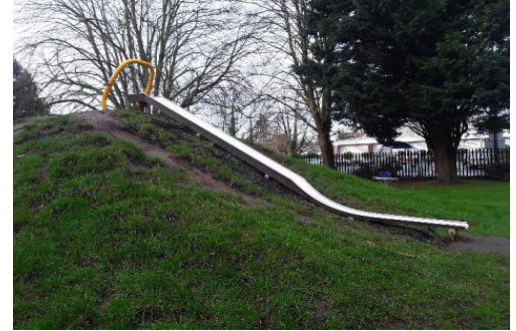
Item:	Embankment Slide
Manufacturer:	Wicksteed Playgrounds
Surface Type:	Mixed Surface
Item Quantity:	1
Equipment Compliance:	Yes
Surface Area Compliance:	Yes
Life Expectancy:	5 -10 Years
Total Findings:	5

The area around the item has eroded and may become slippery when wet - Reinstate eroded area

The edges of the grass mat surface are raised / lifting above the surrounding surface - Secure edges of grass mats as per the API Code of Practice to remove trip hazards

The surfacing is severely damaged creating trip hazards - Repair damaged areas of surfacing

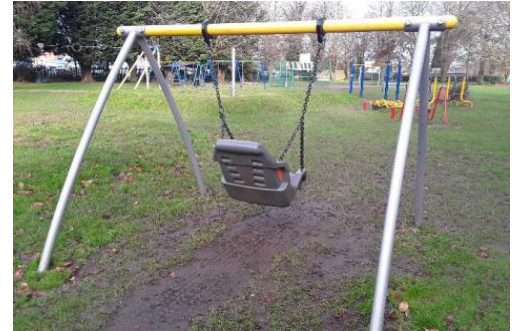
Item: Inclusive Swing
Manufacturer: Hags
Surface Type: Grass Matrix Tiles
Item Quantity: 1
Equipment Compliance: No
Surface Area Compliance: Yes
Life Expectancy: 5 -10 Years
Total Findings: 2

The seat clearance from finished surface level to the underside of the seat is too low and does not meet the requirements of BS EN 1176 Part 2 (350mm minimum clearance required) - Adjust seat height/s (400mm-500mm is recommended)

The Anti Wrap bearings are dry and not moving freely - Lubricate bearings in accordance with the manufacturers recommendations

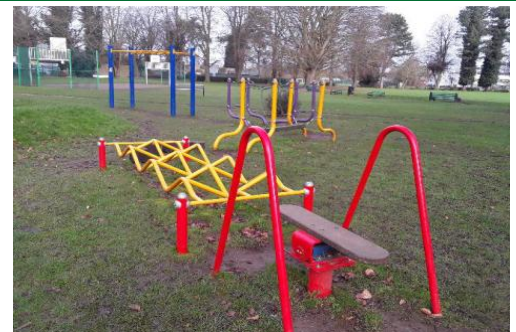
Item: Activity Trail
Manufacturer: Wicksteed Playgrounds
Surface Type: Grass Matrix Tiles
Item Quantity: 1
Equipment Compliance: Yes
Surface Area Compliance: Yes
Life Expectancy: 5 -10 Years
Total Findings: 3

The area around the item has eroded and may become slippery - Reinstate eroded area

There is surface corrosion / rust present on the item - Consider treating the item

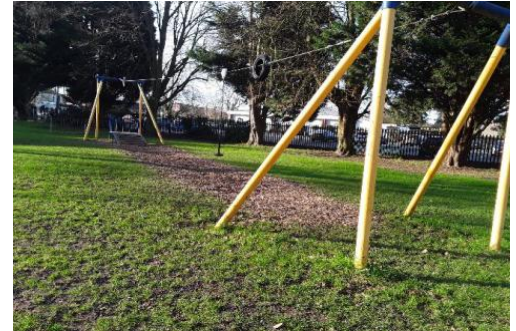
Item: Cable Runway
Manufacturer: Hags
Surface Type: Mixed Surface
Item Quantity: 1
Equipment Compliance: No
Surface Area Compliance: Yes
Life Expectancy: 5 -10 Years
Total Findings: 8

We have completed a visual inspection of the suspension links, cable and fixing points from ground level, however it is not possible to fully inspect these areas without either hiring equipment to gain access or removing the cable and suspension and inspecting at ground level. We recommend that the main cable and fixing security is thoroughly inspected at least in accordance with the manufacturers recommendations to check for wear, damage, security or internal rusting; this will help to ensure the continued safe use of the equipment - Inspect in accordance with the manufacturers recommendations

The loosefill surfacing has displaced from under or around the equipment - Regulate surface levels and maintain

The seat connection cannot be inspected without dismantling the seat - Dismantle the seat to inspect the seat connection for wear

The chain openings are in excess of 8.6mm and do not meet the recommendations of BS EN 1176 Part 1 - Monitor - No action given the risk assessment

The timber has a number of splits/shakes or air cracks and this may affect the stability or allow water ingress which will accelerate the rotting process. Timber splits may also create rough / splintering edges. - Monitor, sand down any rough edges and ensure the splits do not cross through fixing points of the structure and/or cause any instability

There is surface corrosion / rust present on the item - Consider treating the item

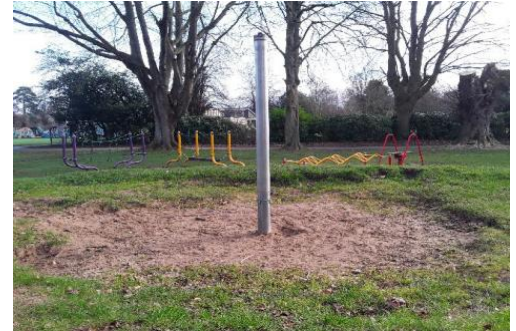
Item: Cone Climber
Manufacturer: Tayplay Ltd
Surface Type: Sand
Item Quantity: 1
Equipment Compliance: N/A
Surface Area Compliance: N/A

There is weed / vegetation growth on and around the loose fill surface - Remove weed / vegetation growth

The item has missing component(s) - Replace the missing components or remove the item completely

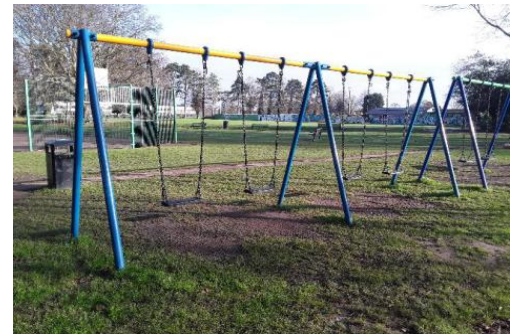
Item: 2 Bay 4 Seat (Flat)
Manufacturer: Wicksteed Playgrounds
Surface Type: Grass Matrix Tiles
Item Quantity: 1
Equipment Compliance: Yes
Surface Area Compliance: Yes
Life Expectancy: 5 -10 Years
Total Findings: 2

The surfacing is damaged - Repair damaged areas of surfacing

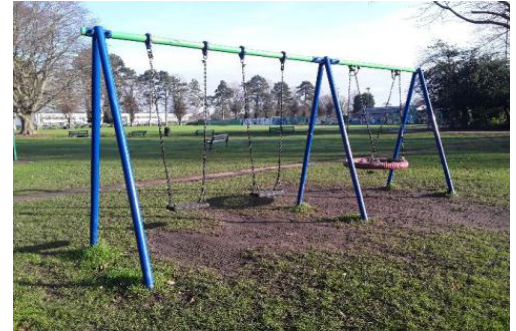
Item: 2 Bay 2 Flat 1 Basket Seat
Manufacturer: Wicksteed Playgrounds
Surface Type: Grass Matrix Tiles
Item Quantity: 1
Equipment Compliance: No
Surface Area Compliance: Yes
Life Expectancy: 5 -10 Years
Total Findings: 5

The basket bushes are showing signs of wear - Monitor for any further deterioration and replace as required

The chain openings are in excess of the 8.6mm as recommended by BS EN 1176 - Monitor - No action given the risk assessment

The Anti Wrap bearings are dry and not moving freely - Lubricate bearings in accordance with the manufacturers recommendations

The split pins are missing from the shackles - Insert split pins to secure the shackles

The paintwork on this item has been damaged or worn exposing the metal underneath which is rusting / corroding - Treat affected areas and repaint

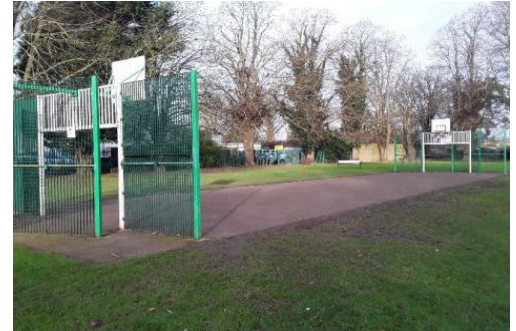
Item: Multi Use Games Area (MUGA)
Manufacturer: Wicksteed Playgrounds
Surface Type: Bitmac
Item Quantity: 1
Equipment Compliance: No
Surface Area Compliance: N/A
Life Expectancy: 5 -10 Years
Total Findings: 11

The area around the item has eroded creating trip hazards and may become slippery when wet - Reinstate eroded area

There are trip hazards present around the post foundations - Remove trip hazards

There is/are finger entrapments in the mesh openings and the item fails to meet the requirements of BS EN 15312 Clause 4.4.2.2 Entrapment of fingers - Monitor - No action given the risk assessment

There is some damage to the fence sections - Monitor for any further deterioration and repair as required

There is/are inserts missing creating finger entrapments in the redundant bolt holes and the item fails to meet the requirements of BS EN 15312 Clause 4.4.2.2 Entrapment of fingers - Replace the missing inserts

There is algae, silt or moss growth on the surface resulting in slippery conditions - Clean and treat appropriately

The paintwork on this item has been damaged or worn exposing the metal underneath which is rusting / corroding - Treat affected areas and repaint

Cable ties are present - Replace with a more appropriate fixing method

The weld(s) on this item have failed - Repair item

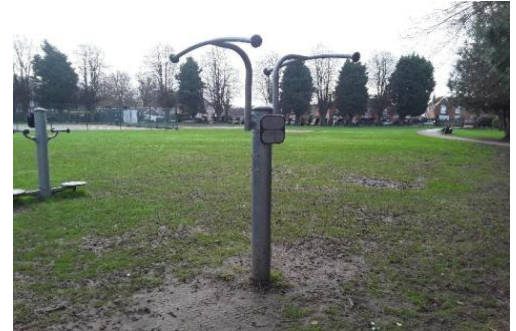
Item: Pull Up Station
Manufacturer: Kompan Ltd
Surface Type: Grass Matrix Tiles
Item Quantity: 1
Equipment Compliance: Yes
Surface Area Compliance: Yes
Life Expectancy: 5 -10 Years
Total Findings: 1

There is / are post or end caps missing / damaged on the item - Replace missing / damaged post or end caps

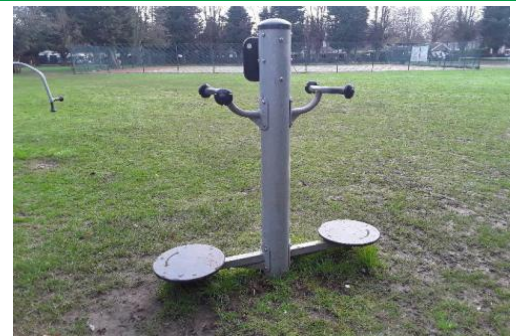
Item: Hip Twister
Manufacturer: Kompan Ltd
Surface Type: Grass Matrix Tiles
Item Quantity: 1
Equipment Compliance: No
Surface Area Compliance: Yes
Life Expectancy: 5 -10 Years
Total Findings: 2

The deflection of the rotating user station exceeds the maximum 105 degrees required by BS EN 16630 - Monitor - No action given the risk assessment

The bearing is showing signs of wear - Monitor for any further deterioration and replace as required

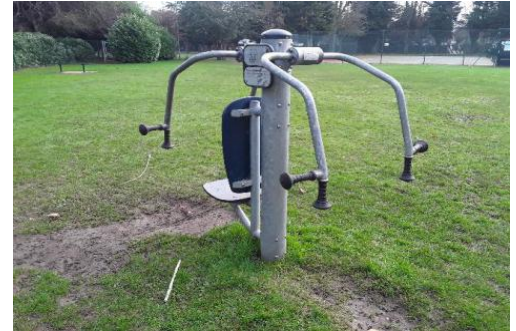
Item: Chest Press
Manufacturer: Kompan Ltd
Surface Type: Grass Matrix Tiles
Item Quantity: 1
Equipment Compliance: Yes
Surface Area Compliance: Yes
Life Expectancy: 5 -10 Years
Total Findings: 1

The surface has eroded / subsided - Repair as required to provide a uniform surface

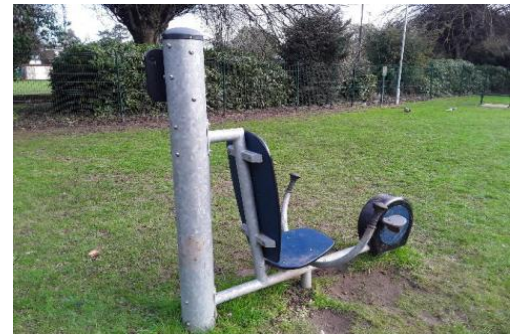
Item: Cycle
Manufacturer: Kompan Ltd
Surface Type: Grass Matrix Tiles
Item Quantity: 1
Equipment Compliance: Yes
Surface Area Compliance: Yes
Life Expectancy: 5 -10 Years
Total Findings: 1

One or more handgrip(s) are damaged - Replace damaged handgrips

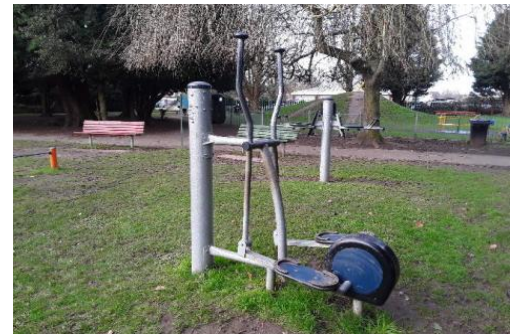
Item: Cross Trainer
Manufacturer: Kompan Ltd
Surface Type: Grass Matrix Tiles
Item Quantity: 1
Equipment Compliance: Yes
Surface Area Compliance: Yes
Life Expectancy: 5 -10 Years
Total Findings: 1

There is or are fixings missing on the item - Replace all missing fixings

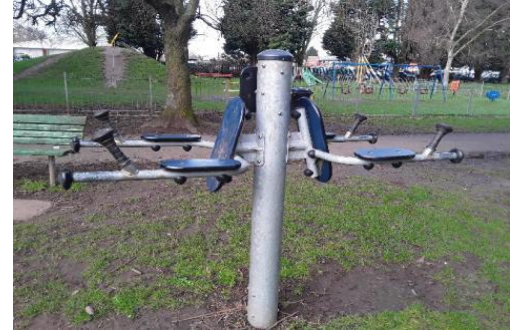
Item: Leg Raise
Manufacturer: Kompan Ltd
Surface Type: Grass Matrix Tiles
Item Quantity: 1
Equipment Compliance: Yes
Surface Area Compliance: Yes
Life Expectancy: 5 -10 Years
Total Findings: 1

There is minor damage to the handgrips - Monitor and replace if required

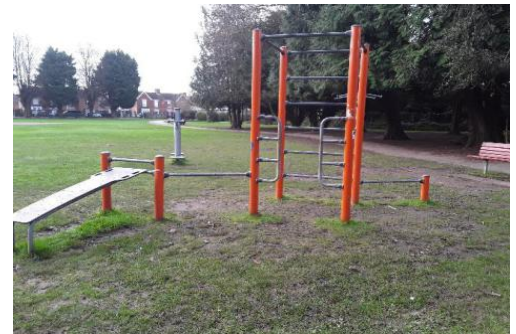
Item: Fit Point
Manufacturer: Kompan Ltd
Surface Type: Grass Matrix Tiles
Item Quantity: 1
Equipment Compliance: Yes
Surface Area Compliance: Yes
Life Expectancy: 5 -10 Years
Total Findings: 2

There is surface corrosion / rust present on the item - Consider treating the item

There is minor damage to the bench - Monitor and repair if required

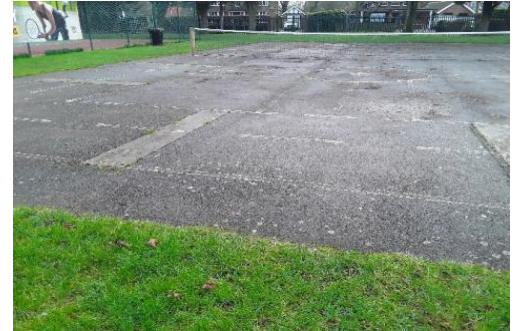
Item: Go Kart Track
Manufacturer: Not Identified
Surface Type: Bitmac
Item Quantity: 1
Equipment Compliance: N/A
Surface Area Compliance: N/A
Life Expectancy: 5 -10 Years
Total Findings: 4

A tennis net has been placed over the track - Monitor and remove the net if required

There is algae, silt or moss growth on the surface resulting in slippery conditions - Clean and treat appropriately

The surfacing is damaged - Repair damaged areas of surfacing
