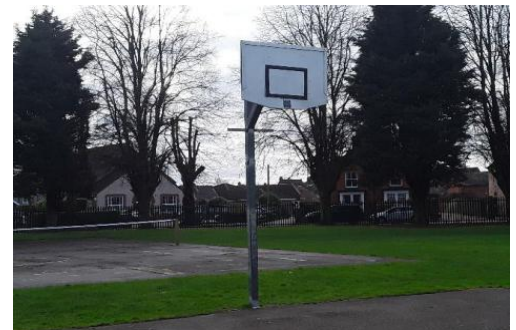
Item: Basketball Post
Manufacturer: Not Identified
Surface Type: Bitmac
Item Quantity: 1
Equipment Compliance: N/A
Surface Area Compliance: N/A
Total Findings: 4

The hoop has been removed - Consider replacing the missing hoop

The backboard braces are missing - Replace the braces

There are gaps opening between the surfacing and the edging surround or between the joints in the surfacing - Monitor for any further deterioration and repair as required

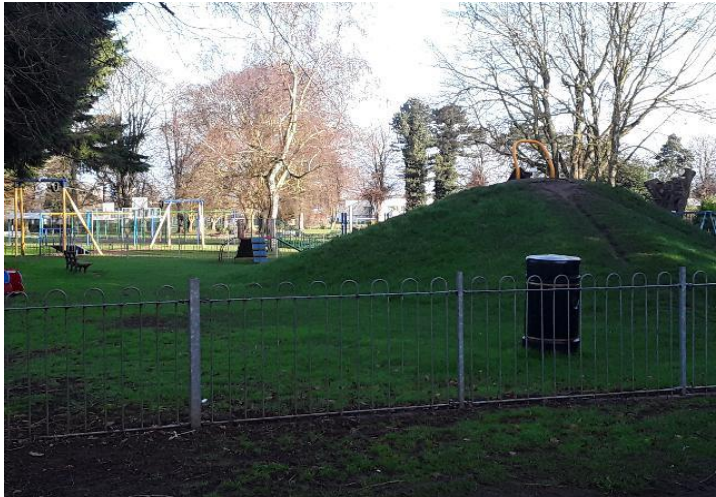
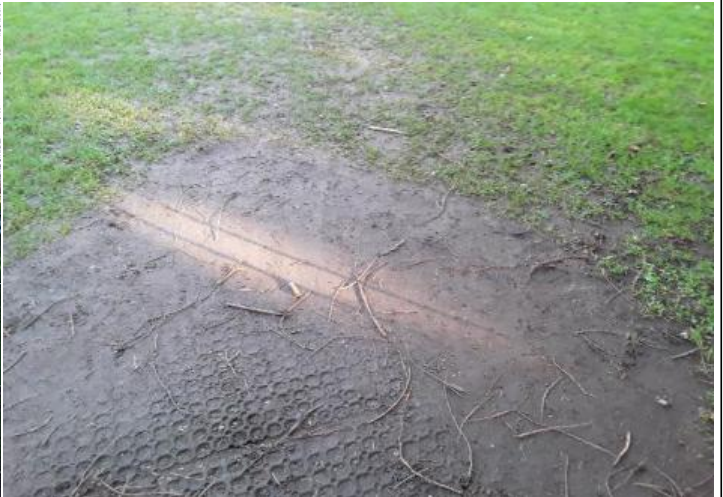
Finding: The grass mats are silted up, the soil is compacted and the area will become very slippery when the soil is wet. **Action:** Reinstate as required

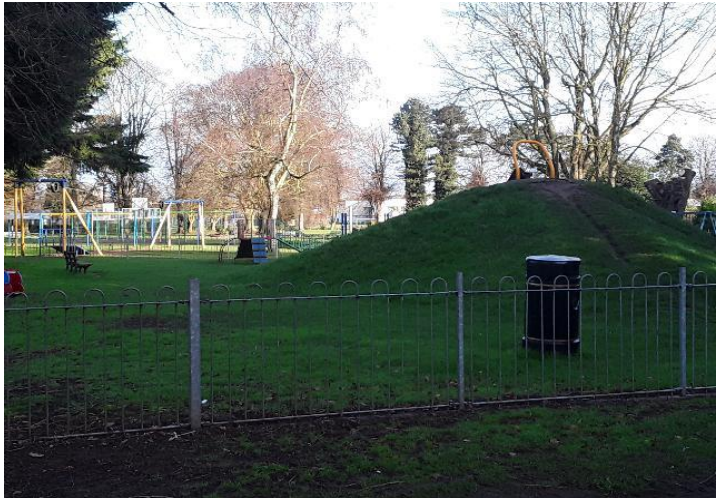
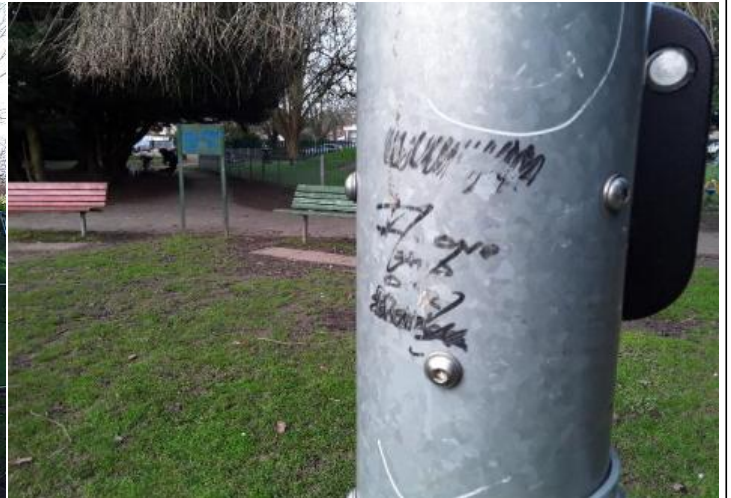
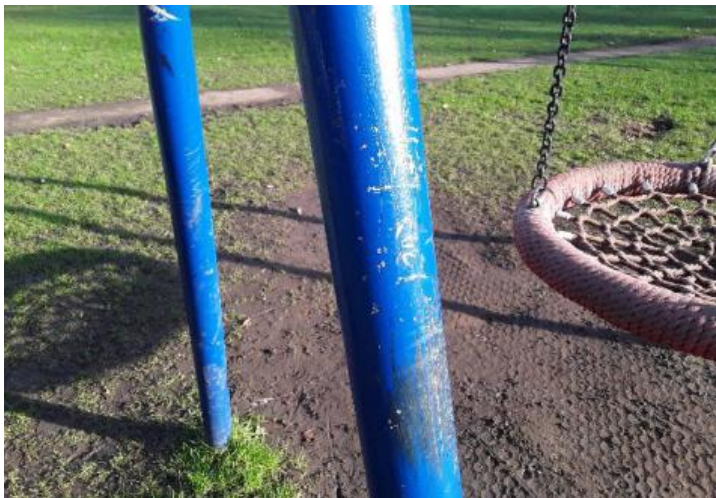
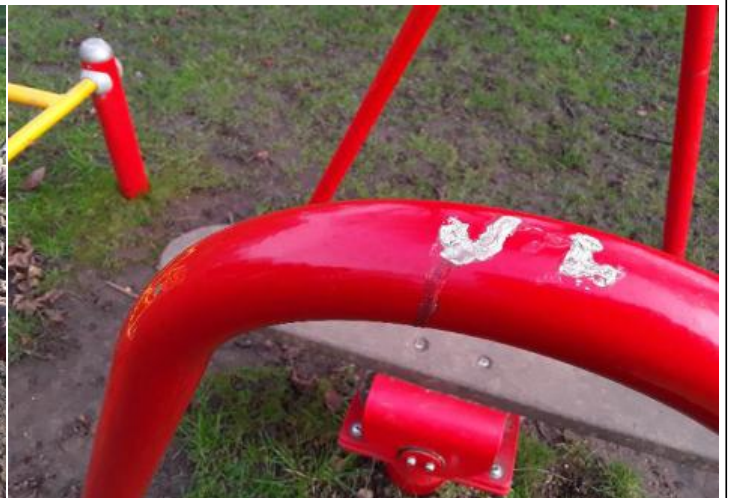
Finding: There is some graffiti present

Action: Remove the graffiti

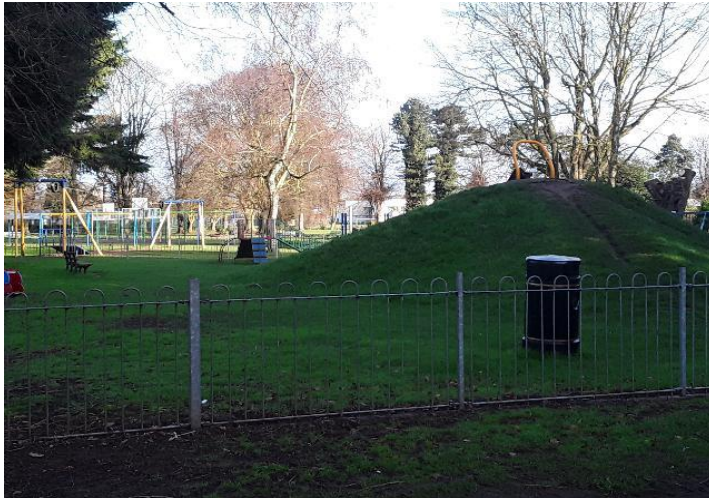
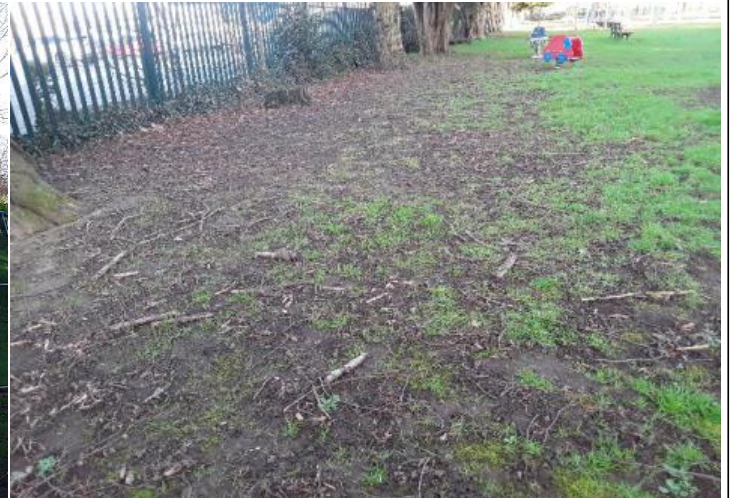
Finding: There is some tree debris present

Action: Remove and maintain

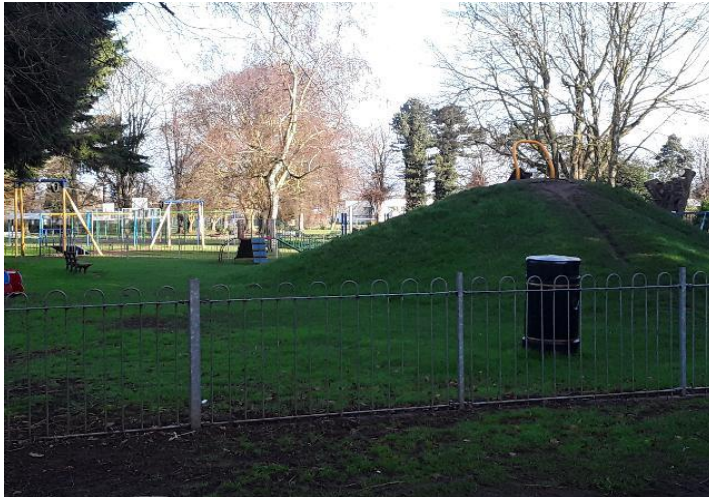
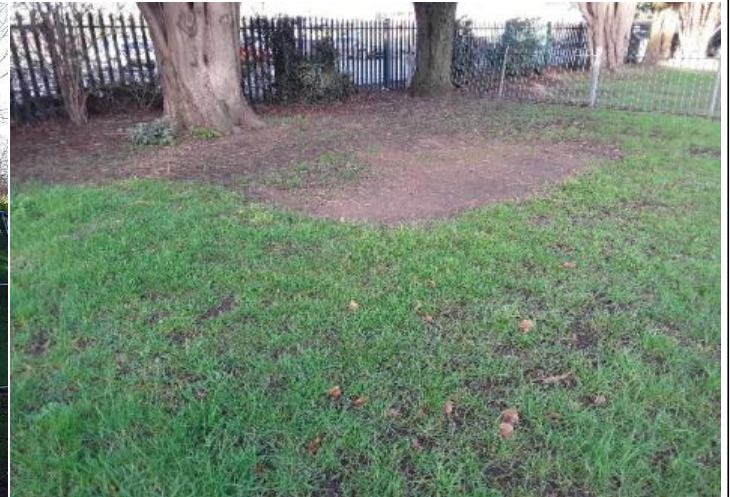
Finding: The surface has eroded in some areas and may be slippery in wet conditions

Action: Reinstate the surface

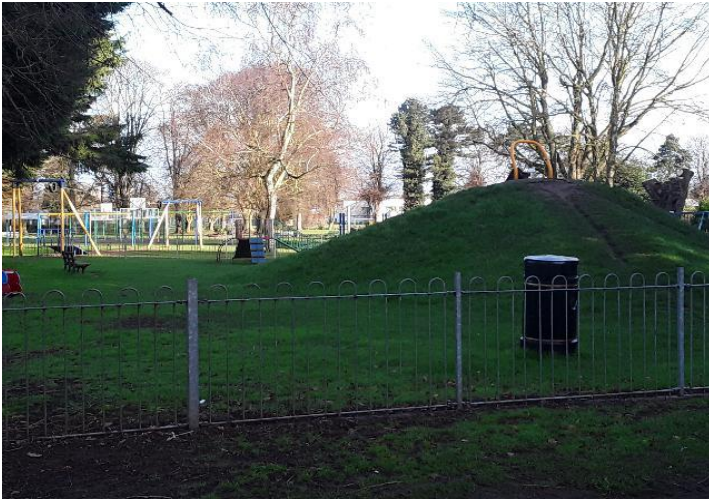
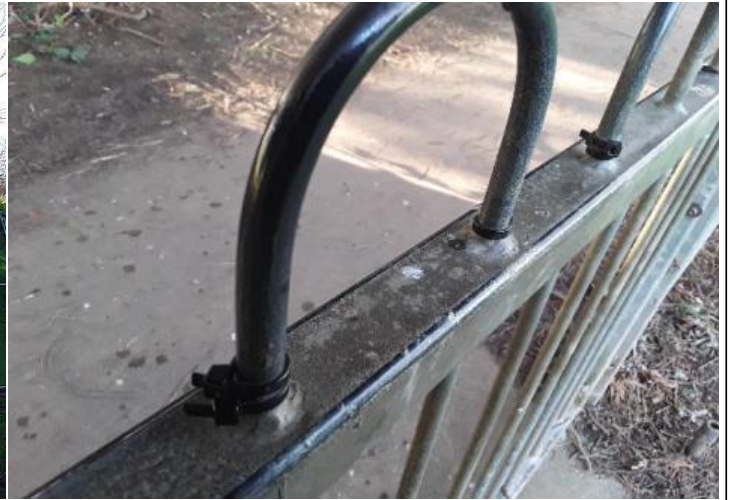
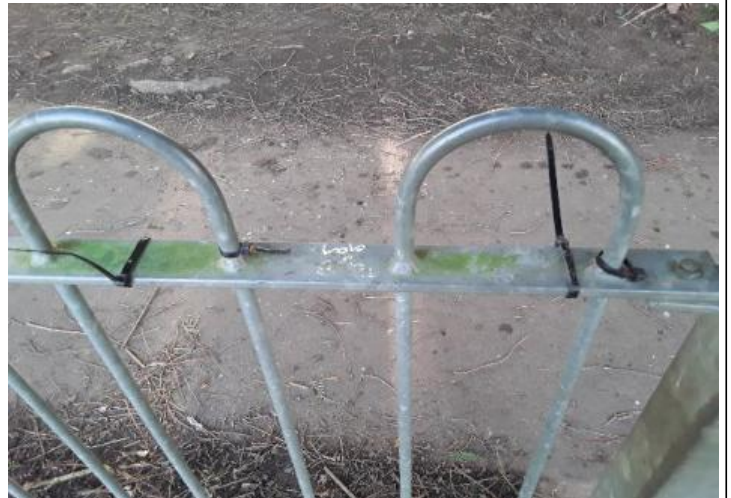
Finding: Redundant cable ties are secured to the gate and fence with exposed sharp protrusions

Action: Remove the cable ties

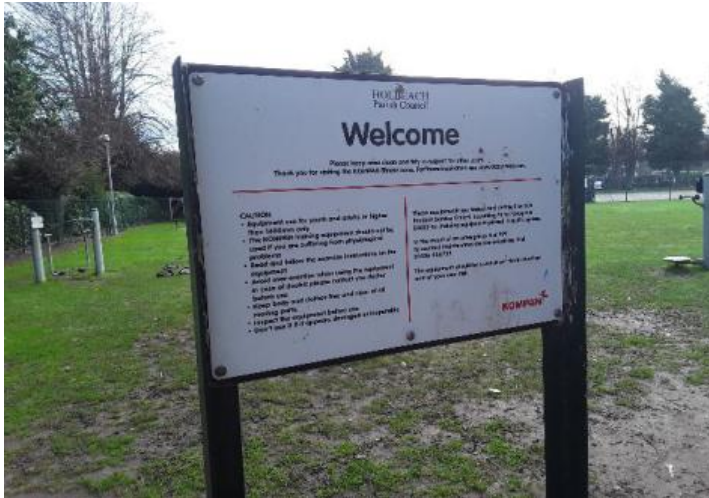
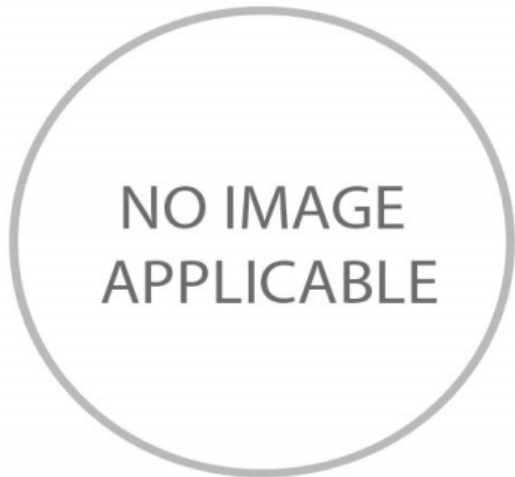
Finding: It is recommended that signage, with information including the site address, contact information for maintenance issues and emergency contact details are provided for the playground facility

Action: Provide in accordance with the recommendations

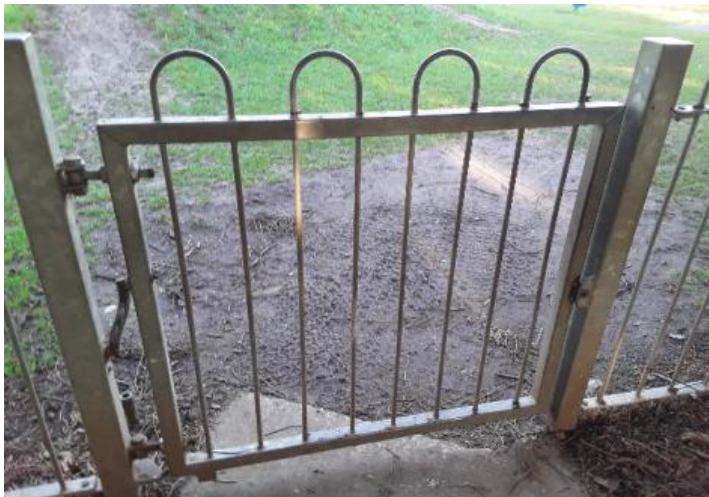
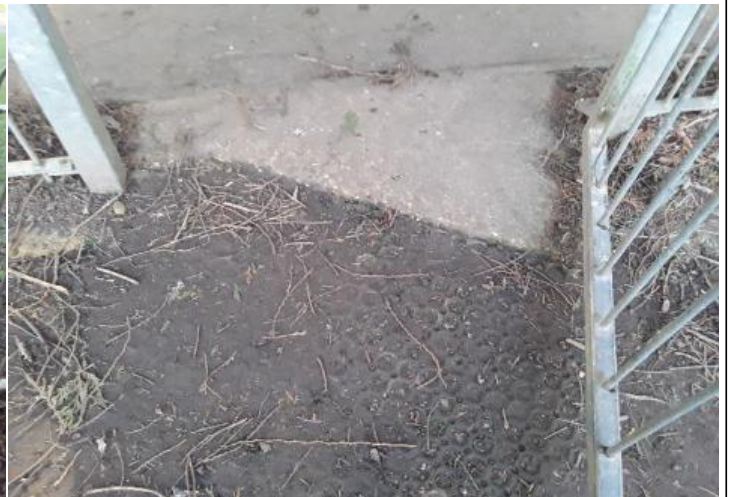
There are trip hazards present over the concrete base under the gate - Remove trip hazard

Finding: There are trip hazards present over the concrete base under the gate

Action: Remove trip hazard

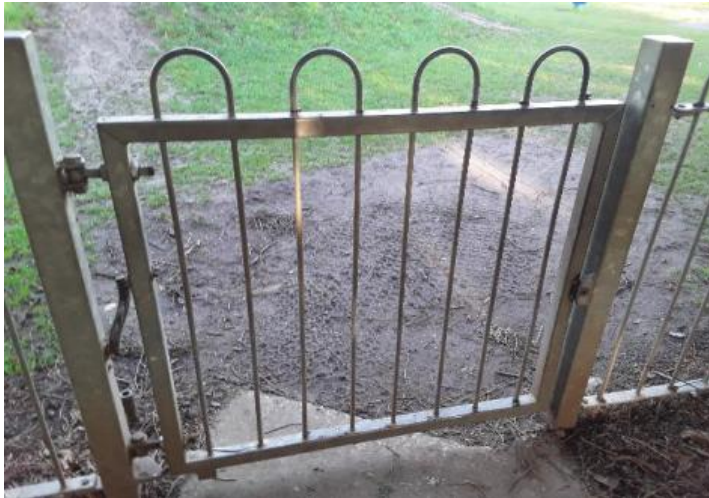
Finding: The gate is closing too quickly (less than 4 seconds)

Action: Take corrective action to ensure that the gate closes in 4-8 seconds from 90 degrees

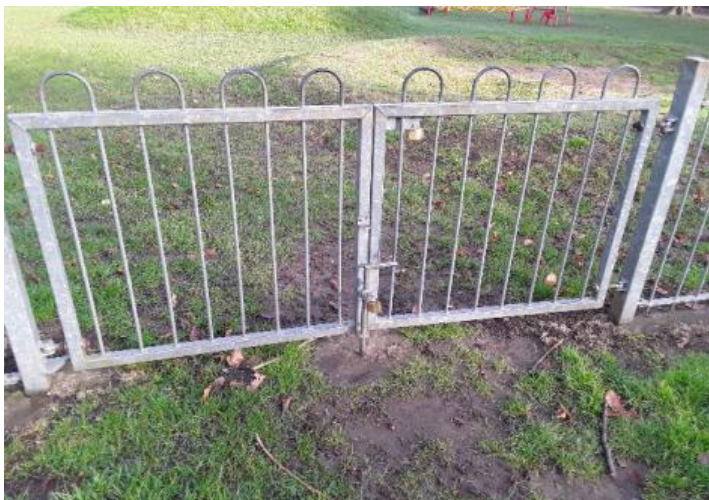
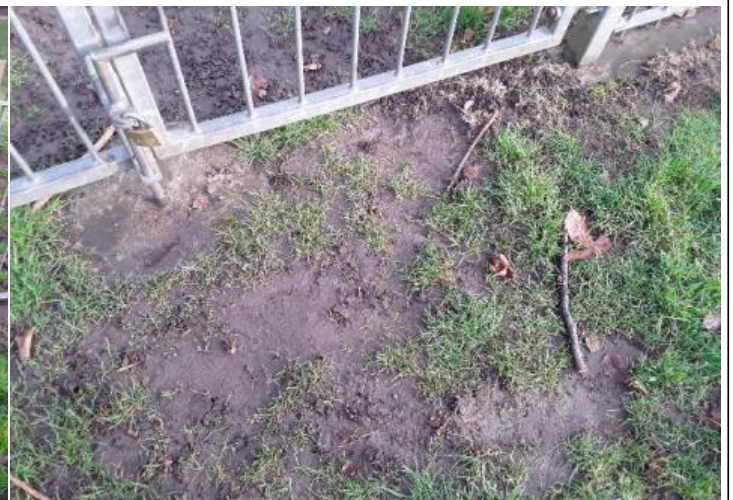
Item: Gates - Gate - Maintenance
Manufacturer: Not Identified

Risk Level: L - Low Risk
Surface: Grass

Finding: The area around the item has eroded and may become slippery

Action: Reinstate eroded area

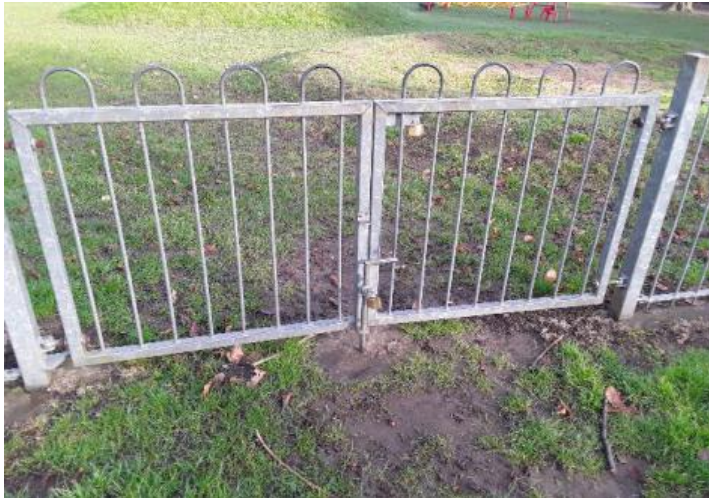
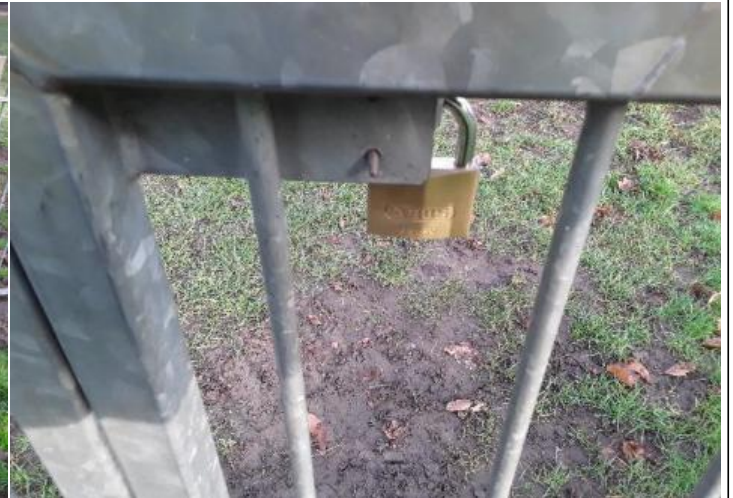
Item: Gates - Gate - Maintenance
Manufacturer: Not Identified

Risk Level: N - Risk Assessment not Undertaken
Surface: Grass

Finding: The maintenance gate was correctly padlocked at the time of inspection, however this means that the inspector was unable to fully assess the gate

Action: Ensure that there are 12mm gaps throughout the full range of motion on gate/s and between leaves where relevant

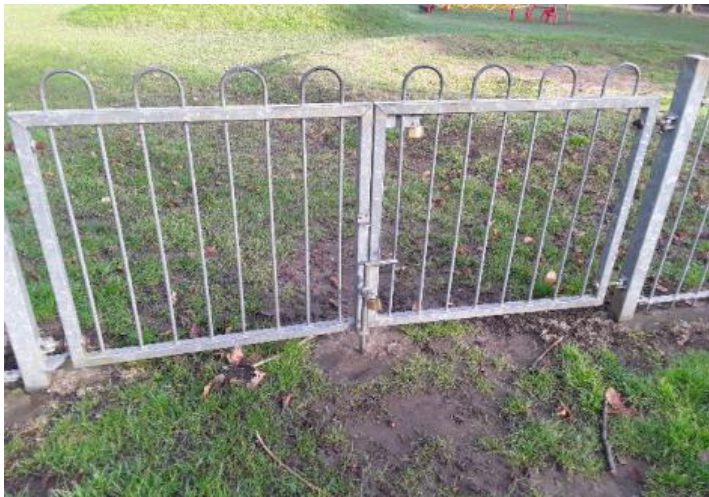
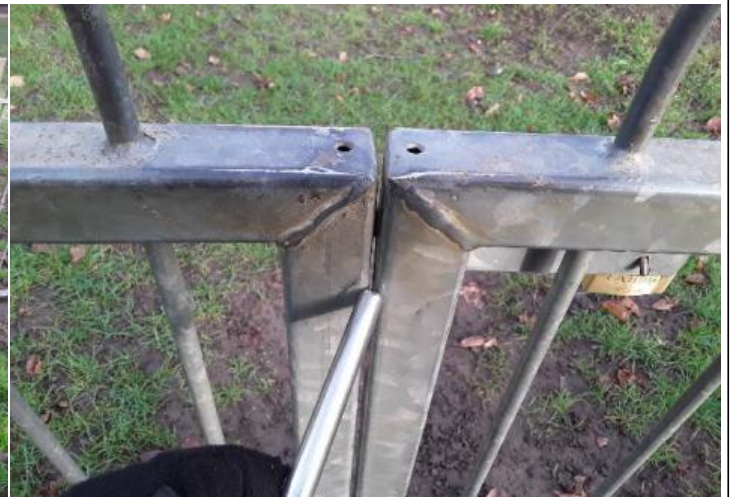
Item: Gates - Gate - Maintenance
Manufacturer: Not Identified

Risk Level: L - Low Risk
Surface: Grass

Finding: There are openings that are less than 12mm that could trap or crush fingers

Action: Provide a 12mm gap throughout full range of motion at both sides of gate

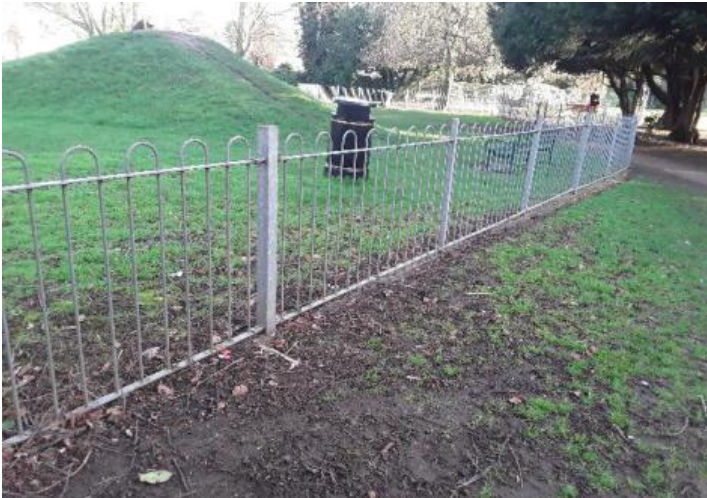
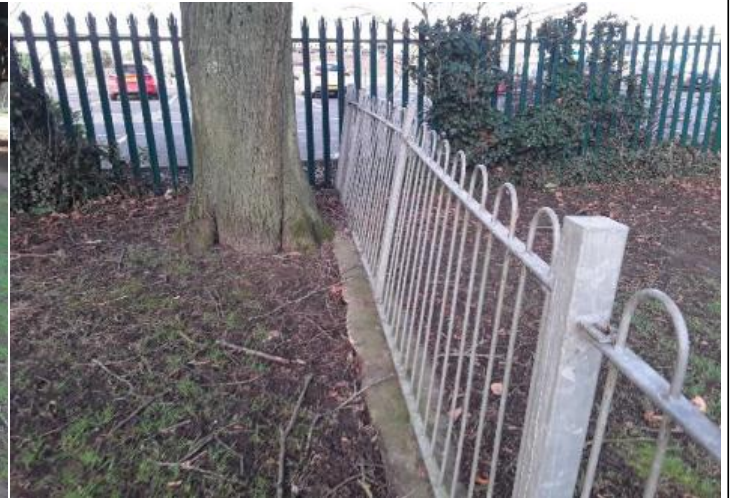
Item: Fences - Fence - Bow Top
Manufacturer: Not Identified

Risk Level: L - Low Risk
Surface: Grass

Finding: A number of posts are out of plumb but are stable **Action:** Monitor and reset the posts as required

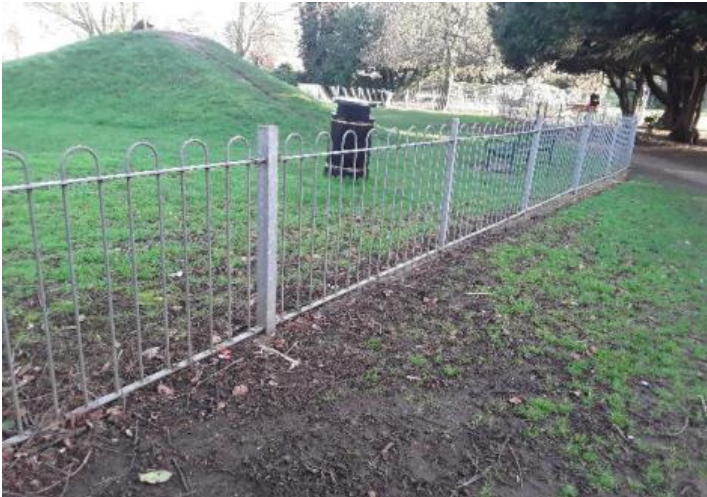
Item: Fences - Fence - Bow Top
Manufacturer: Not Identified

Risk Level: L - Low Risk
Surface: Grass

Finding: There is minor damage to the fence sections **Action:** Monitor for any further deterioration and repair as required

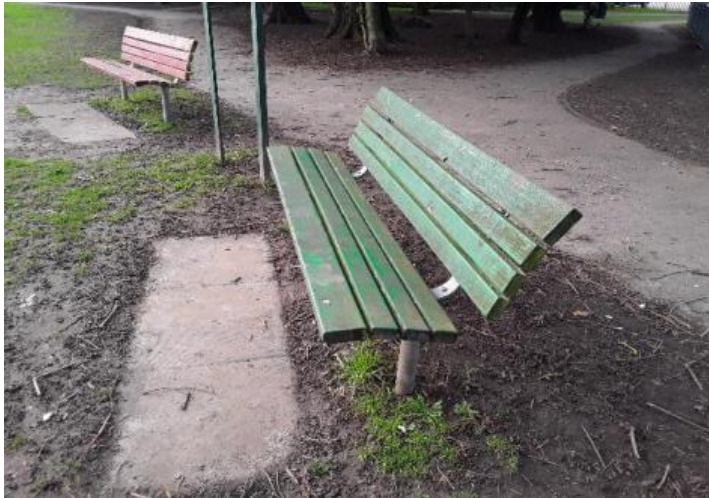
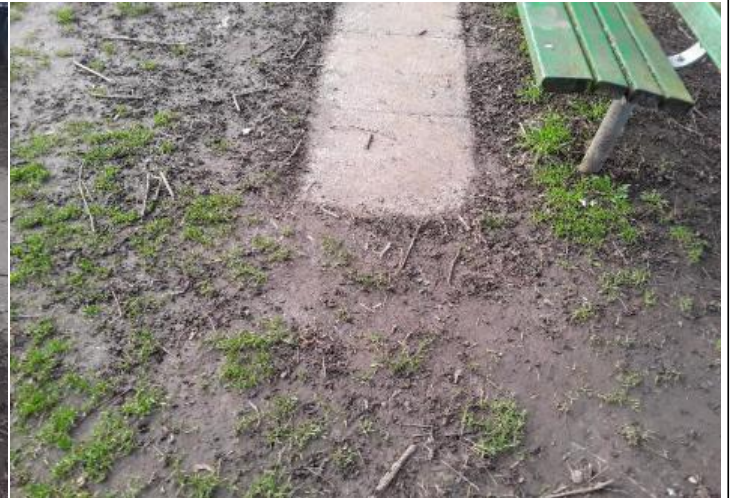
Item: Ancillary Items - Bench
Manufacturer: Not Identified

Risk Level: L - Low Risk
Surface: Concrete

Finding: The area around the item has eroded and may become slippery when wet

Action: Reinststate eroded area

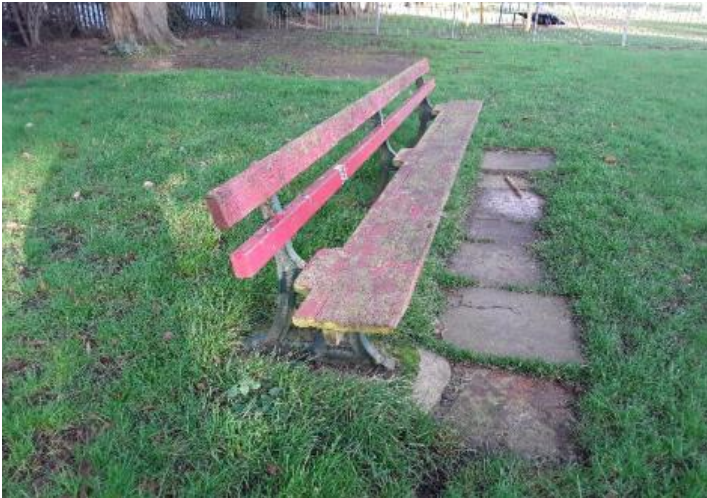
Item: Ancillary Items - Bench
Manufacturer: Not Identified

Risk Level: L - Low Risk
Surface: Concrete

Finding: There is minor vandalism damage to the bench

Action: Monitor and repair if required

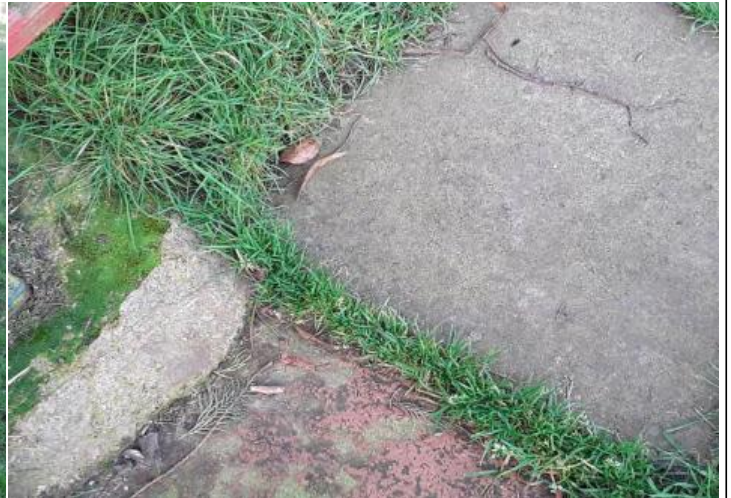
Item: Ancillary Items - Bench
Manufacturer: Not Identified

Risk Level: L - Low Risk
Surface: Concrete

Finding: There is weed / vegetation growth on and around the paved surface

Action: Remove weed / vegetation growth

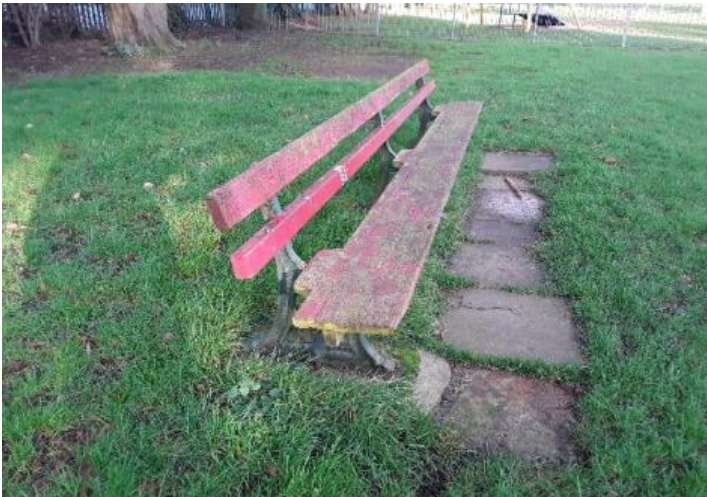
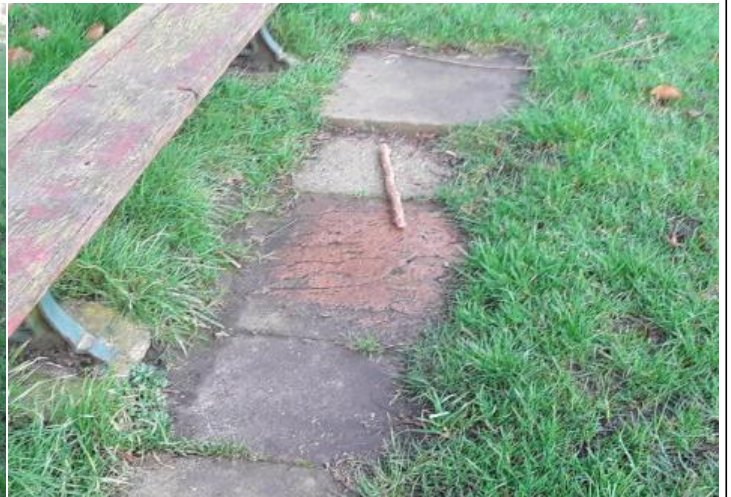
Item: Ancillary Items - Bench
Manufacturer: Not Identified

Risk Level: L - Low Risk
Surface: Concrete

Finding: There are trip hazards present over the displaced pavings

Action: Remove trip hazard

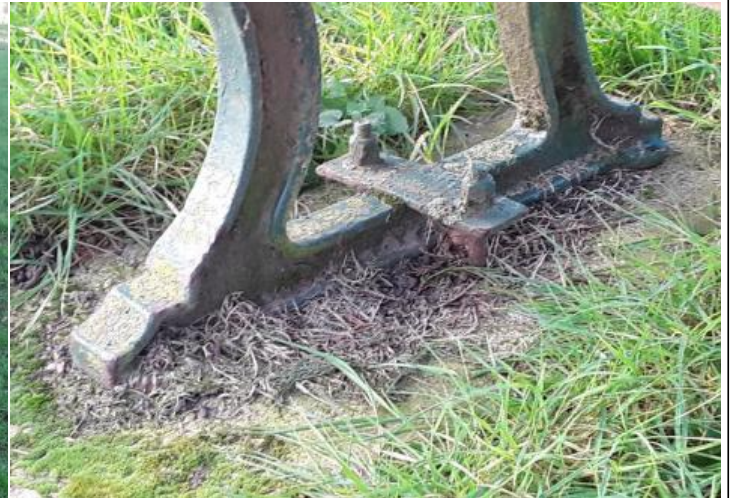
Item: Ancillary Items - Bench
Manufacturer: Not Identified

Risk Level: L - Low Risk
Surface: Concrete

Finding: There are projecting bolt thread(s) present

Action: Remove excess thread length and deburr or provide cap

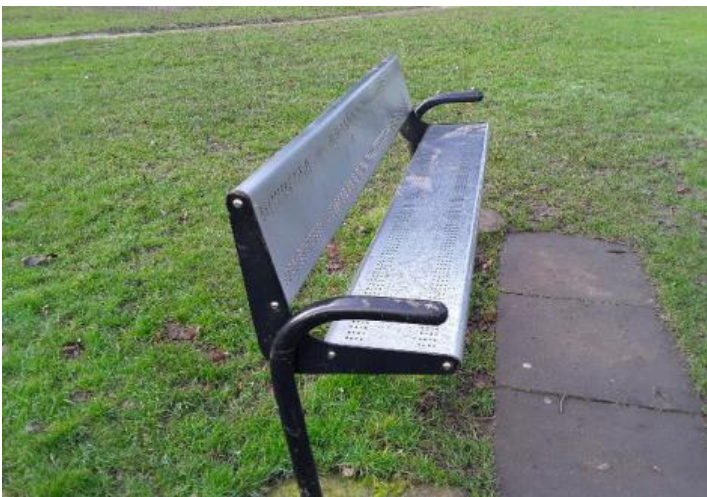
Item: Ancillary Items - Bench
Manufacturer: Not Identified

Risk Level: L - Low Risk
Surface: Mixed Surface

Finding: The paintwork on this item has been damaged or worn exposing the metal underneath which is rusting / corroding

Action: Treat affected areas and repaint

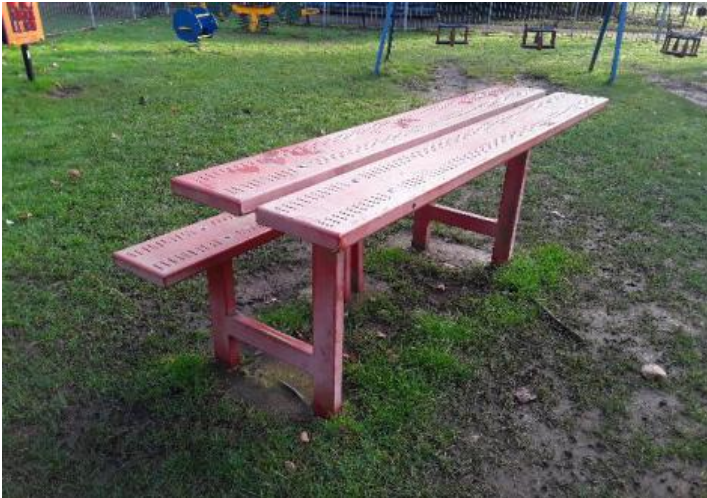
Item: Ancillary Items - Picnic Table
Manufacturer: Wicksteed Playgrounds

Risk Level: V - Very Low Risk
Surface: Concrete

Finding: There is/are inserts missing

Action: Replace missing inserts

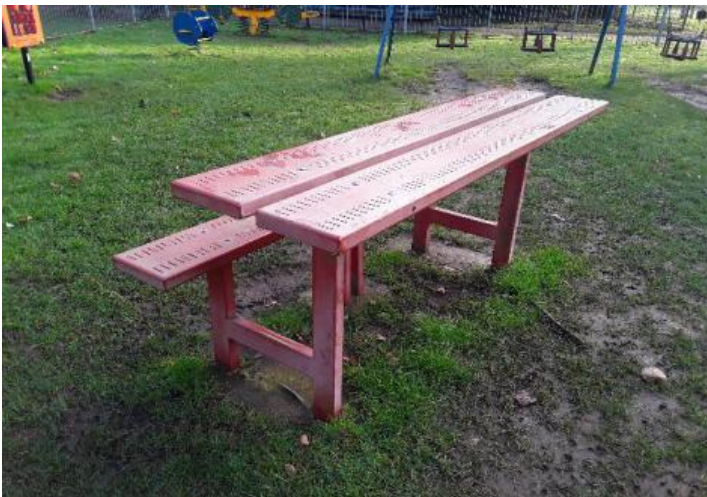
Item: Ancillary Items - Picnic Table
Manufacturer: Wicksteed Playgrounds

Risk Level: L - Low Risk
Surface: Concrete

Finding: The surface has eroded and the foundations are exposed

Action: Reinstate surrounding surfaces to cover the foundations

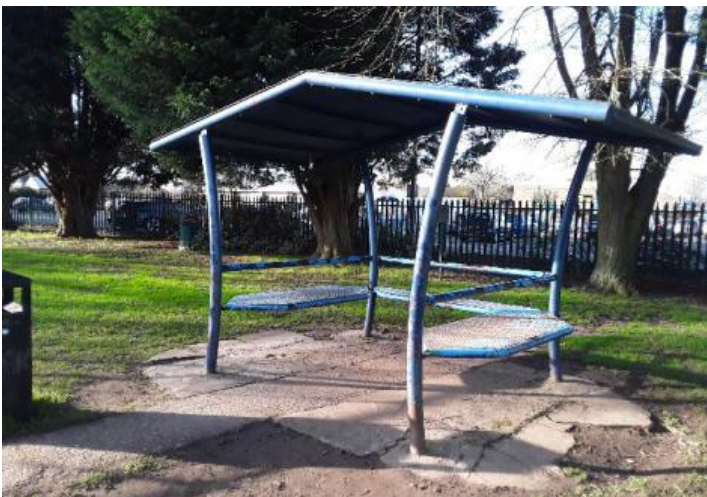
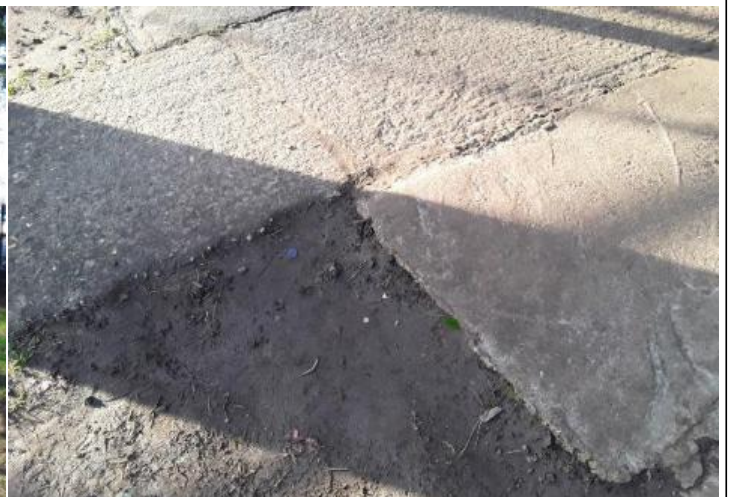
Item: Ancillary Items - Shelter
Manufacturer: Not Identified

Risk Level: L - Low Risk
Surface: Paving Slabs

Finding: The area around the item has eroded creating trip hazards and may become slippery when wet

Action: Reinstate eroded area

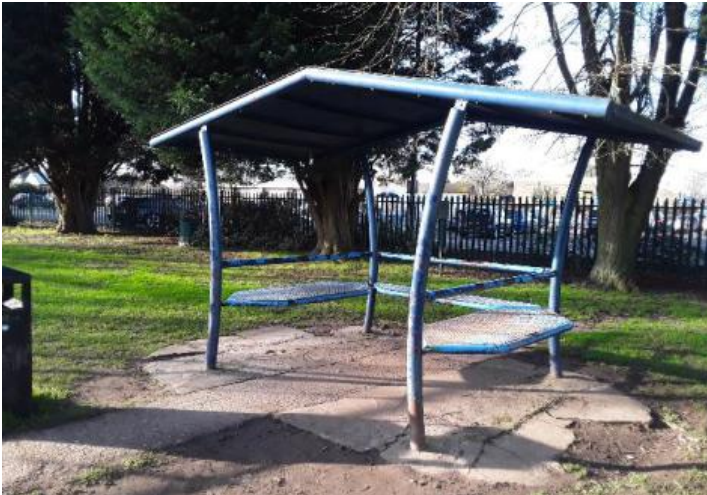
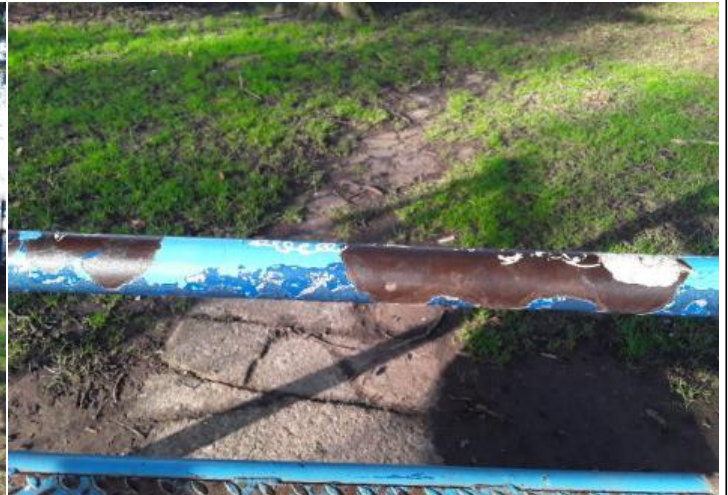
Item: Ancillary Items - Shelter
Manufacturer: Not Identified

Risk Level: L - Low Risk
Surface: Paving Slabs

Finding: The paintwork on this item has been damaged or worn exposing the metal underneath which is rusting / corroding

Action: Treat affected areas and repaint

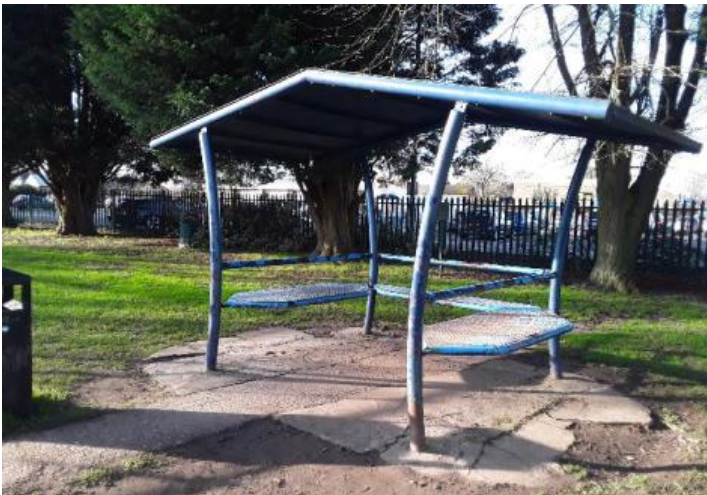
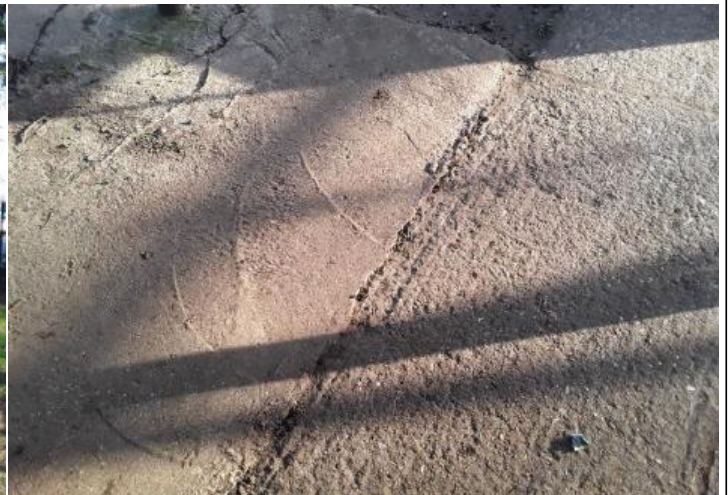
Item: Ancillary Items - Shelter
Manufacturer: Not Identified

Risk Level: V - Very Low Risk
Surface: Paving Slabs

Finding: There is minor damage to the concrete surface

Action: Monitor for any further deterioration and repair as required

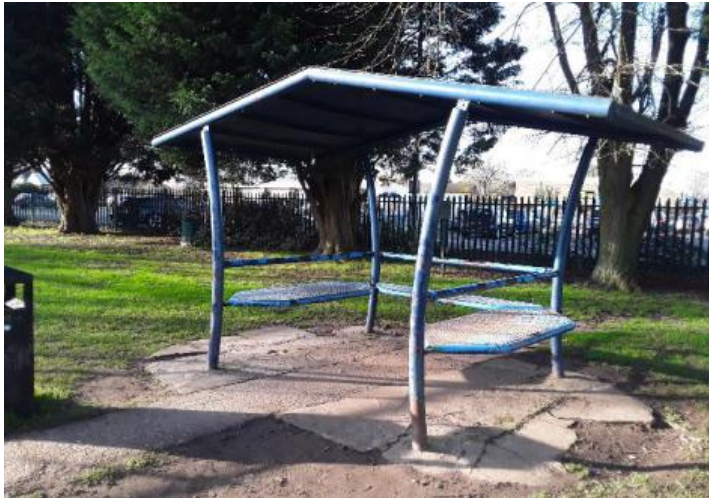
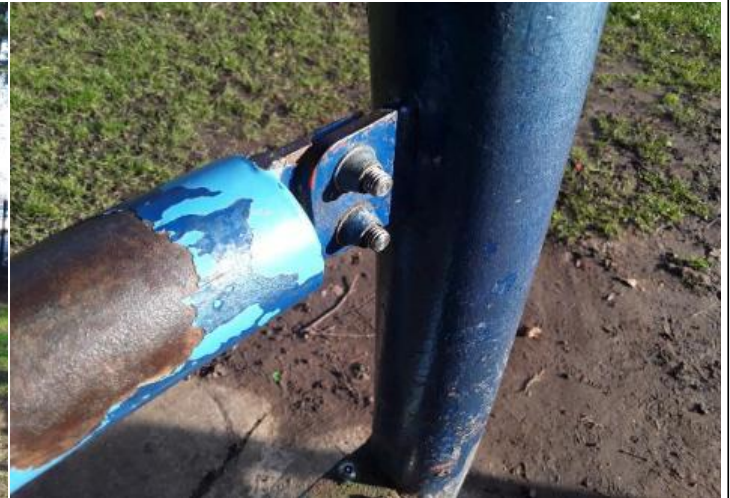
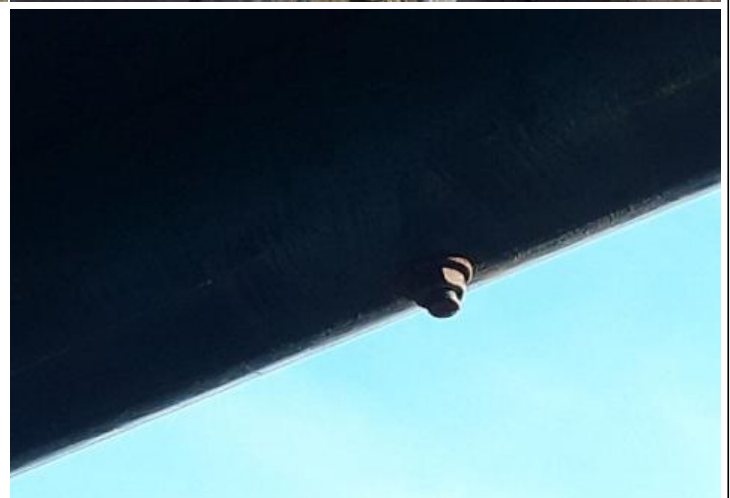
Item: Ancillary Items - Shelter
Manufacturer: Not Identified

Risk Level: L - Low Risk
Surface: Paving Slabs

Finding: There are projecting bolt thread(s) present

Action: Remove excess thread length and deburr or provide cap

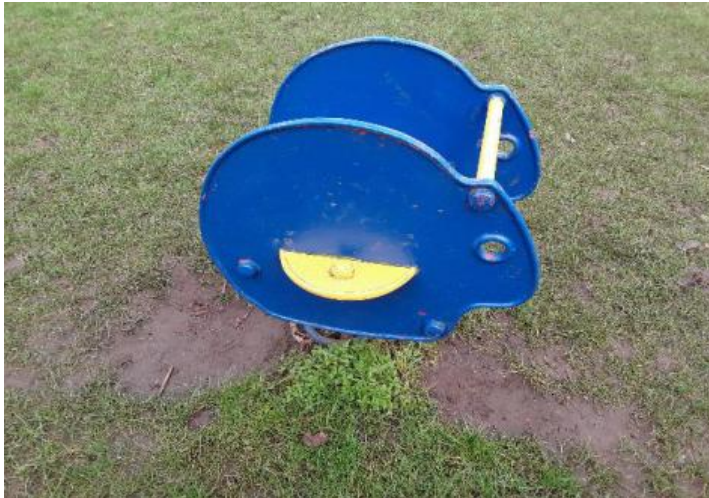
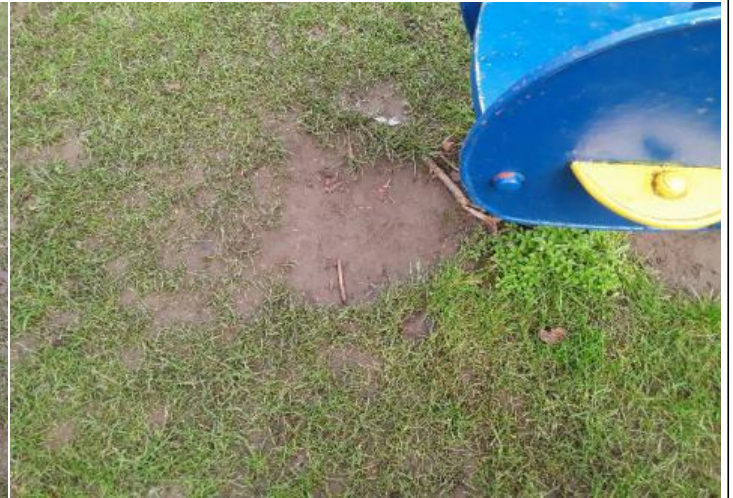
Item: Rocking Equipment - Spring Wombat
Manufacturer: Ausplay

Risk Level: L - Low Risk
Surface: Grass Matrix Tiles

Finding: The grass has eroded within the impact area of the equipment and may not provide the necessary impact attenuating properties for the equipment fall height; the surface may also be slippery in wet weather
Action: Reinststate the grass or provide an all weather surface

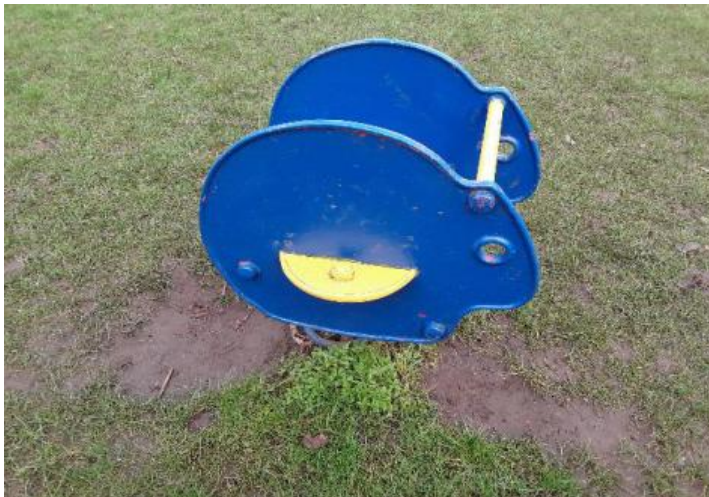
Item: Rocking Equipment - Spring Wombat
Manufacturer: Ausplay

Risk Level: L - Low Risk
Surface: Grass Matrix Tiles

Finding: There is surface corrosion / rust present on the item
Action: Consider treating the item

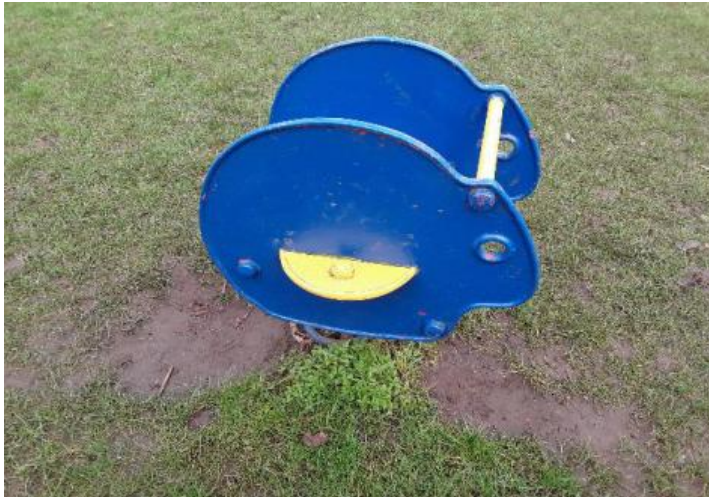
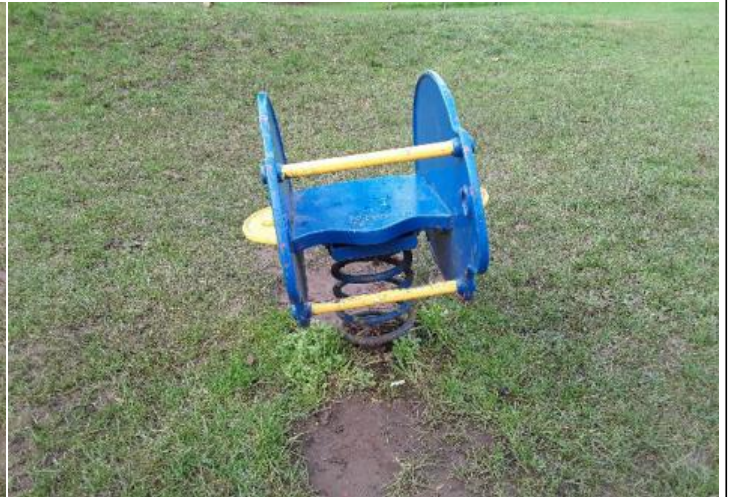
Item: Rocking Equipment - Spring Wombat
Manufacturer: Ausplay

Risk Level: L - Low Risk
Surface: Grass Matrix Tiles

Finding: The seat isn't level at rest

Action: Adjust the seat

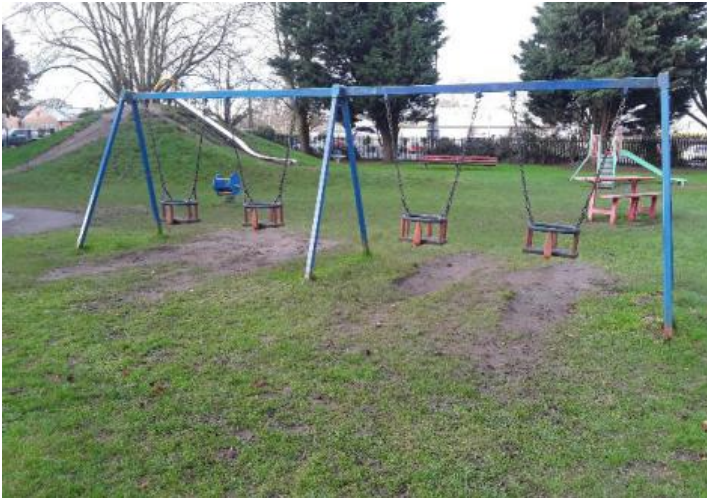
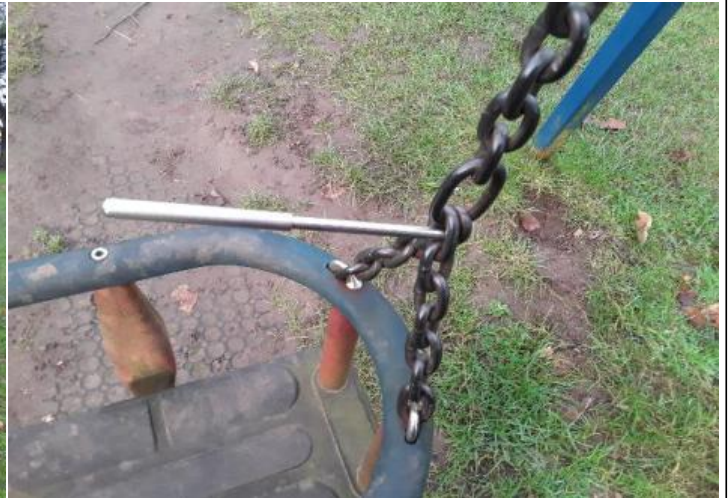
Item: Swings - 2 Bay 4 Seat (Cradle)
Manufacturer: Wicksteed Playgrounds

Risk Level: V - Very Low Risk
Surface: Grass Matrix Tiles

Finding: The chain openings are in excess of the 8.6mm as recommended by BS EN 1176 **Action:** Monitor - No action given the risk assessment

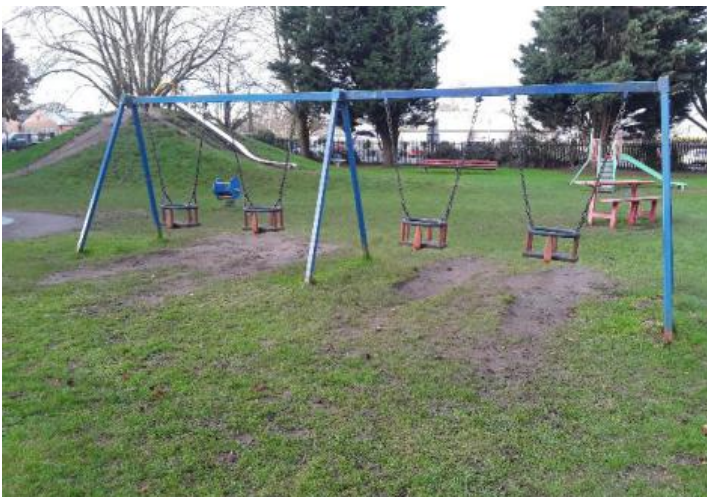
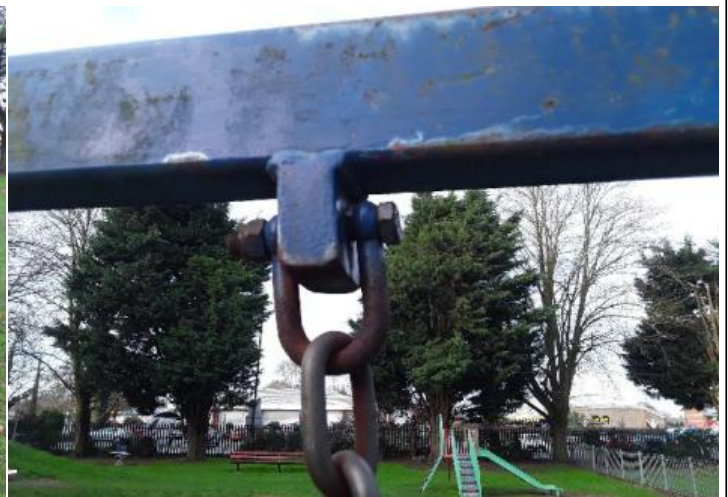
Item: Swings - 2 Bay 4 Seat (Cradle)
Manufacturer: Wicksteed Playgrounds

Risk Level: V - Very Low Risk
Surface: Grass Matrix Tiles

Finding: The bushes are showing signs of wear **Action:** Monitor for any further deterioration and replace as required

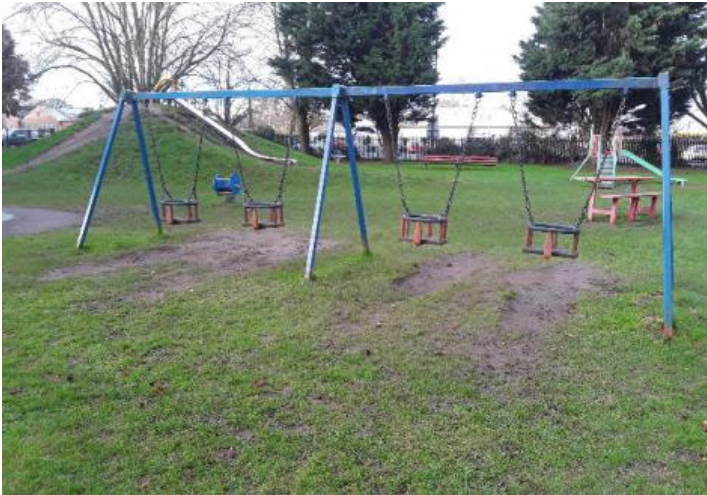
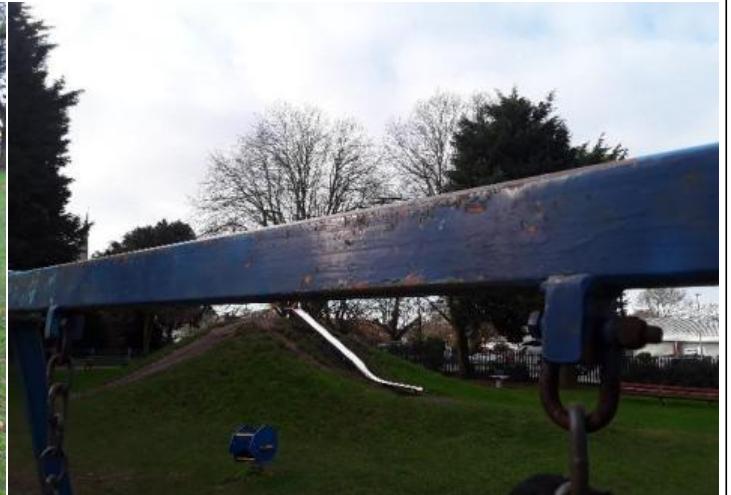
Item: Swings - 2 Bay 4 Seat (Cradle)
Manufacturer: Wicksteed Playgrounds

Risk Level: L - Low Risk
Surface: Grass Matrix Tiles

Finding: The paintwork on this item has been damaged or worn exposing the metal underneath which is rusting / corroding

Action: Treat affected areas and repaint

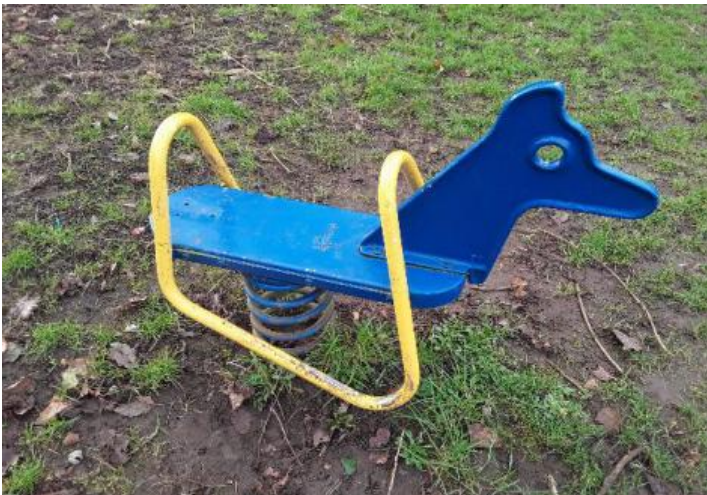
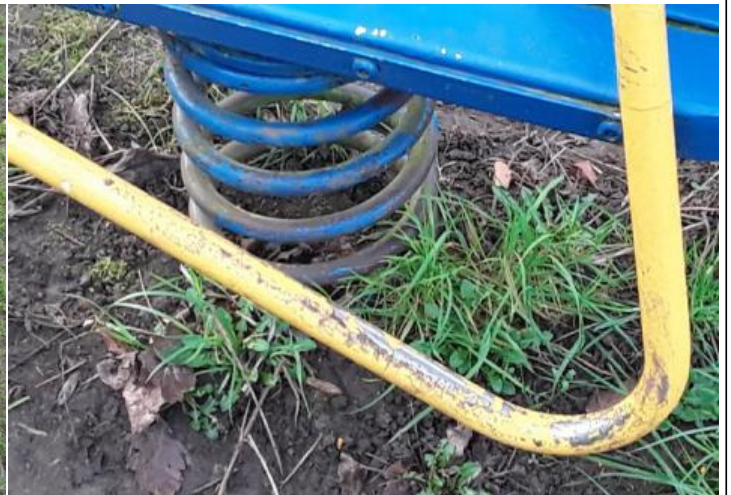
Item: Rocking Equipment - Spring Horse
Manufacturer: Ausplay

Finding: There is surface corrosion / rust present on the item

Action: Consider treating the item
