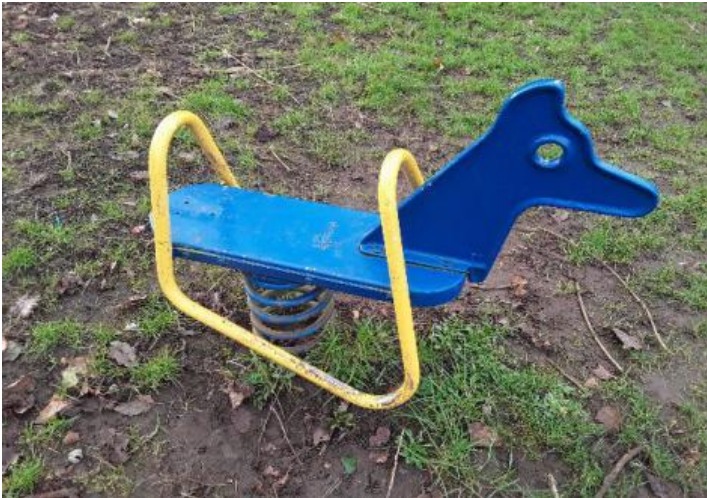
Item: Rocking Equipment - Spring Horse
Manufacturer: Ausplay

Finding: The item has missing component(s)

Action: Consider replacing missing components

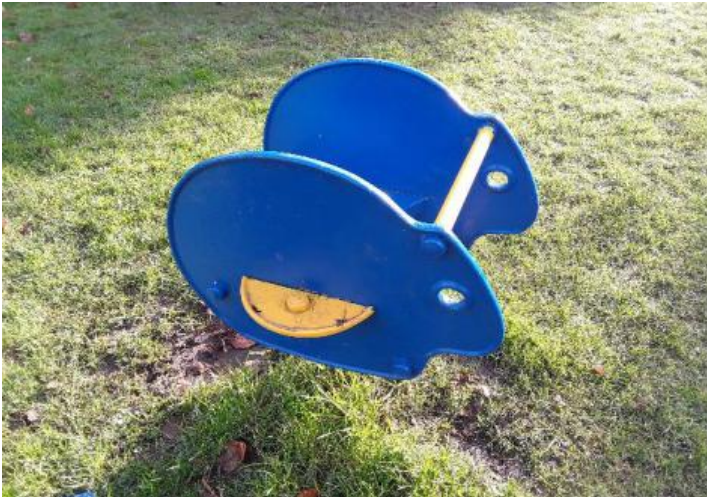
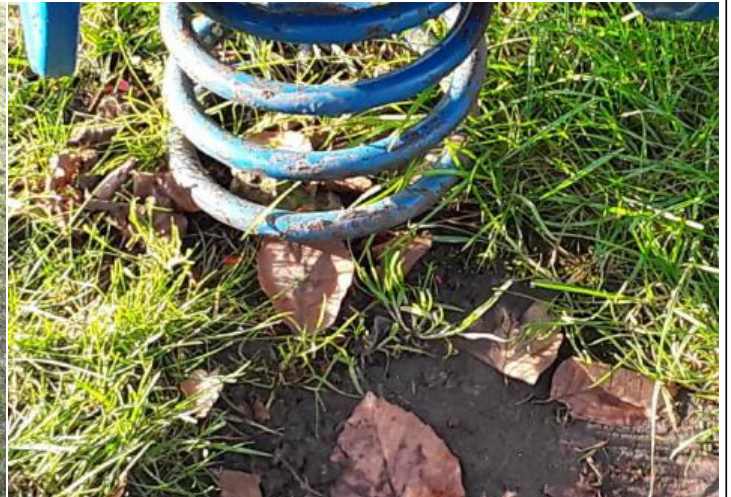
Item: Rocking Equipment - Spring Wombat
Manufacturer: Ausplay

Finding: The paintwork on the spring has been damaged or worn exposing the metal underneath which is rusting

Action: Treat any rusting components and repaint

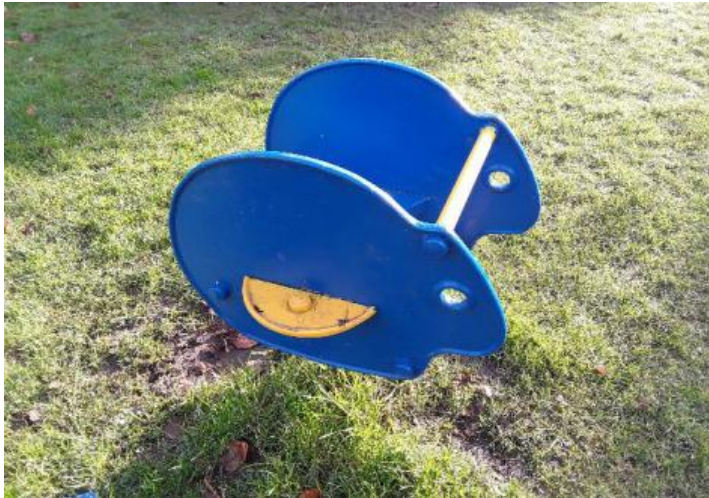
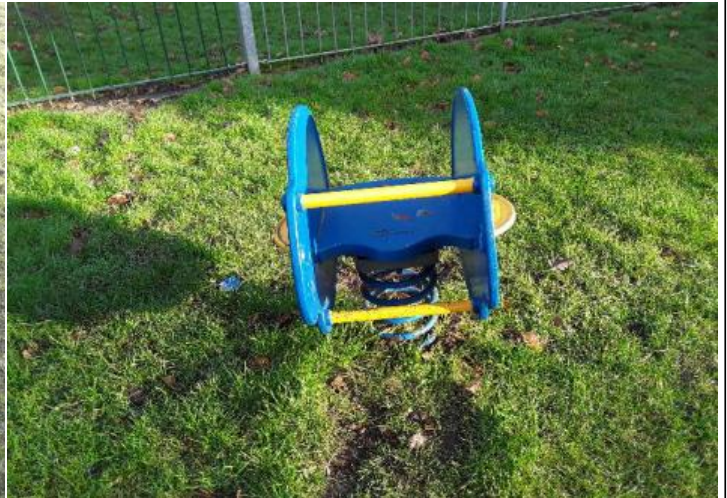
Item: Rocking Equipment - Spring Wombat
Manufacturer: Ausplay

Finding: The seat isn't level at rest

Action: Adjust the seat

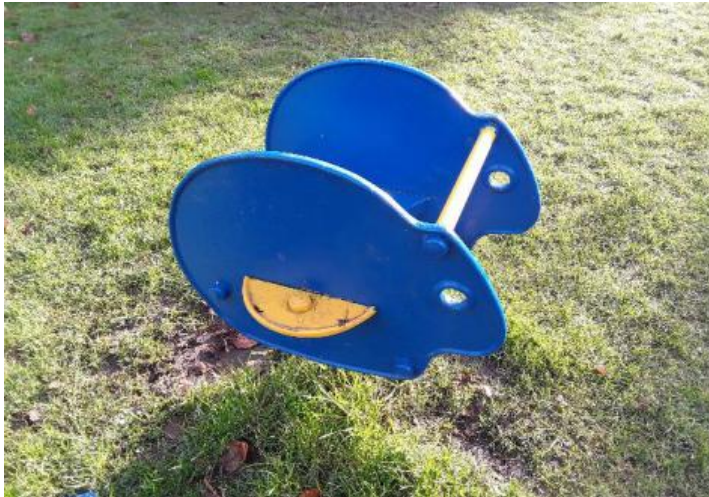
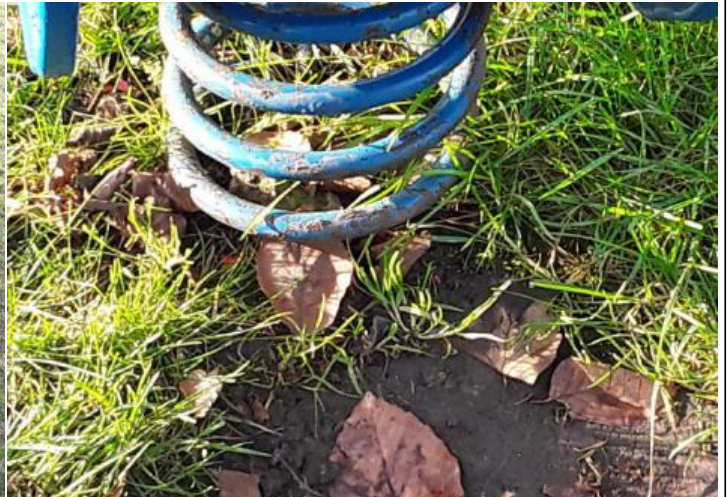
Item: Rocking Equipment - Spring Wombat
Manufacturer: Ausplay

Finding: The spring clamps are loose

Action: Tighten all loose fixings

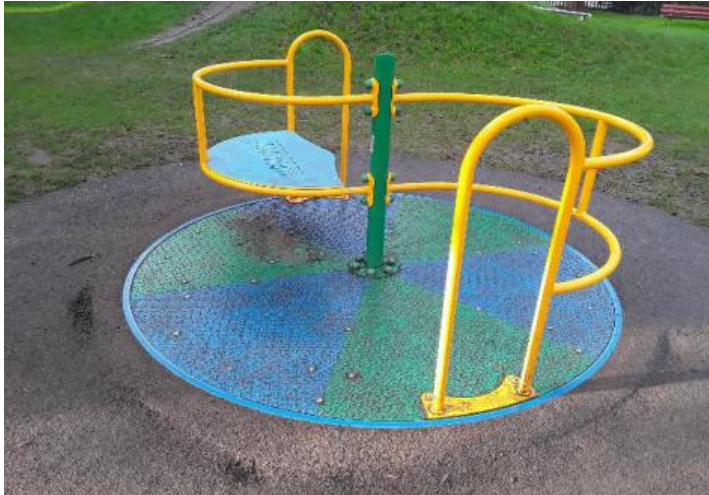
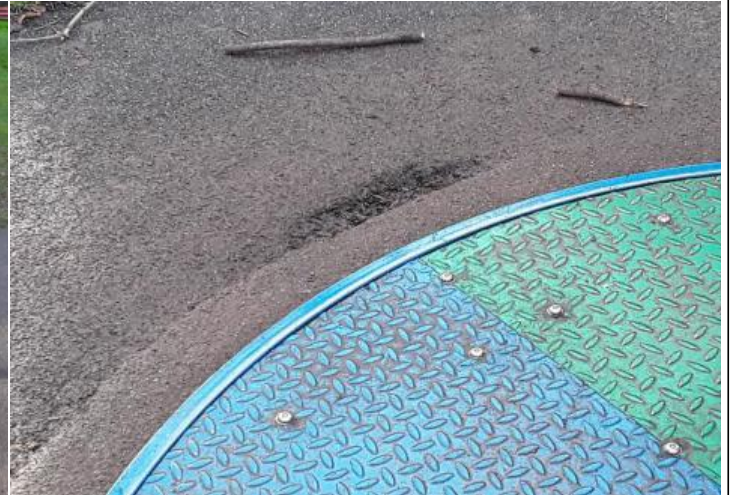
Item: Rotor Play - Inclusive Roundabout
Manufacturer: Wicksteed Playgrounds

Finding: The surfacing is severely damaged

Action: Repair damaged areas of surfacing

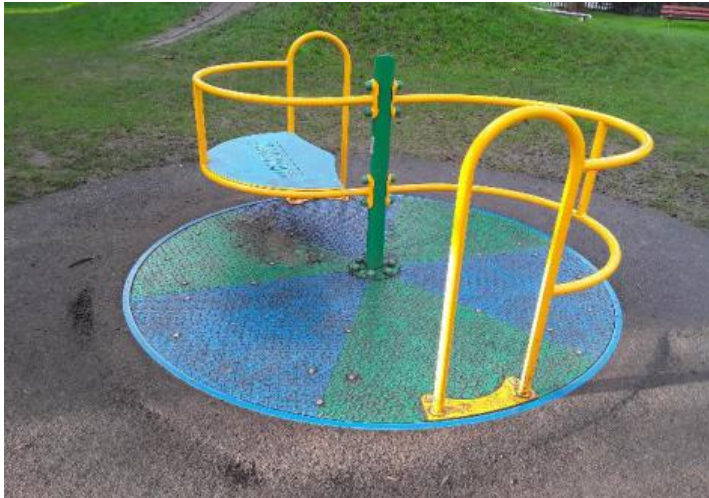
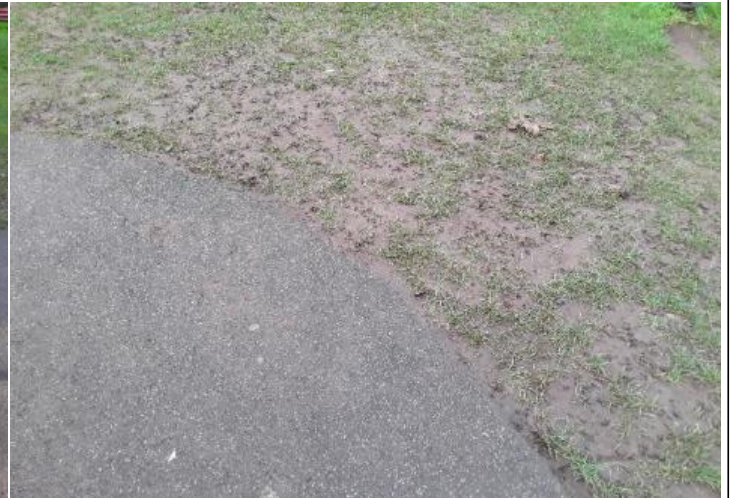
Item: Rotor Play - Inclusive Roundabout
Manufacturer: Wicksteed Playgrounds

Finding: The grass has eroded within the impact area of the equipment and may not provide the necessary impact attenuating properties for the equipment fall height; the surface may also be slippery in wet weather
Action: Reinststate the grass or provide an all weather surface

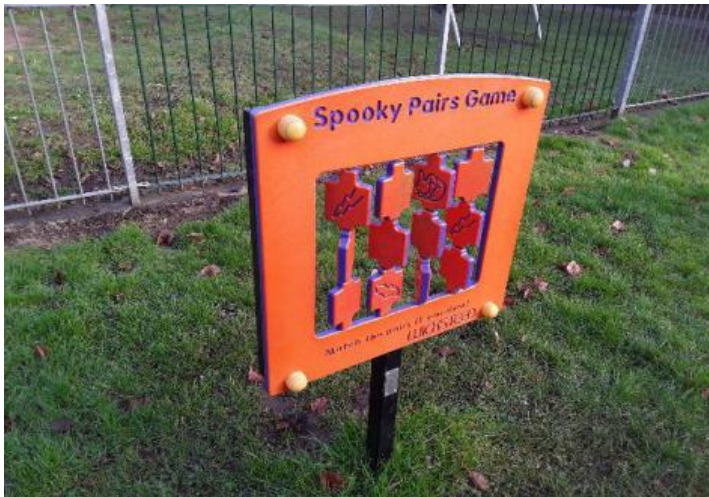
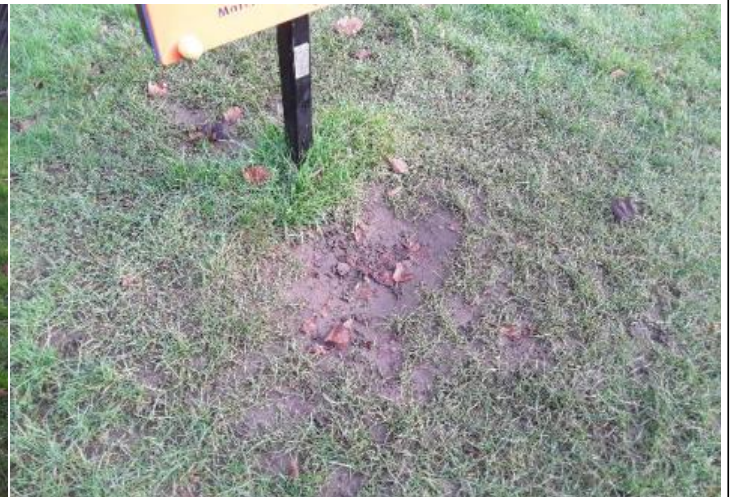
Item: Activity Equipment - Play Panel
Manufacturer: Wicksteed Playgrounds

Finding: The area around the item has eroded and may become slippery
Action: Reinststate eroded area

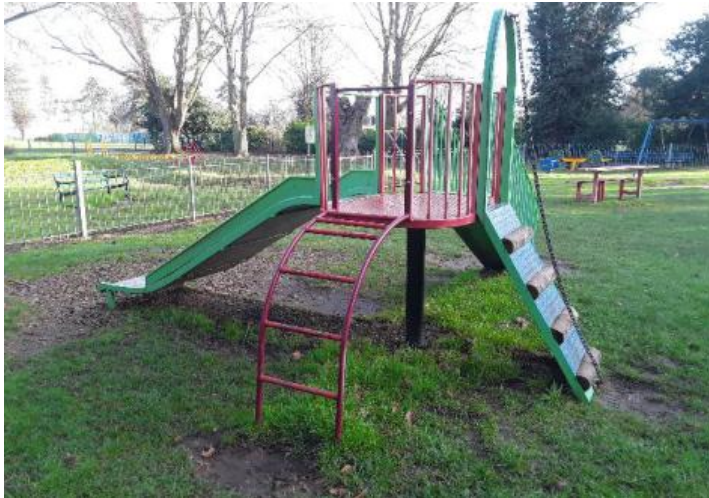
Item: Activity Equipment - Multi Play (Junior)
Manufacturer: Wicksteed Playgrounds

Finding: There is surface corrosion / rust present on the item

Action: Consider treating the item

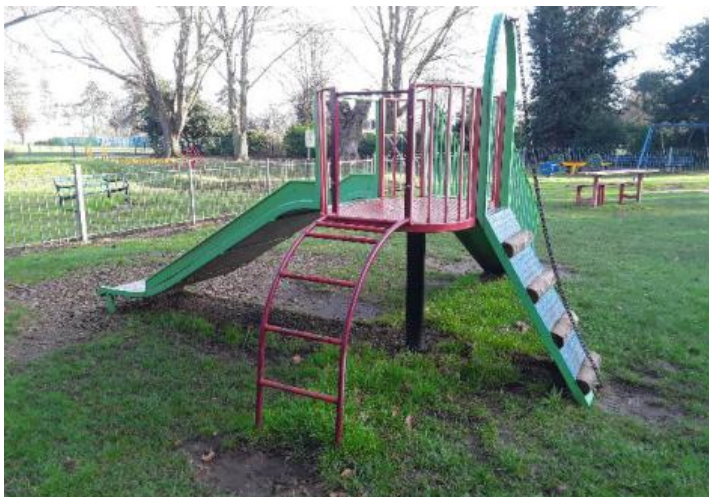
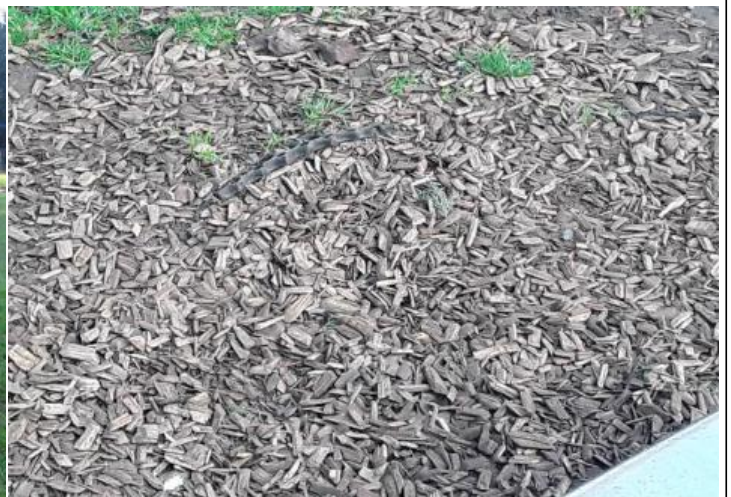
Item: Activity Equipment - Multi Play (Junior)
Manufacturer: Wicksteed Playgrounds

Finding: The loosefill surfacing has displaced from under or around the slide run out

Action: Regulate surface levels and maintain

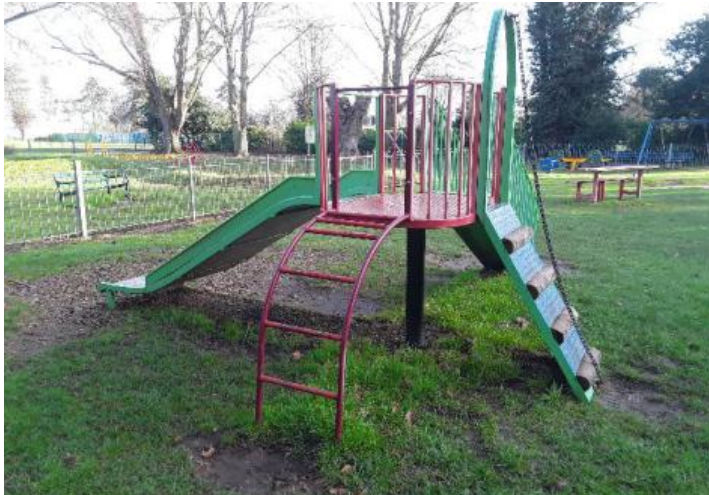
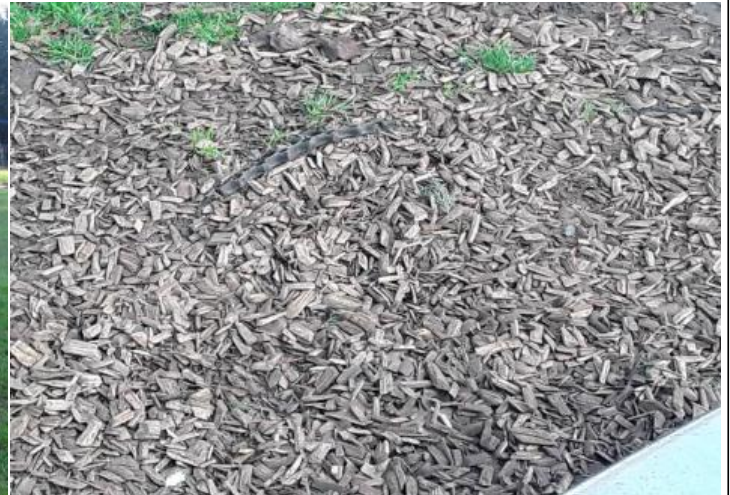
Item: Activity Equipment - Multi Play (Junior)
Manufacturer: Wicksteed Playgrounds

Finding: The edges of the grass mat surface are raised / lifting above the surrounding surface in front of the slide run out

Action: Secure edges of grass mats as per the API Code of Practice to remove trip hazards

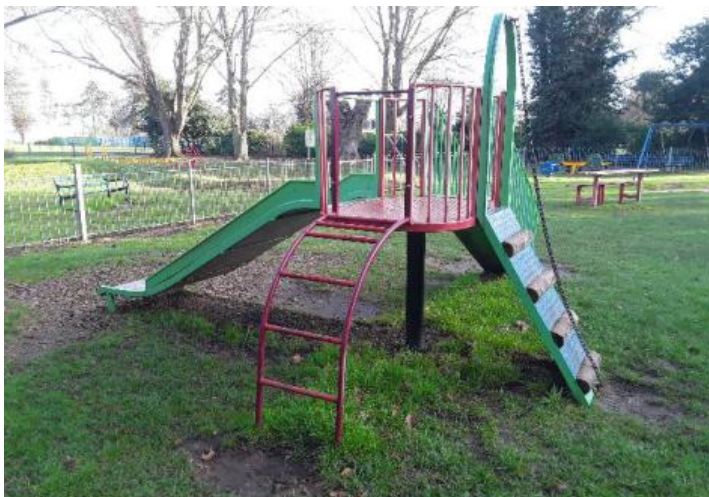
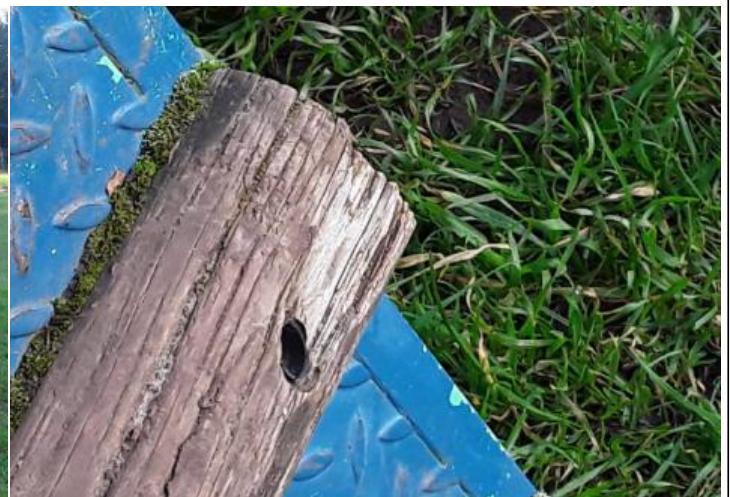
Item: Activity Equipment - Multi Play (Junior)
Manufacturer: Wicksteed Playgrounds

Finding: Parts of the timber are rough or splintered

Action: Remove all rough or sharp edges

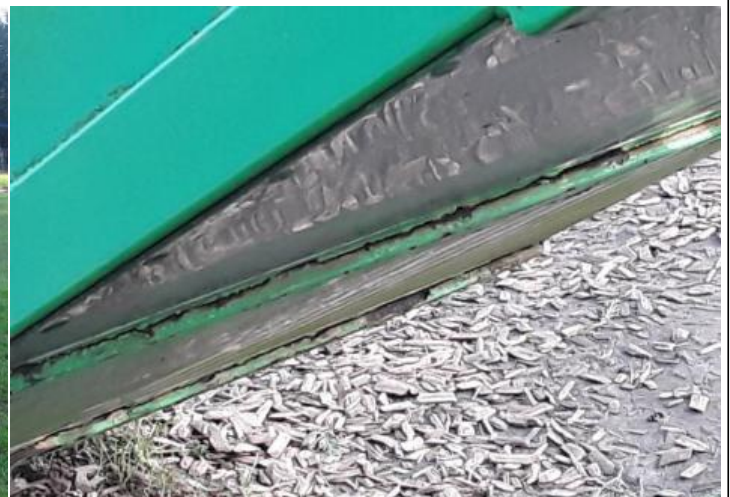
Item: Activity Equipment - Multi Play (Junior)
Manufacturer: Wicksteed Playgrounds

Finding: The weld(s) on this slide braces have failed

Action: Repair item

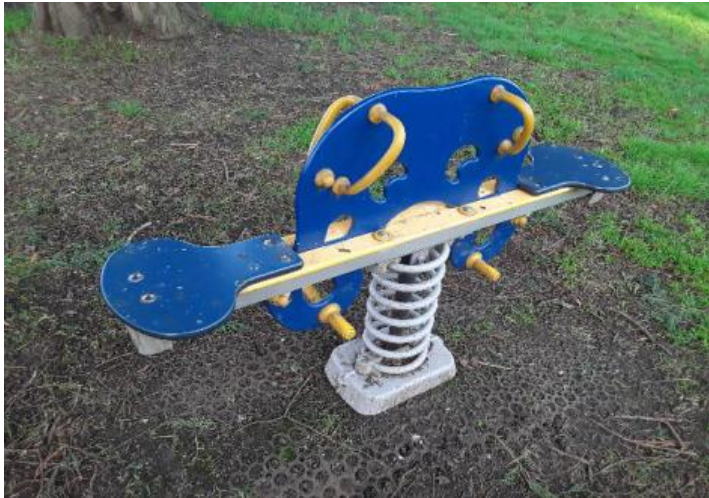
Item: Rocking Equipment - Spring Octopus
Manufacturer: Wicksteed Playgrounds

Finding: The surface has subsided in some areas

Action: Repair as required to provide a uniform surface

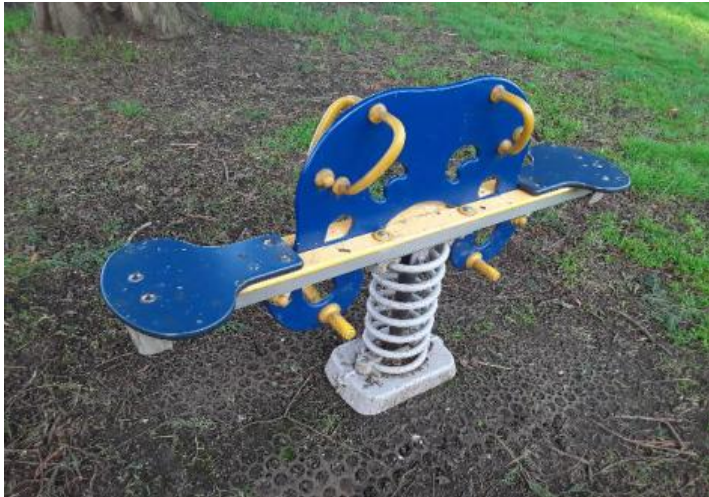
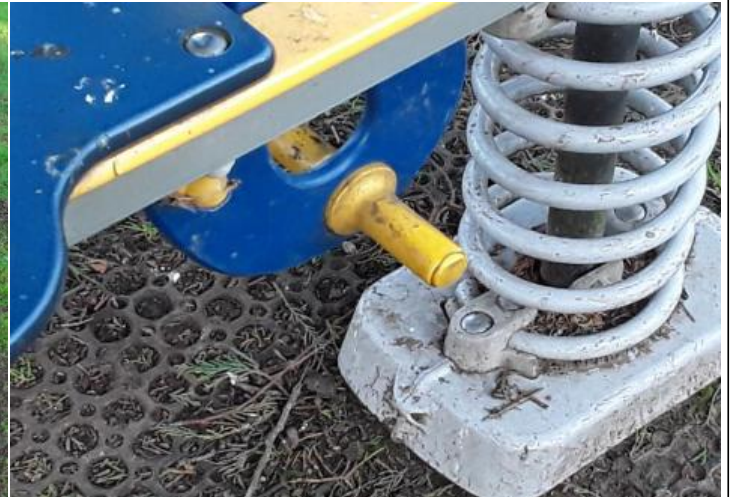
Item: Rocking Equipment - Spring Octopus
Manufacturer: Wicksteed Playgrounds

Finding: The end of handgrips and/or footrests have a cross section of less than 15cm² and fail to meet the requirements of BS EN 1176 Part 6

Action: Monitor - No action given the risk assessment

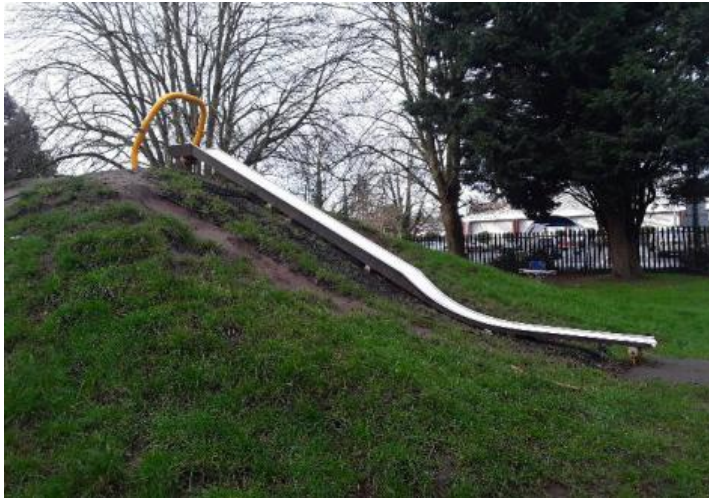
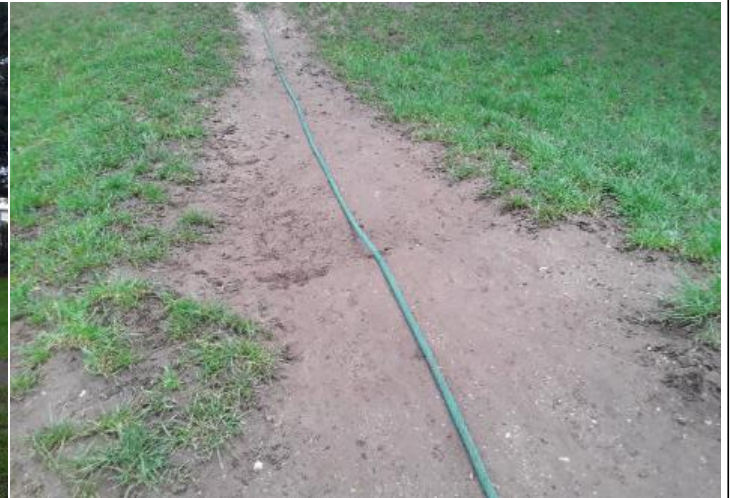
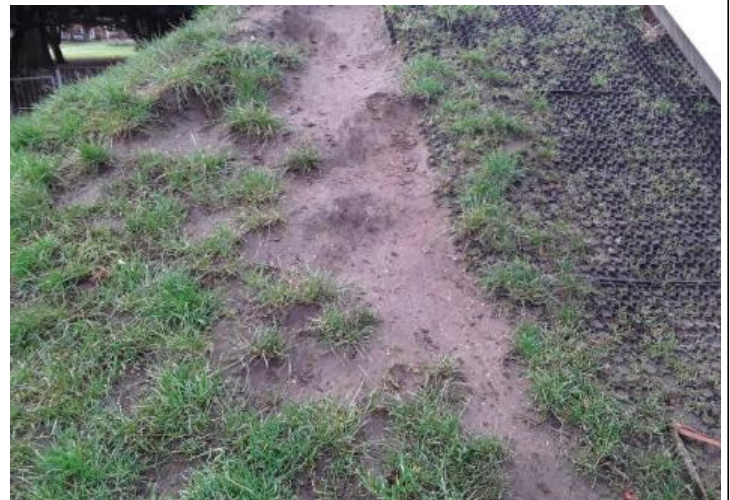
Item: Other - Embankment Slide
Manufacturer: Wicksteed Playgrounds

Finding: The area around the item has eroded and may become slippery when wet

Action: Reinststate eroded area

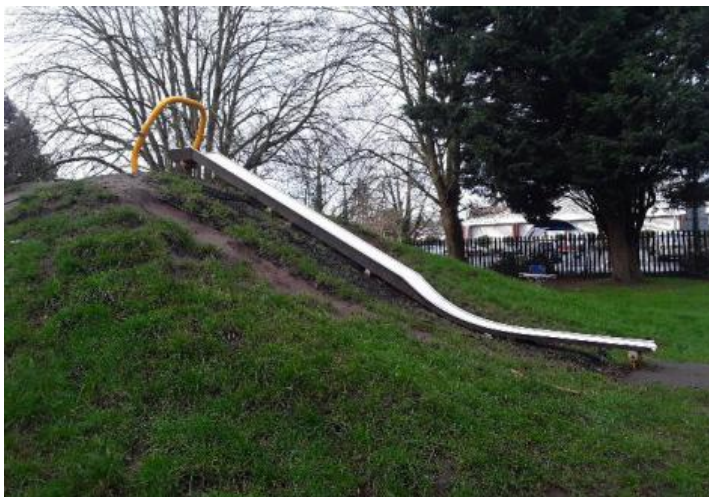
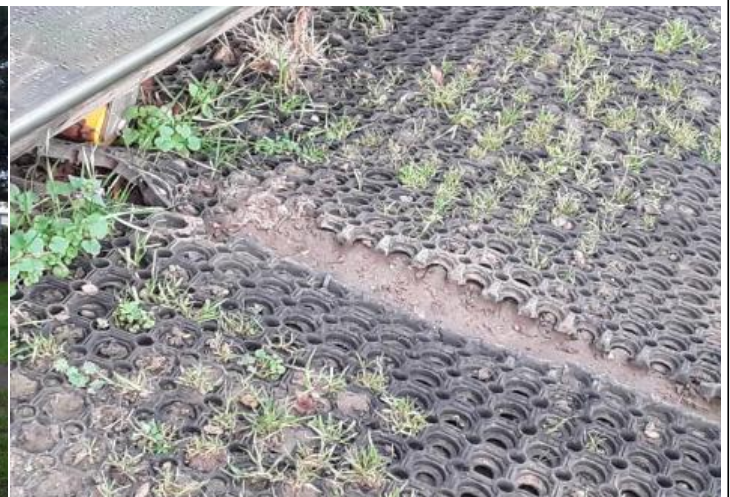
Item: Other - Embankment Slide
Manufacturer: Wicksteed Playgrounds

Finding: There are gaps opening between the grass mat tiles

Action: Provide additional ties or secure / reinstate surface

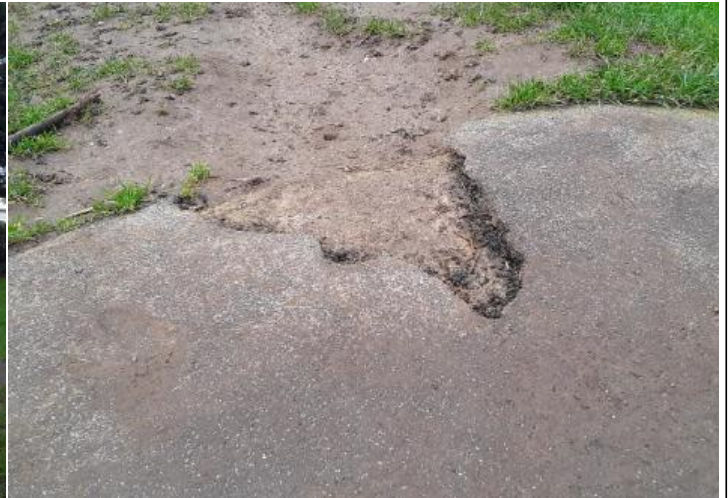
Item: Other - Embankment Slide
Manufacturer: Wicksteed Playgrounds

Finding: The surfacing is severely damaged creating trip hazards

Action: Repair damaged areas of surfacing

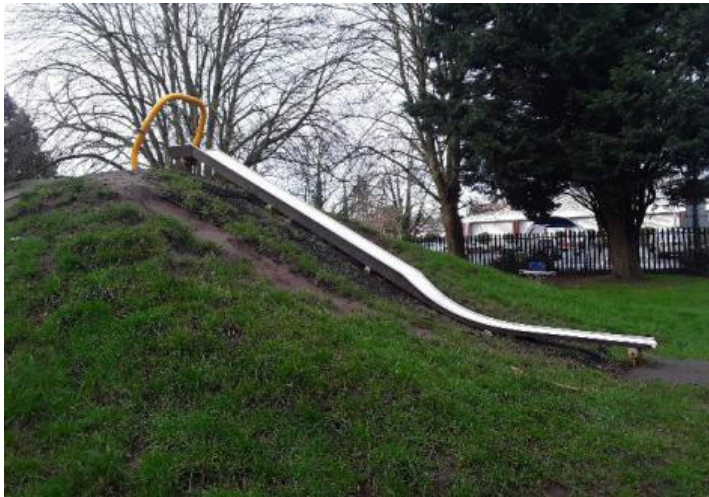
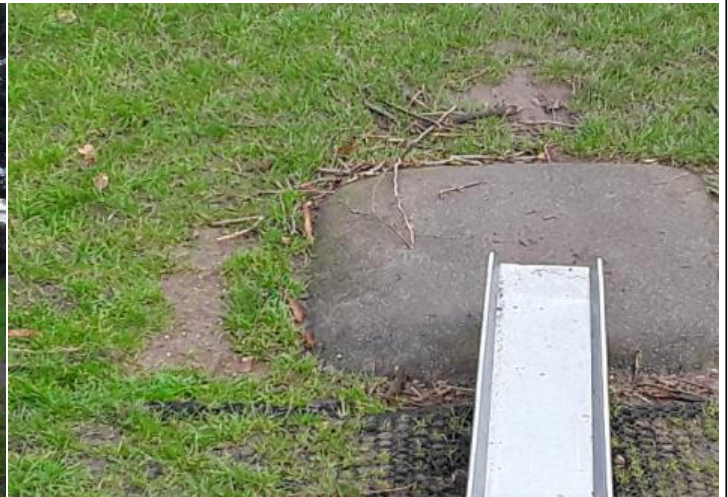
Item: Other - Embankment Slide
Manufacturer: Wicksteed Playgrounds

Finding: The grass has eroded within the impact area of the equipment and may not provide the necessary impact attenuating properties for the equipment fall height; the surface may also be slippery in wet weather

Action: Reinststate the grass or provide an all weather surface

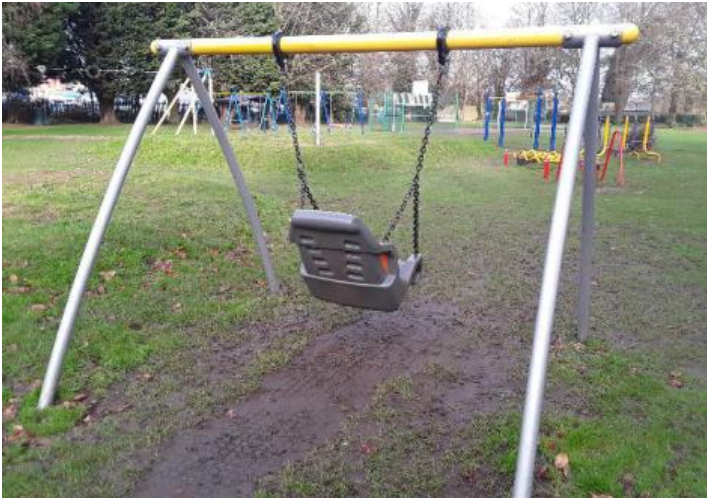
Item: Swings - Inclusive Swing
Manufacturer: Hags

Finding: The seat clearance from finished surface level to the underside of the seat is too low and does not meet the requirements of BS EN 1176 Part 2 (350mm minimum clearance required)

Action: Adjust seat height/s (400mm-500mm is recommended)

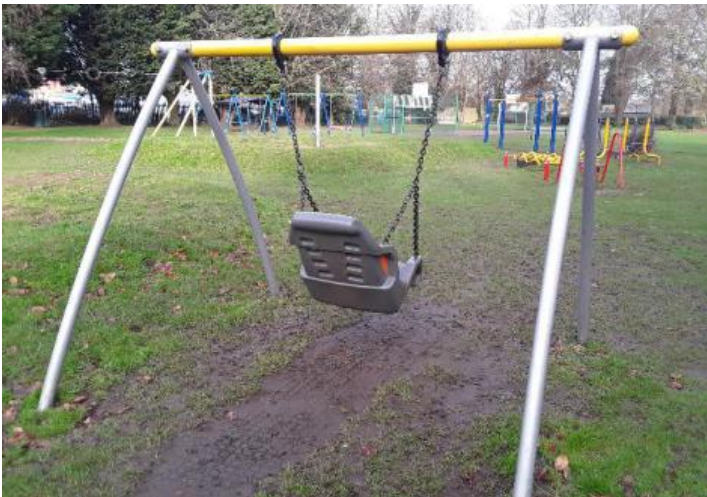
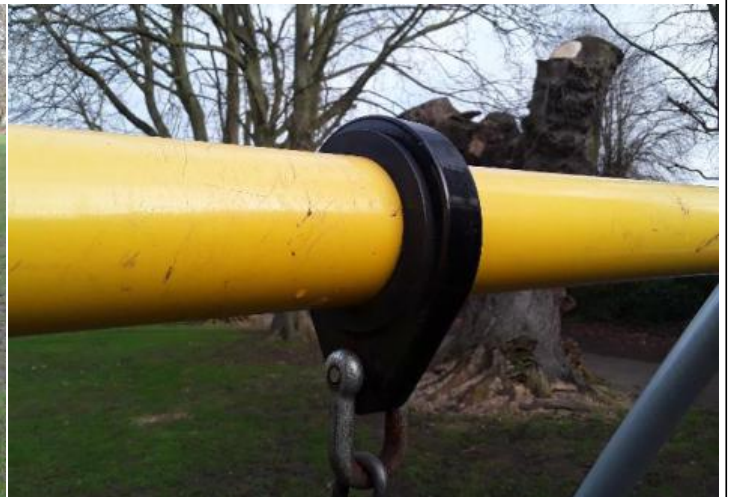
Item: Swings - Inclusive Swing
Manufacturer: Hags

Finding: The Anti Wrap bearings are dry and not moving freely

Action: Lubricate bearings in accordance with the manufacturers recommendations

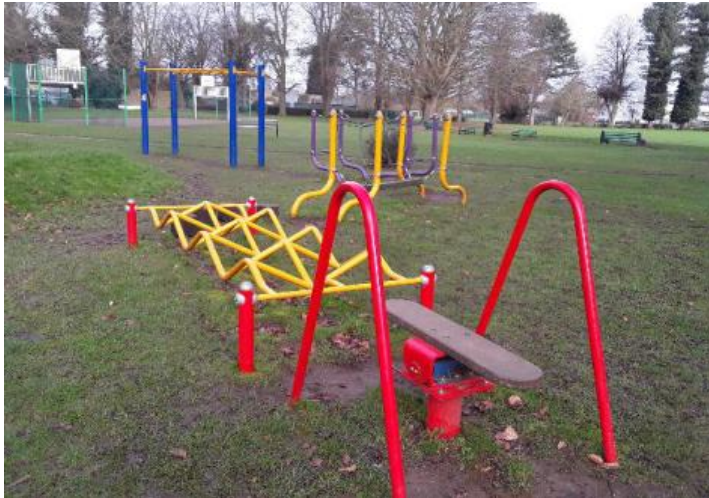
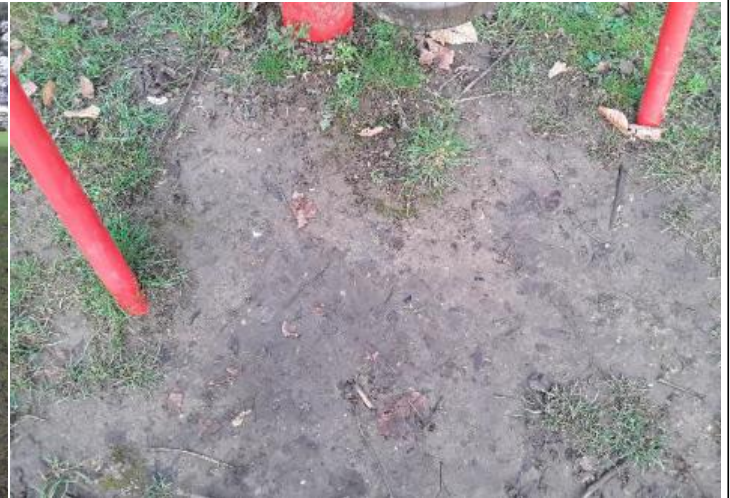
Item: Activity Equipment - Activity Trail
Manufacturer: Wicksteed Playgrounds

Finding: The area around the item has eroded and may become slippery

Action: Reinstate eroded area

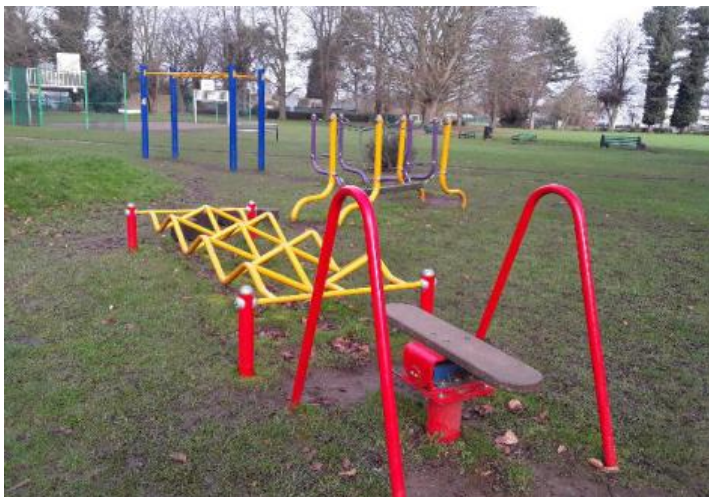
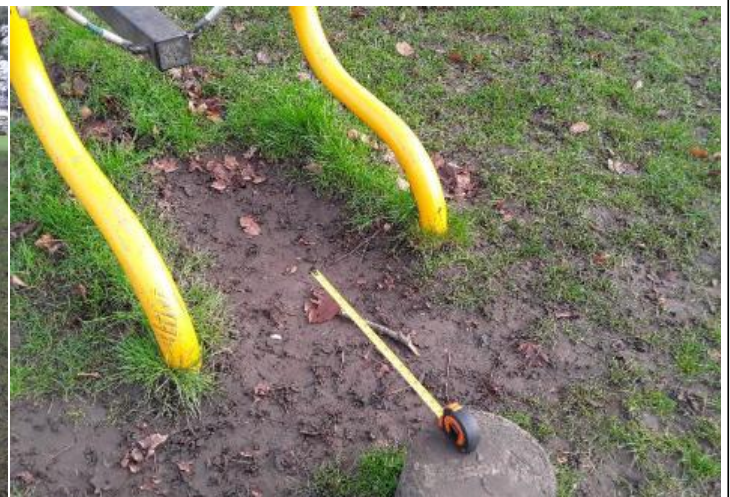
Item: Activity Equipment - Activity Trail
Manufacturer: Wicksteed Playgrounds

Finding: The step between the items is quite large and users may not be able to complete the step without touching ground, the items could therefore be considered to be within the falling space of each other, however the intention of the play activity continuity is easily apparent and foreseeable to the user

Action: Monitor - No action given the risk assessment

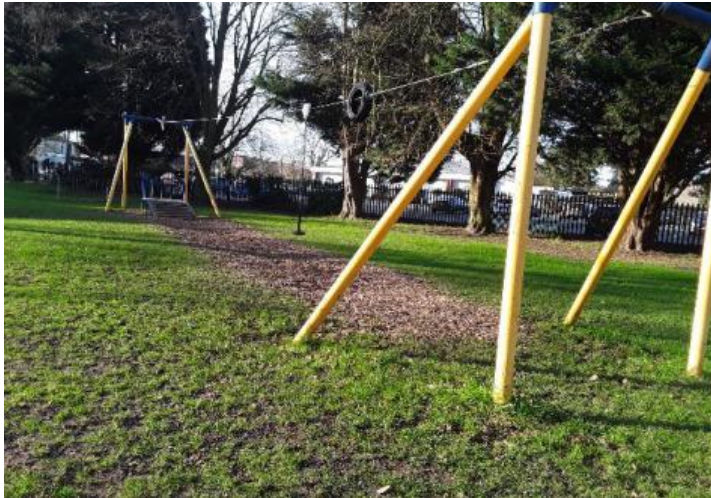
Item: Other - Cable Runway
Manufacturer: Hags

Finding: We have completed a visual inspection of the suspension links, cable and fixing points from ground level, however it is not possible to fully inspect these areas without either hiring equipment to gain access or removing the cable and suspension and inspecting at ground level. We recommend that the main cable and fixing security is thoroughly inspected at least in accordance with the manufacturers recommendations to check for wear, damage, security or internal rusting; this will help to ensure the continued safe use of the equipment

Action: Inspect in accordance with the manufacturers recommendations

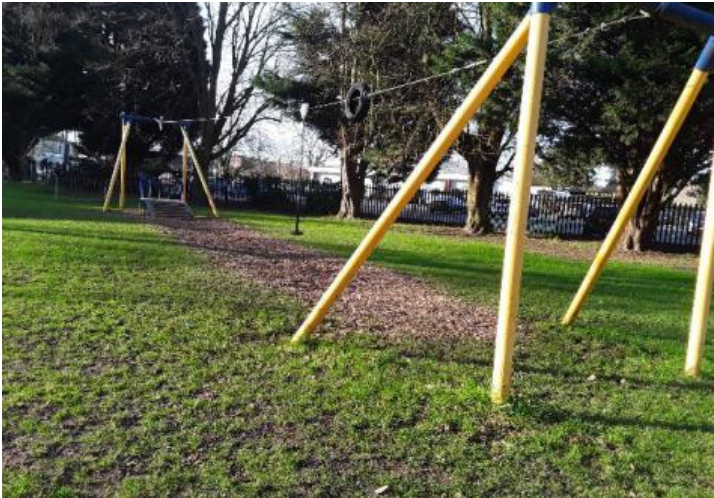
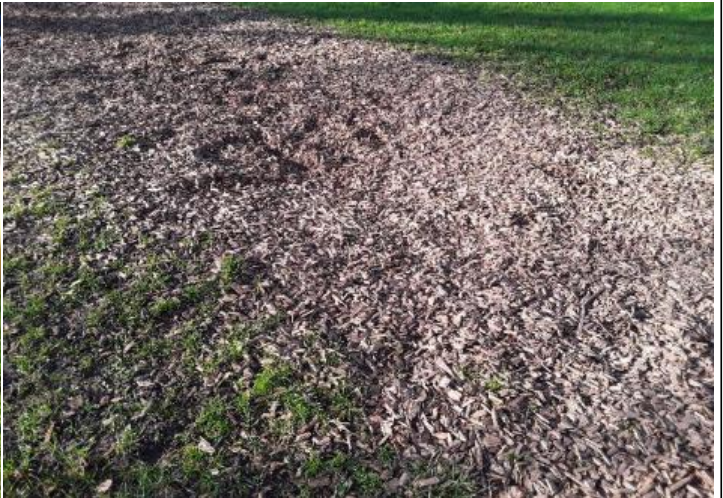
Item: Other - Cable Runway
Manufacturer: Hags

Finding: The loosefill surfacing has displaced from under or around the equipment
Action: Regulate surface levels and maintain

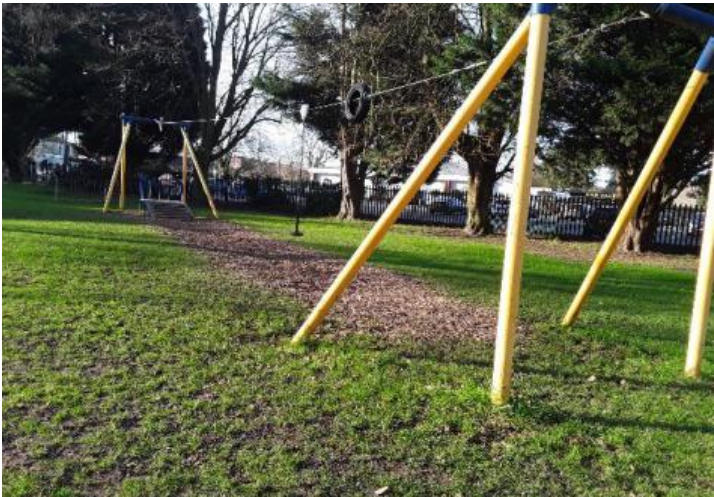
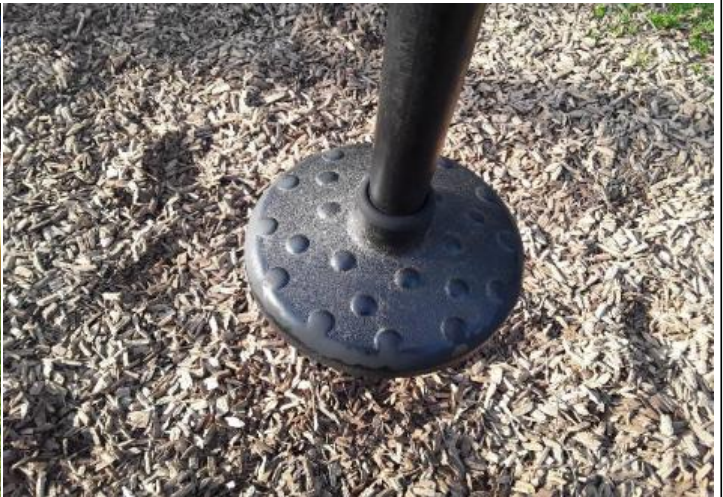
Item: Other - Cable Runway
Manufacturer: Hags

Finding: The seat connection cannot be inspected without dismantling the seat
Action: Dismantle the seat to inspect the seat connection for wear

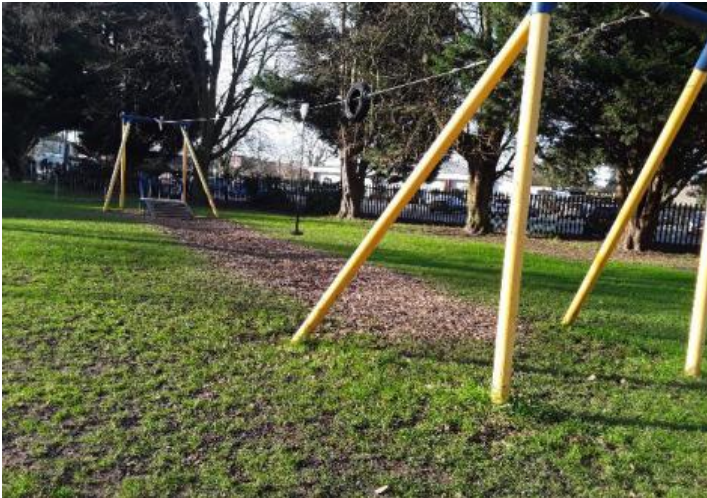
Item: Other - Cable Runway
Manufacturer: Hags

Finding: The chain openings are in excess of 8.6mm and do not meet the recommendations of BS EN 1176 Part 1

Action: Monitor - No action given the risk assessment

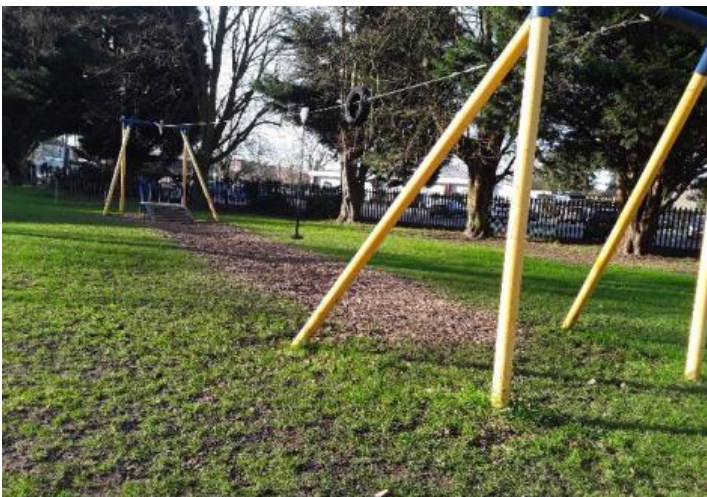
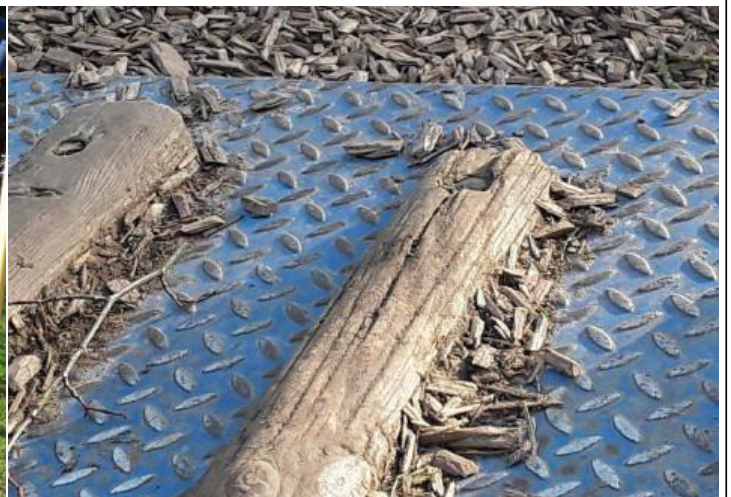
Item: Other - Cable Runway
Manufacturer: Hags

Finding: The timber has a number of splits/shakes or air cracks and this may affect the stability or allow water ingress which will accelerate the rotting process. Timber splits may also create rough / splintering edges.

Action: Monitor, sand down any rough edges and ensure the splits do not cross through fixing points of the structure and/or cause any instability

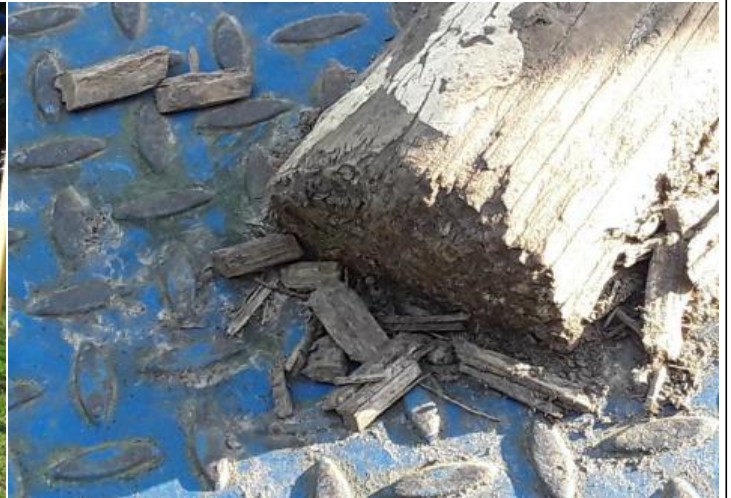
Item: Other - Cable Runway
Manufacturer: Hags

Finding: Parts of the timber are rough or splintered

Action: Remove all rough or sharp edges

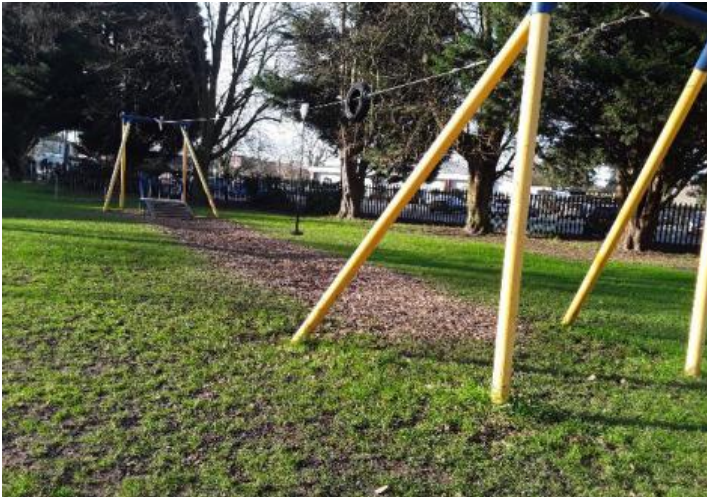
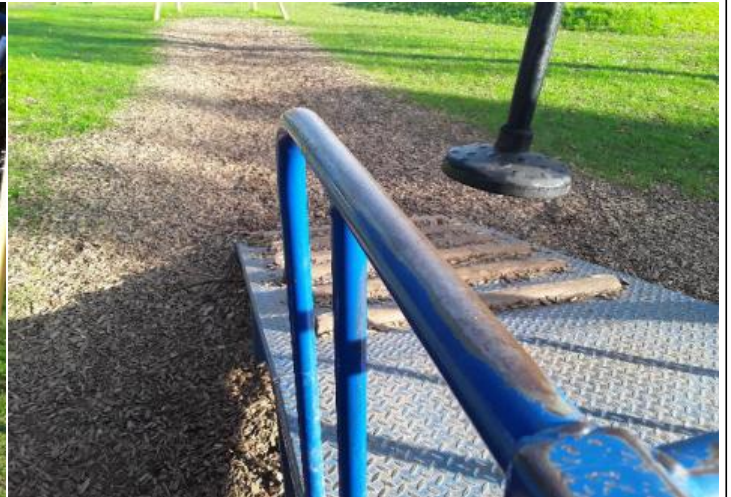
Item: Other - Cable Runway
Manufacturer: Hags

Finding: There is surface corrosion / rust present on the item

Action: Consider treating the item

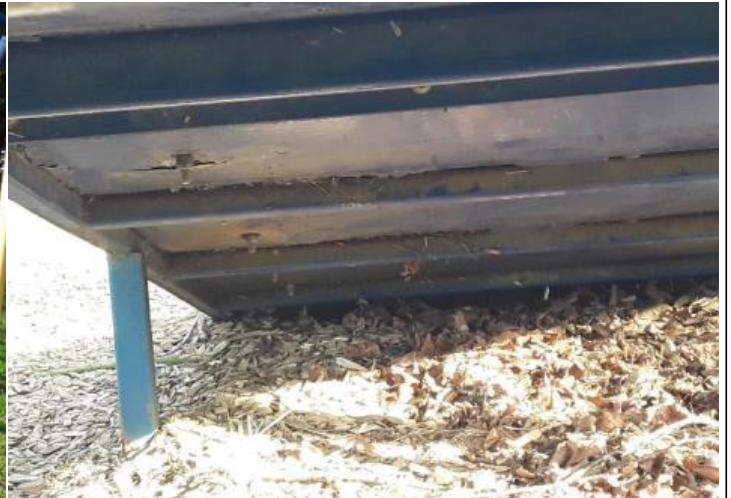
Item: Other - Cable Runway
Manufacturer: Hags

Finding: There are projecting bolt thread(s) present

Action: Remove excess thread length and deburr or provide cap

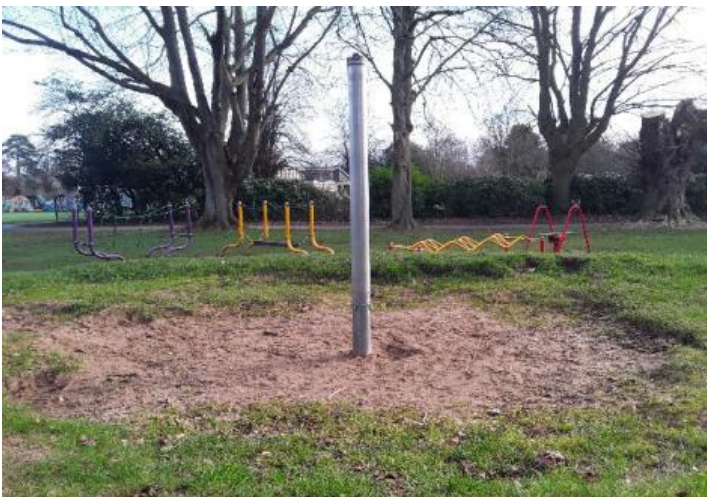
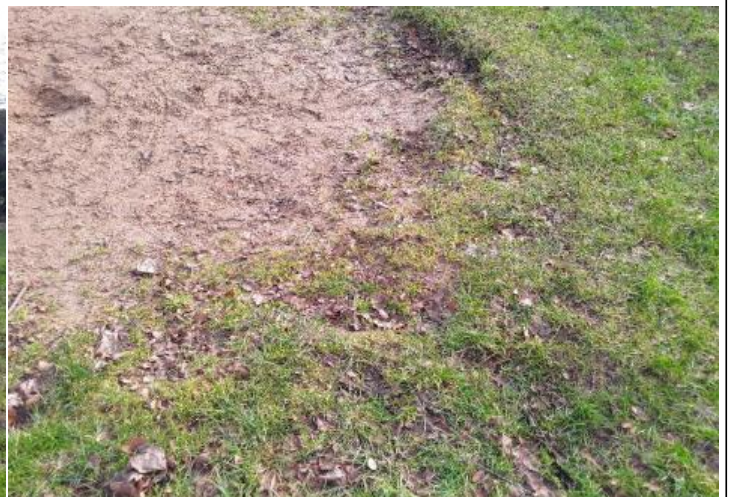
Item: Rotor Play - Cone Climber
Manufacturer: Tayplay Ltd

Finding: There is weed / vegetation growth on and around the loose fill surface

Action: Remove weed / vegetation growth

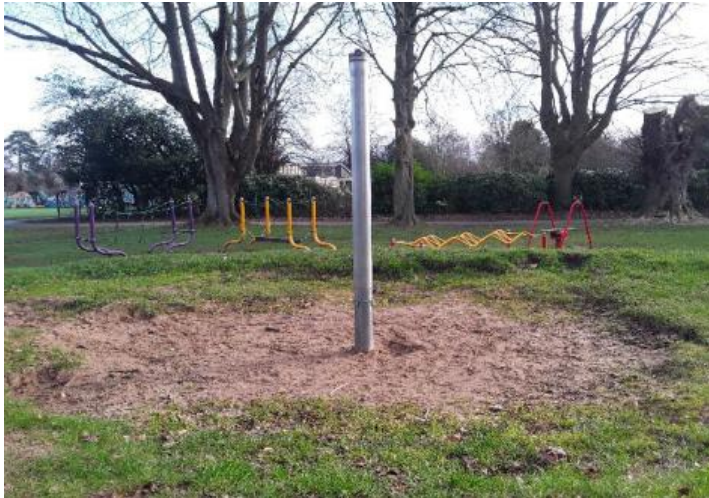
Item: Rotor Play - Cone Climber
Manufacturer: Tayplay Ltd

Finding: The item has missing component(s)

Action: Replace the missing components or remove the item completely

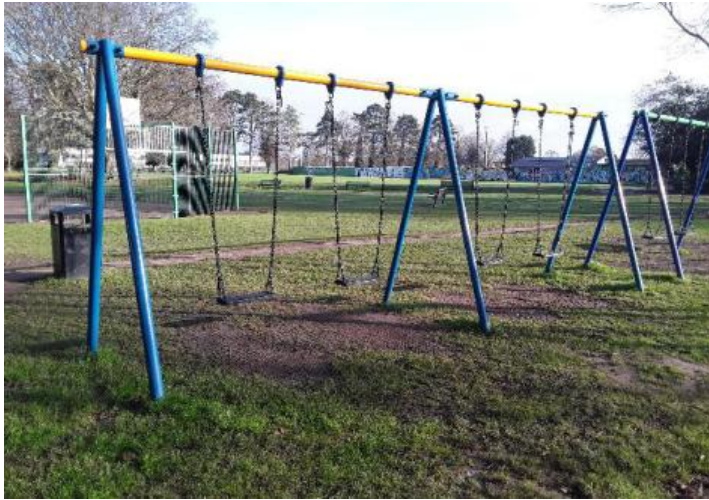
Item: Swings - 2 Bay 4 Seat (Flat)
Manufacturer: Wicksteed Playgrounds

Finding: The surfacing is damaged

Action: Repair damaged areas of surfacing

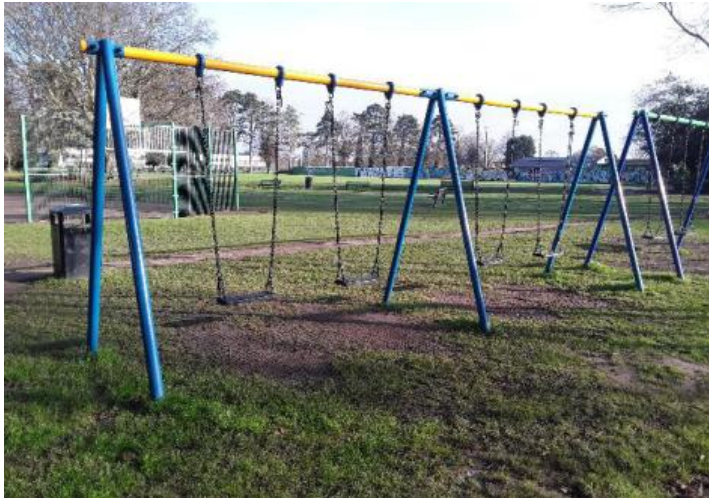
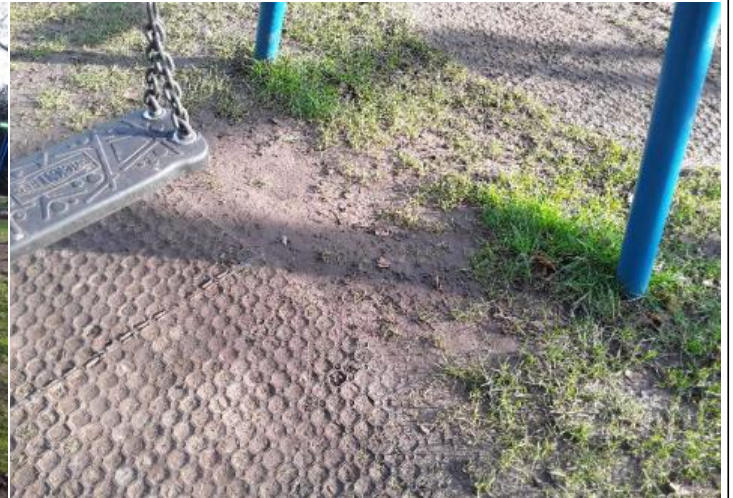
Item: Swings - 2 Bay 4 Seat (Flat)
Manufacturer: Wicksteed Playgrounds

Finding: The grass has eroded within the impact area of the equipment and may not provide the necessary impact attenuating properties for the equipment fall height; the surface may also be slippery in wet weather
Action: Reinstate the grass or provide an all weather surface

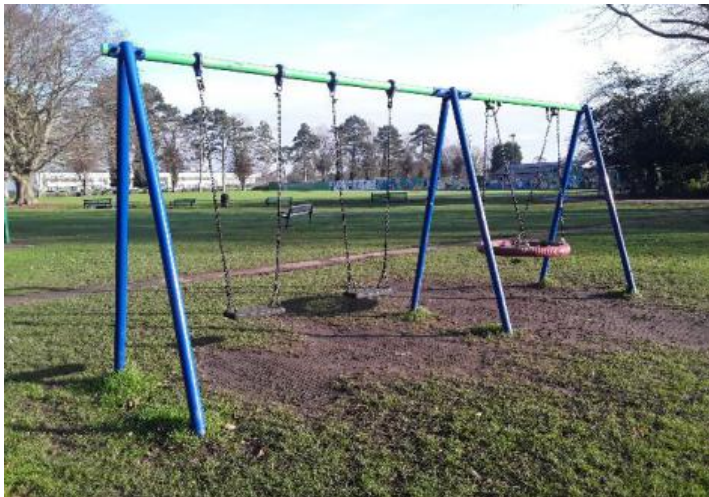
Item: Swings - 2 Bay 2 Flat 1 Basket Seat
Manufacturer: Wicksteed Playgrounds

Finding: The basket bushes are showing signs of wear
Action: Monitor for any further deterioration and replace as required
