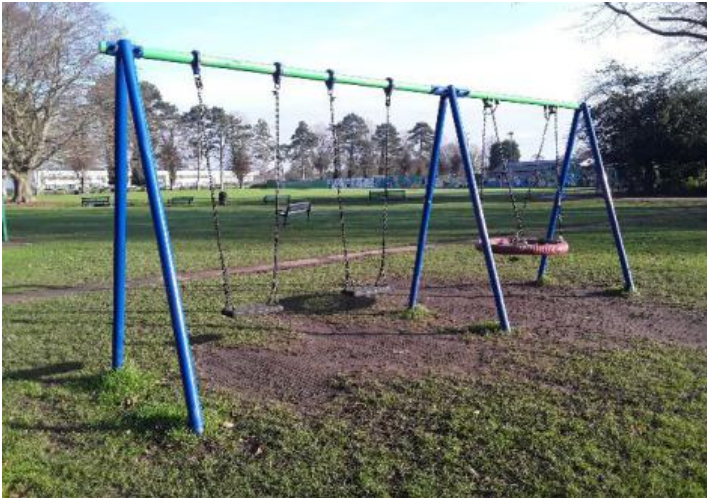
Item: Swings - 2 Bay 2 Flat 1 Basket Seat
Manufacturer: Wicksteed Playgrounds

Finding: The chain openings are in excess of the 8.6mm as recommended by BS EN 1176
Action: Monitor - No action given the risk assessment

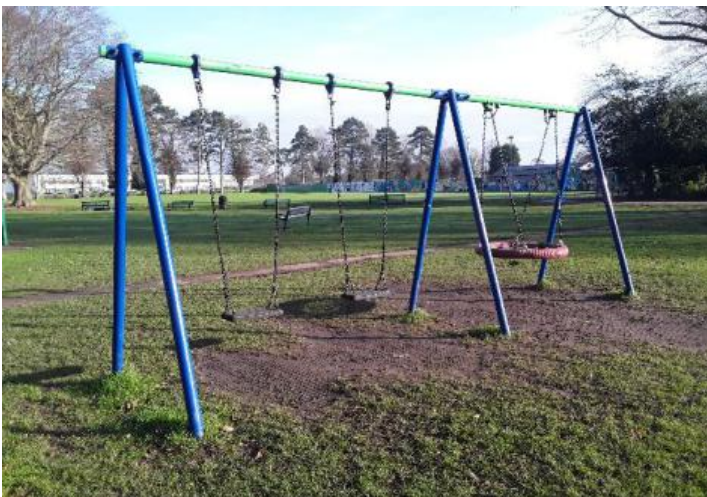
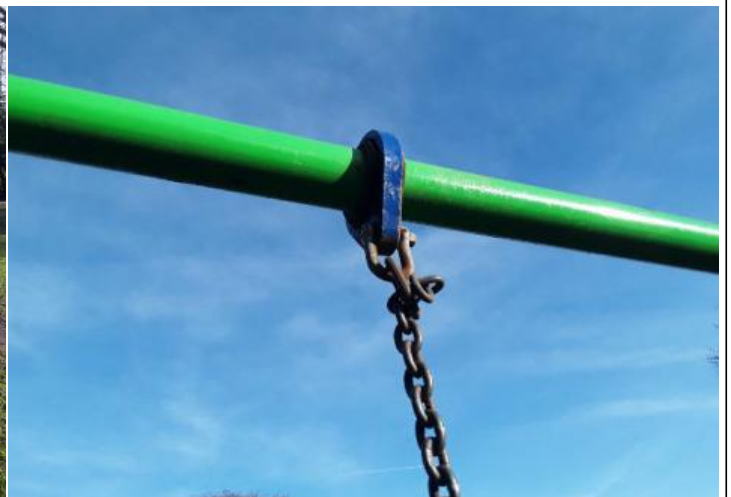
Item: Swings - 2 Bay 2 Flat 1 Basket Seat
Manufacturer: Wicksteed Playgrounds

Finding: The Anti Wrap bearings are dry and not moving freely
Action: Lubricate bearings in accordance with the manufacturers recommendations

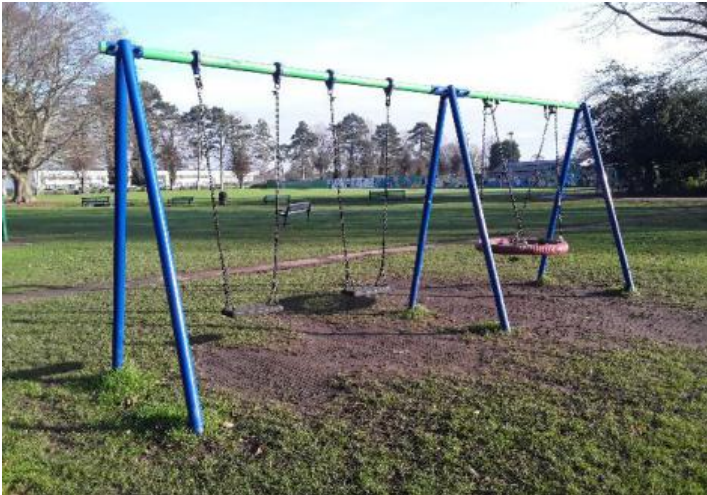
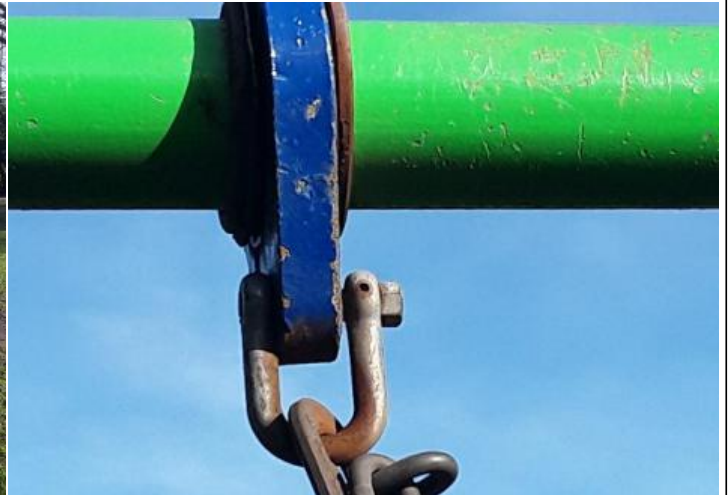
Item: Swings - 2 Bay 2 Flat 1 Basket Seat
Manufacturer: Wicksteed Playgrounds

Finding: The split pins are missing from the shackles

Action: Insert split pins to secure the shackles

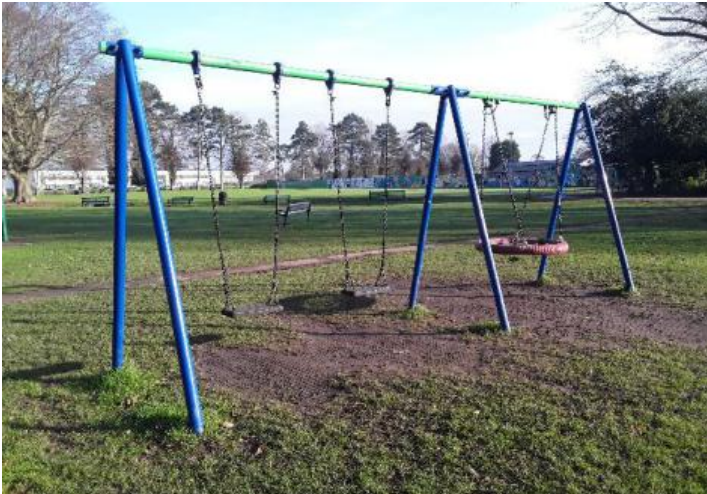
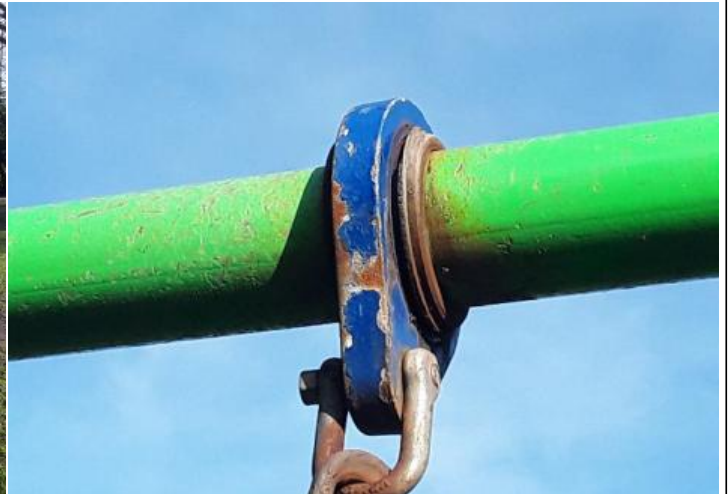
Item: Swings - 2 Bay 2 Flat 1 Basket Seat
Manufacturer: Wicksteed Playgrounds

Finding: The paintwork on this item has been damaged or worn exposing the metal underneath which is rusting / corroding

Action: Treat affected areas and repaint

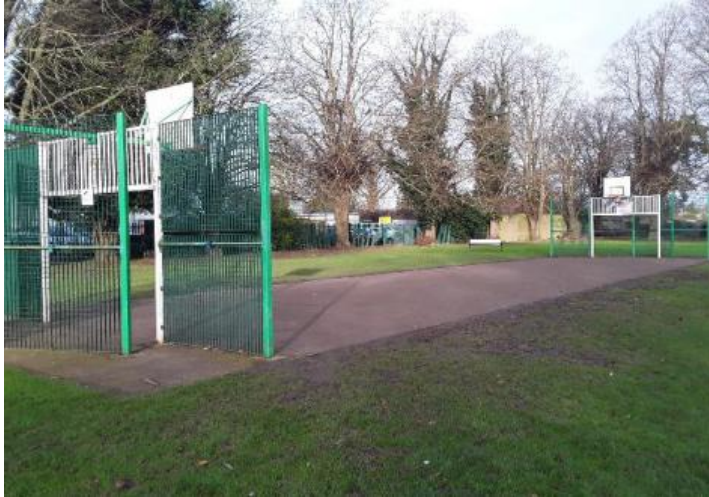
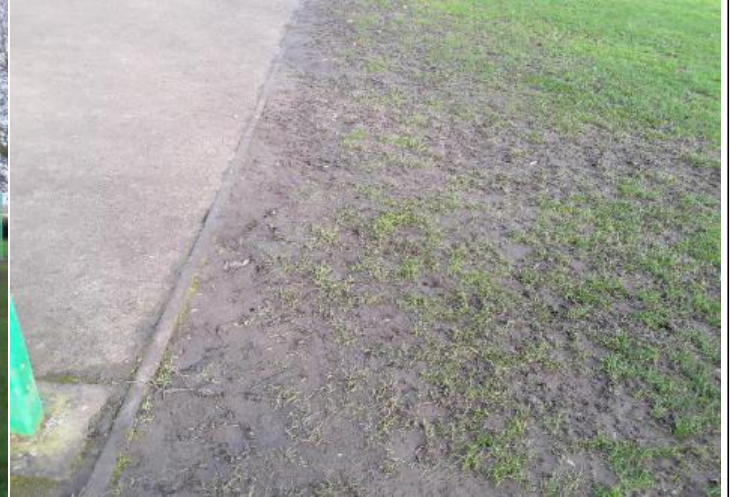
Item: Multi Use Games Area - Multi Use Games Area (MUGA) **Risk Level:** L - Low Risk
Manufacturer: Wicksteed Playgrounds **Surface:** Bitmac

Finding: The area around the item has eroded creating trip hazards and may become slippery when wet **Action:** Reinstate eroded area

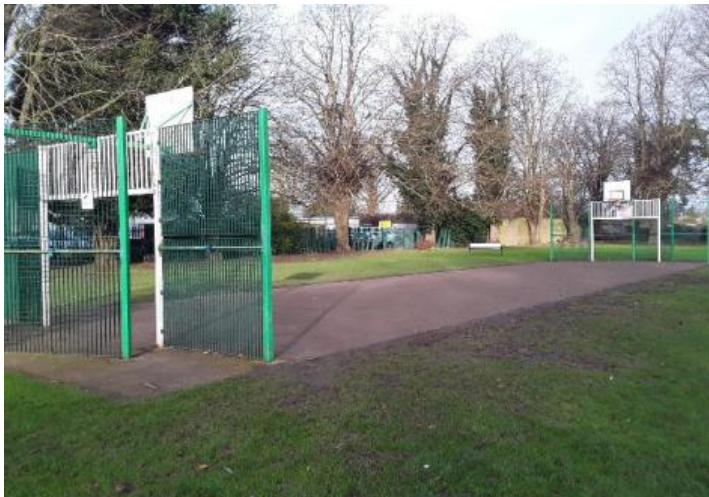
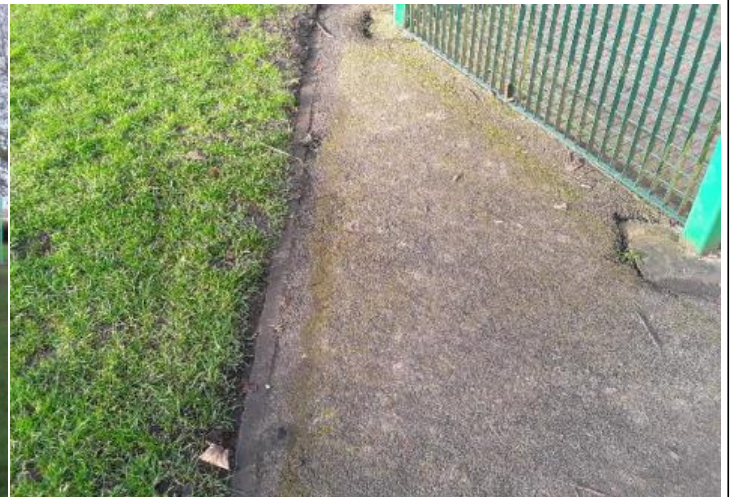
Item: Multi Use Games Area - Multi Use Games Area (MUGA) **Risk Level:** L - Low Risk
Manufacturer: Wicksteed Playgrounds **Surface:** Bitmac

Finding: There is algae, silt or moss growth on the surface resulting in slippery conditions **Action:** Clean and treat appropriately

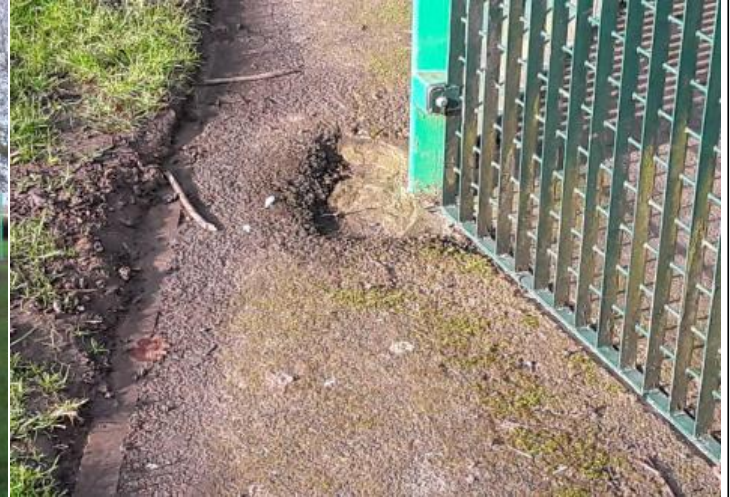
Item: Multi Use Games Area - Multi Use Games Area (MUGA) **Risk Level:** L - Low Risk
Manufacturer: Wicksteed Playgrounds **Surface:** Bitmac

Finding: There are trip hazards present around the post foundations

Action: Remove trip hazards

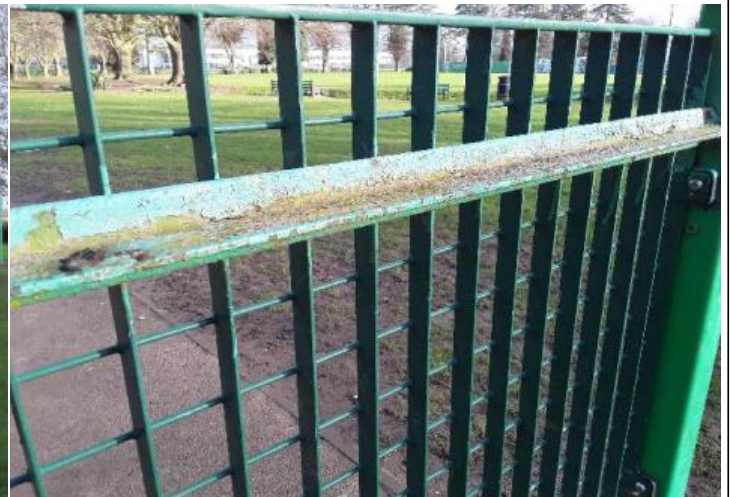
Item: Multi Use Games Area - Multi Use Games Area (MUGA) **Risk Level:** L - Low Risk
Manufacturer: Wicksteed Playgrounds **Surface:** Bitmac

Finding: The paintwork on this item has been damaged or worn exposing the metal underneath which is rusting / corroding

Action: Treat affected areas and repaint

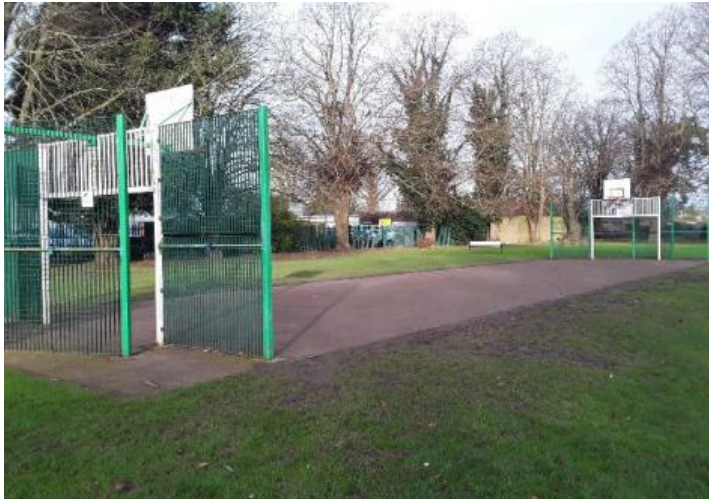
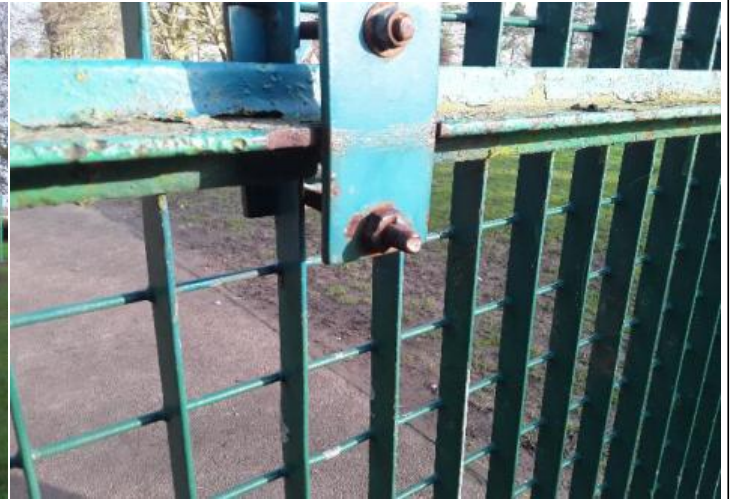
Item: Multi Use Games Area - Multi Use Games Area (MUGA)
Manufacturer: Wicksteed Playgrounds

Finding: There are projecting bolt thread(s) present

Action: Remove excess thread length and deburr or provide cap

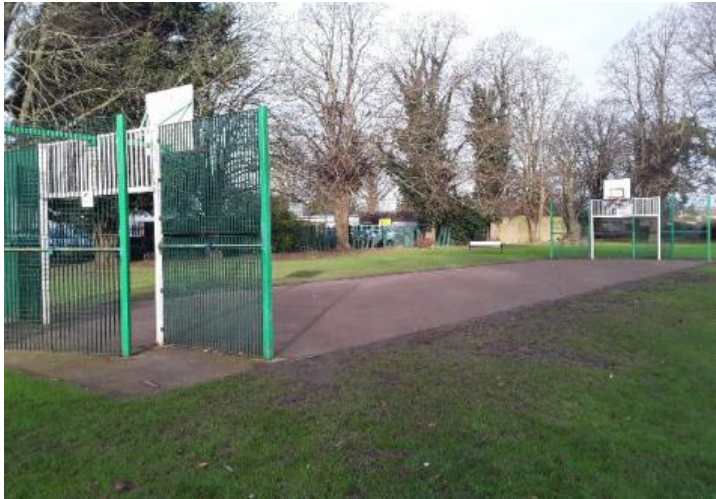
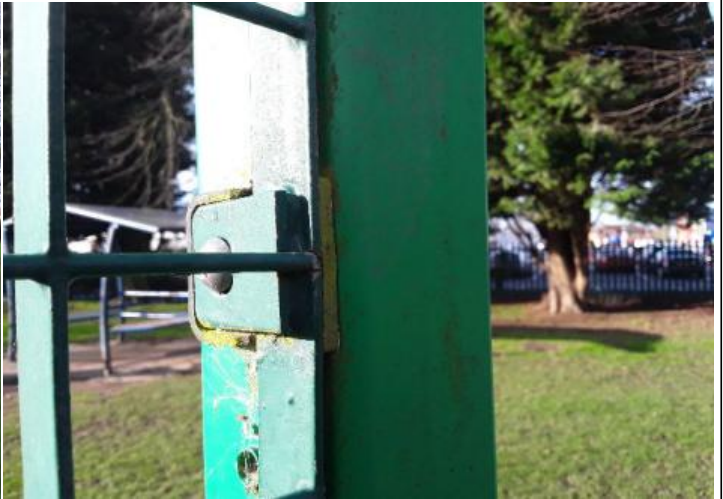
Item: Multi Use Games Area - Multi Use Games Area (MUGA) **Risk Level:** L - Low Risk
Manufacturer: Wicksteed Playgrounds **Surface:** Bitmac

Finding: The weld(s) on this item have failed

Action: Repair item

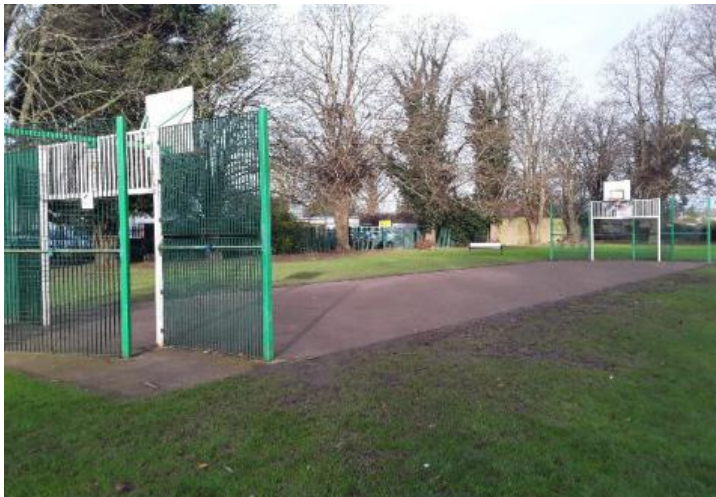
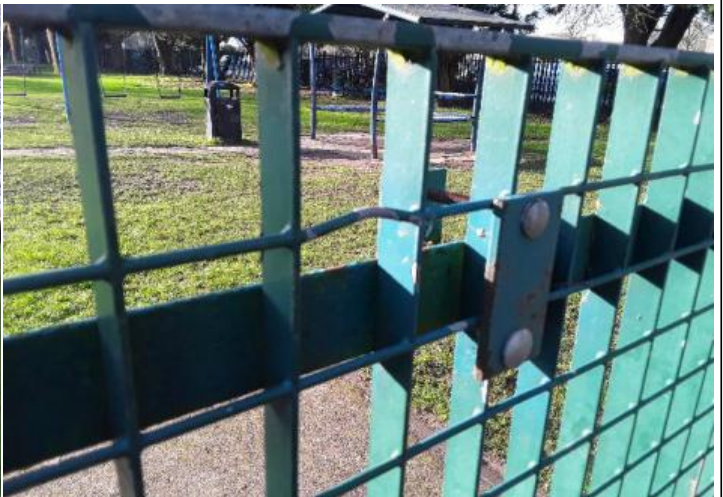
Item: Multi Use Games Area - Multi Use Games Area (MUGA) **Risk Level:** L - Low Risk
Manufacturer: Wicksteed Playgrounds **Surface:** Bitmac

Finding: There is some damage to the fence sections

Action: Monitor for any further deterioration and repair as required

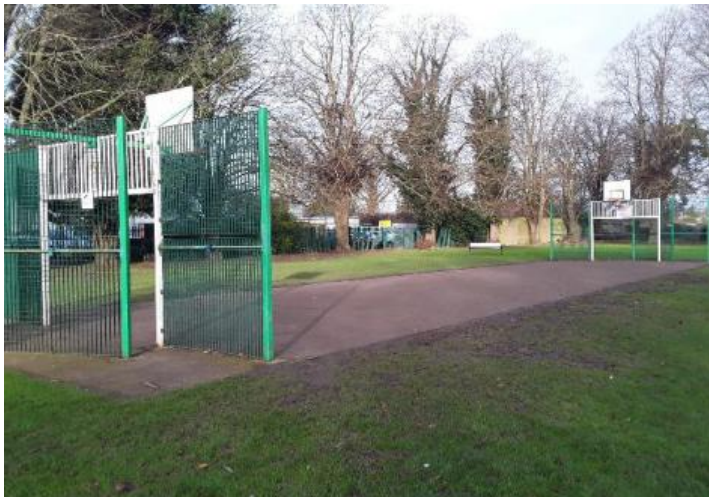
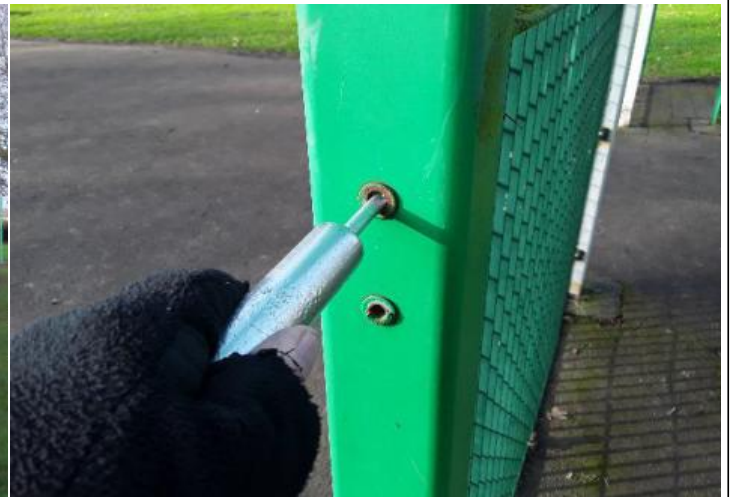
Finding: There is/are inserts missing creating finger entrapments in the redundant bolt holes and the item fails to meet the requirements of BS EN 15312 Clause 4.4.2.2 Entrapment of fingers

Action: Replace the missing inserts

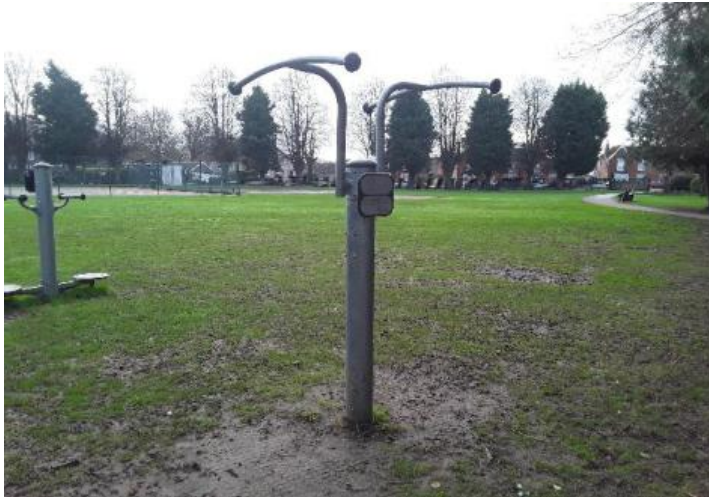
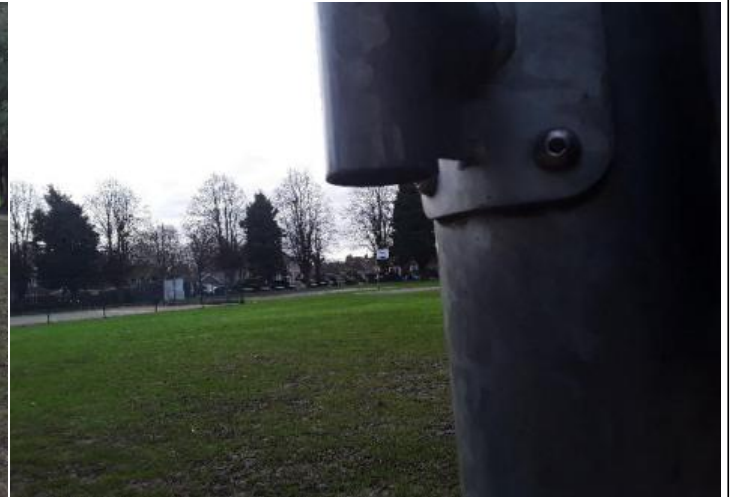
Finding: There is / are post or end caps missing / damaged on the item
Action: Replace missing / damaged post or end caps

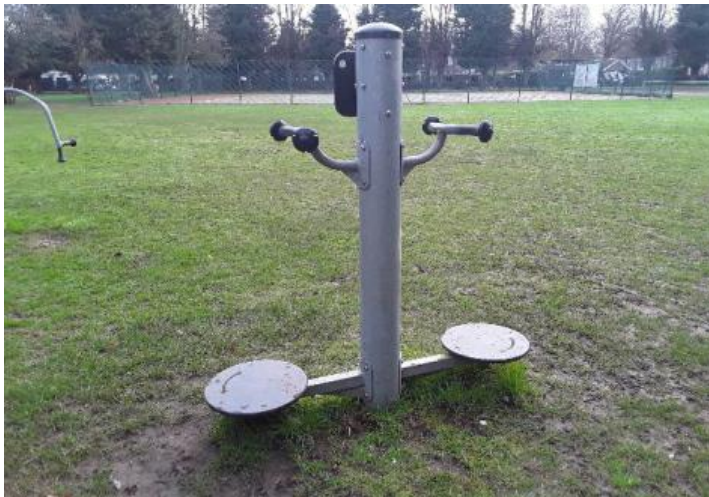
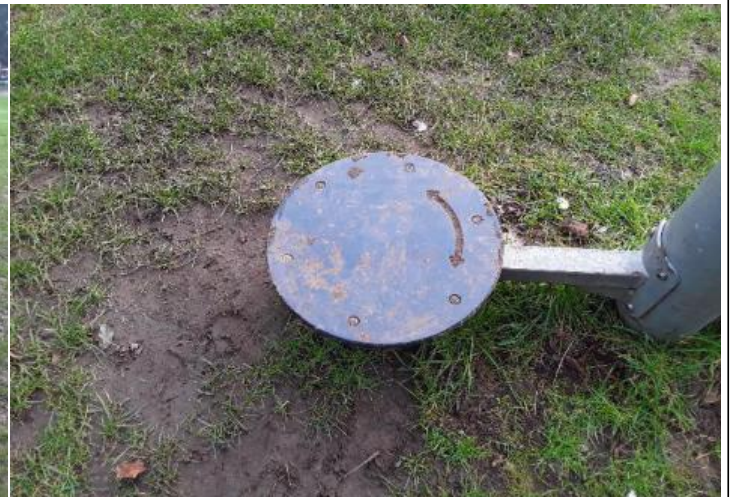
Finding: The deflection of the rotating user station exceeds the maximum 105 degrees required by BS EN 16630
Action: Monitor - No action given the risk assessment

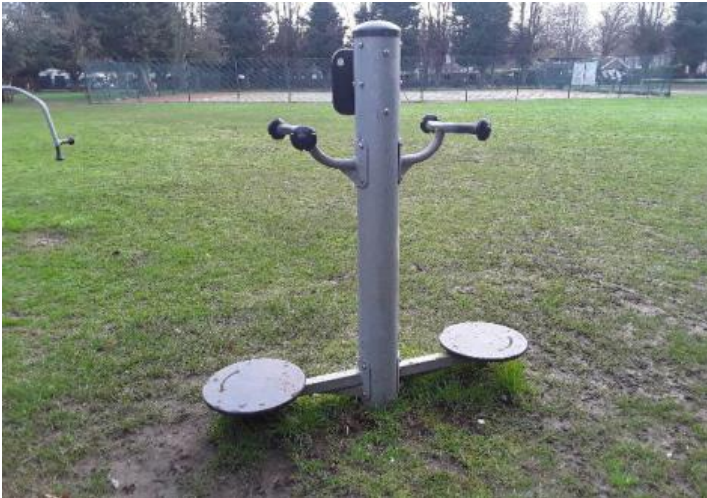
Finding: The bearing is showing signs of wear

Action: Monitor for any further deterioration and replace as required

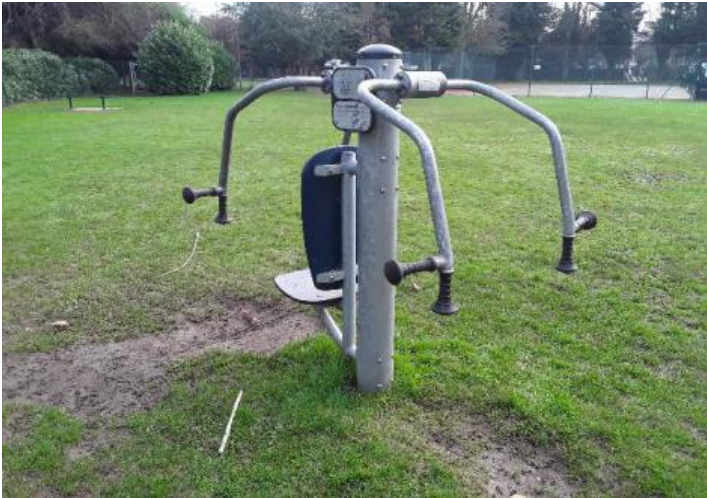
Finding: The surface has eroded / subsided

Action: Repair as required to provide a uniform surface

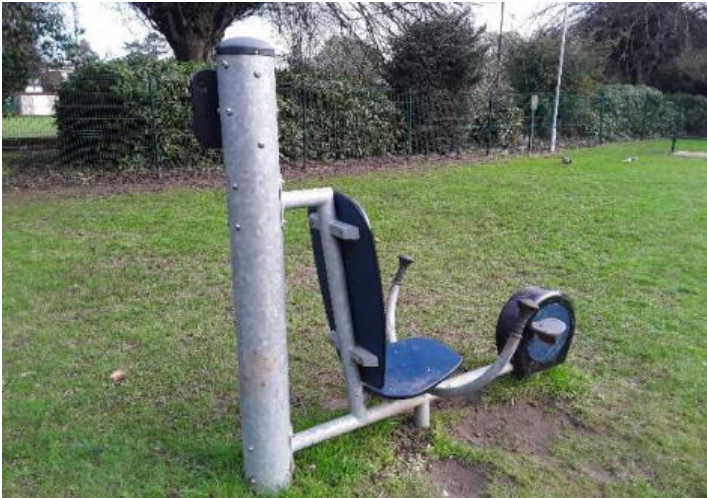
Finding: One or more handgrip(s) are damaged

Action: Replace damaged handgrips

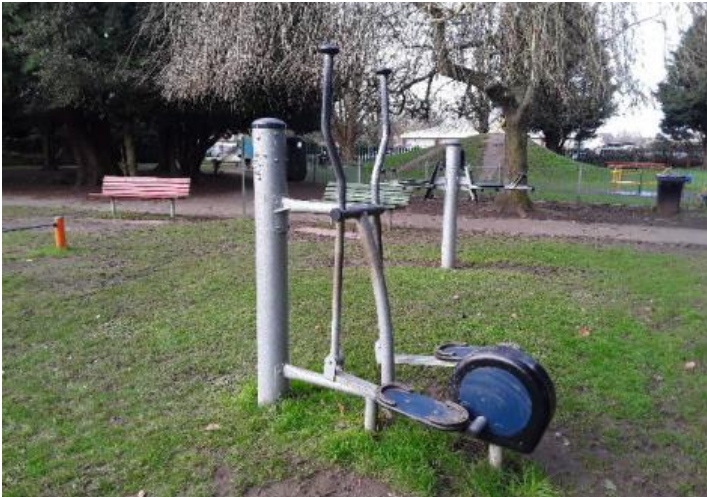
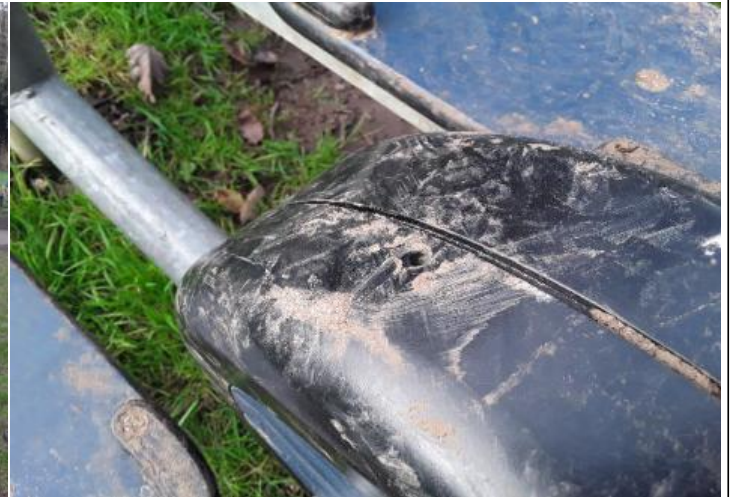
Finding: There is or are fixings missing on the item

Action: Replace all missing fixings

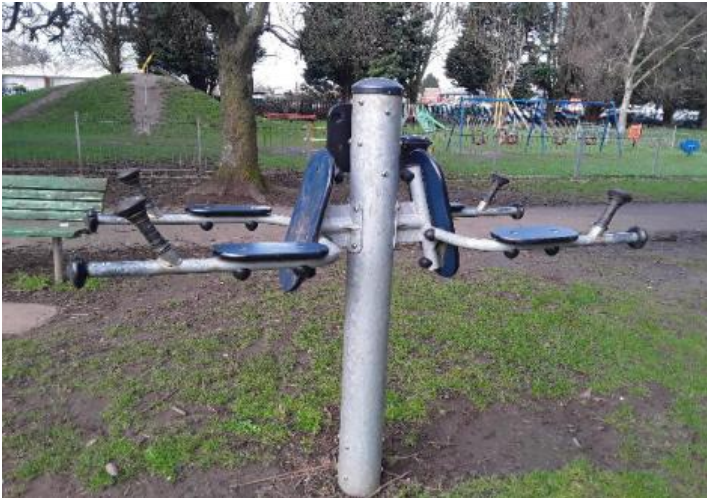
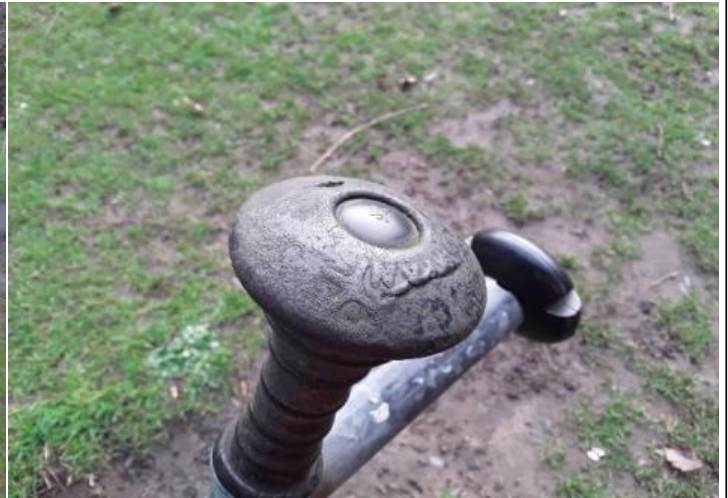
Finding: There is minor damage to the handgrips

Action: Monitor and replace if required

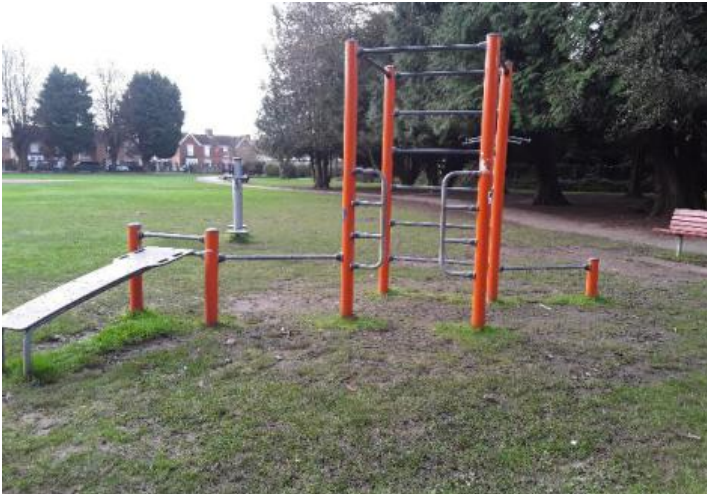
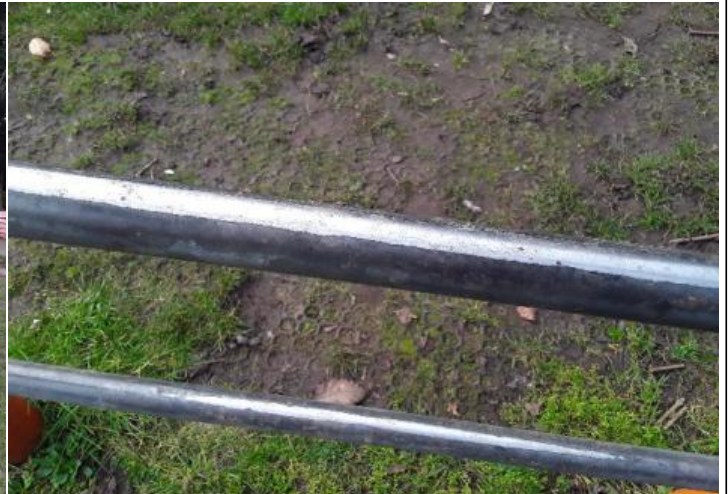
Finding: There is surface corrosion / rust present on the item

Action: Consider treating the item

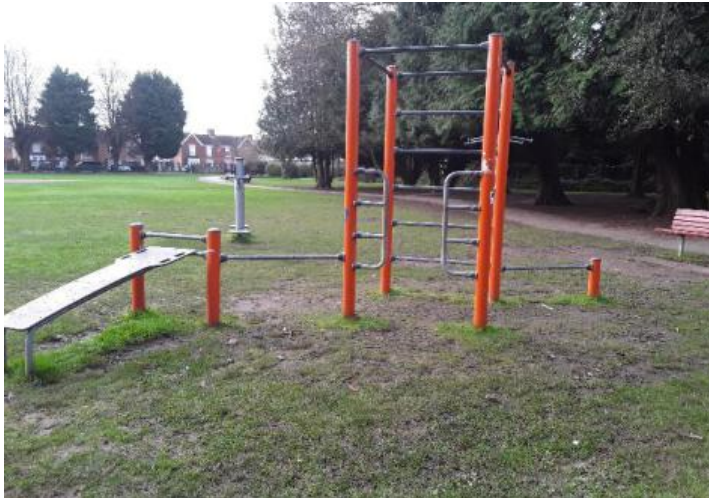
Finding: There is minor damage to the bench

Action: Monitor and repair if required

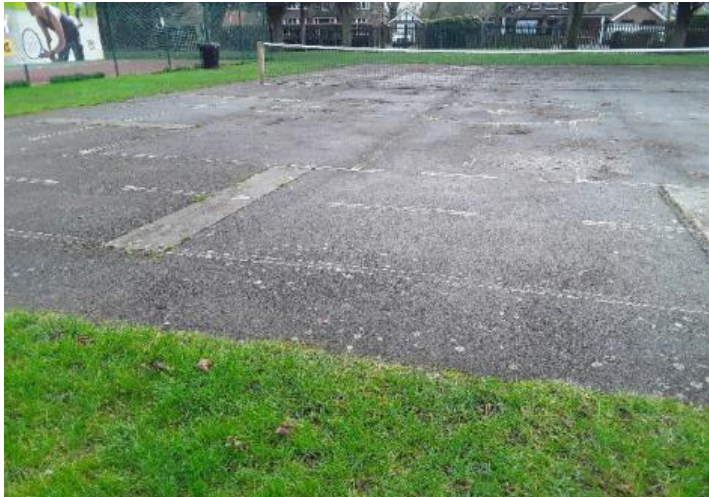
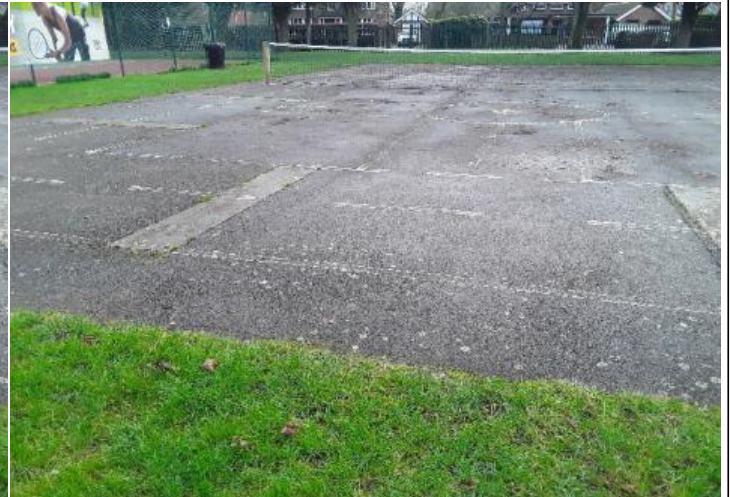
Finding: A tennis net has been placed over the track

Action: Monitor and remove the net if required

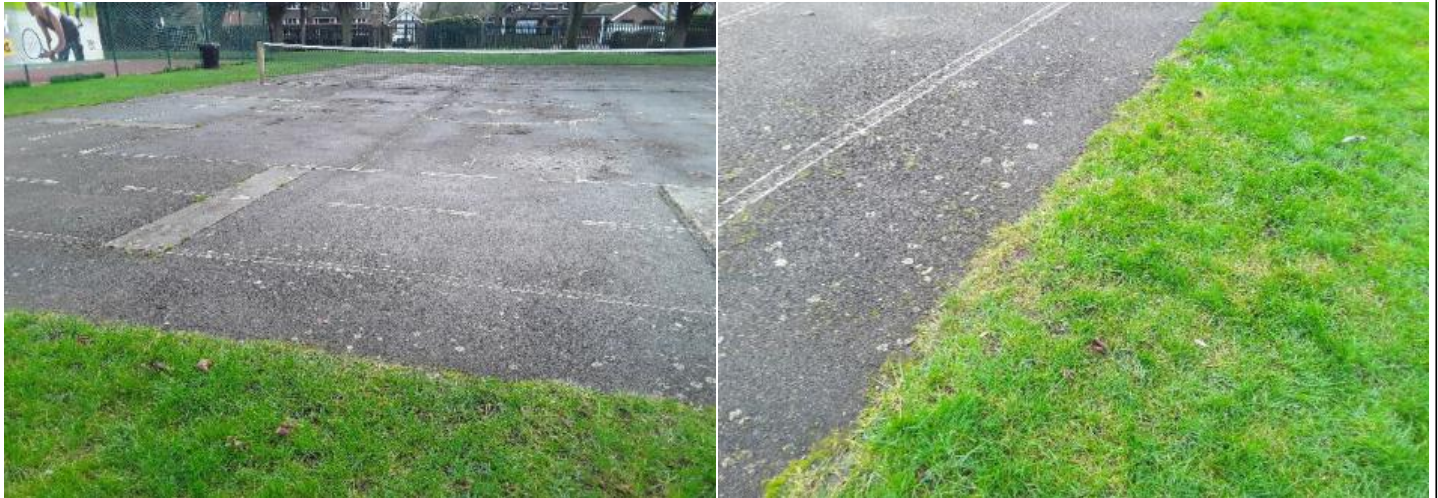
Finding: There is weed / vegetation growth on and around the surface
Action: Remove weed / vegetation growth

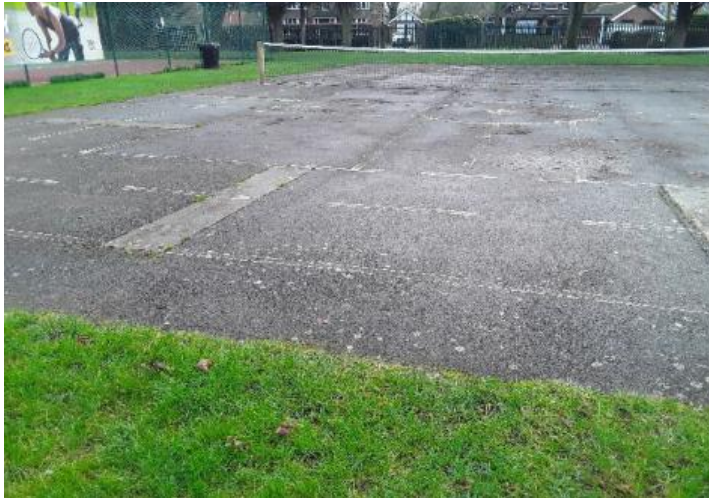
Finding: The surfacing is damaged

Action: Repair damaged areas of surfacing

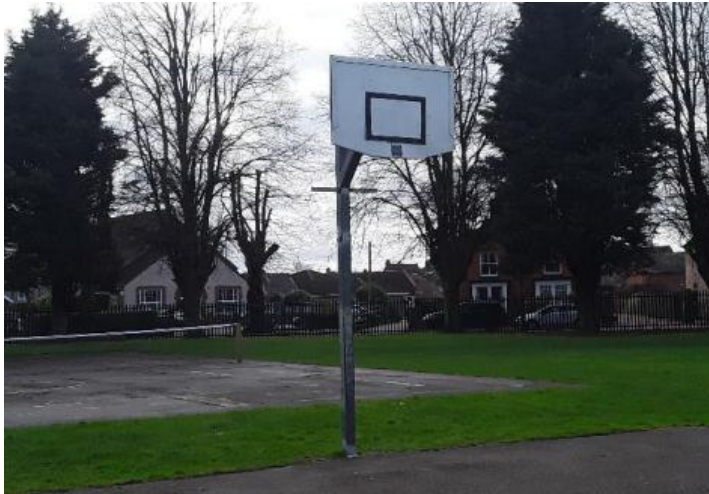
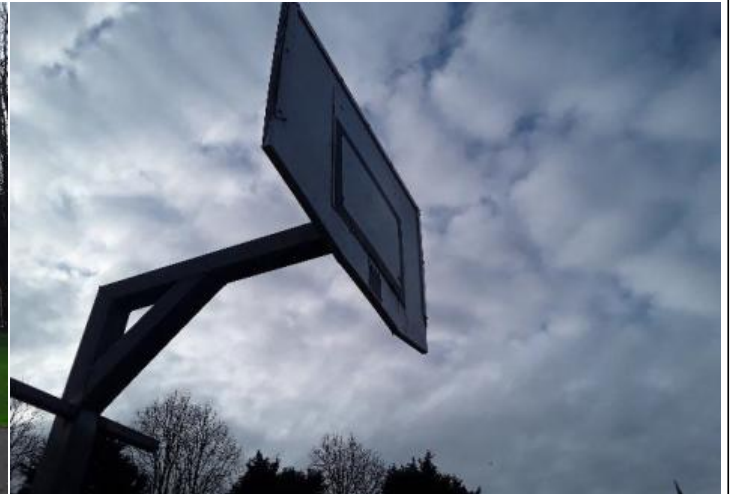
Finding: The hoop has been removed

Action: Consider replacing the missing hoop

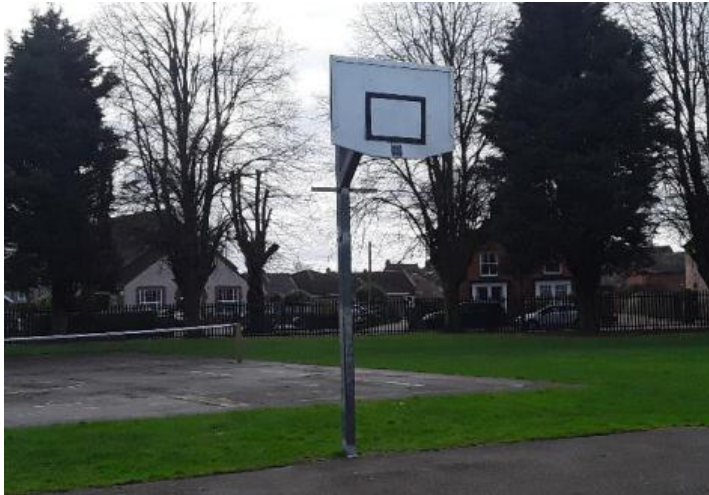
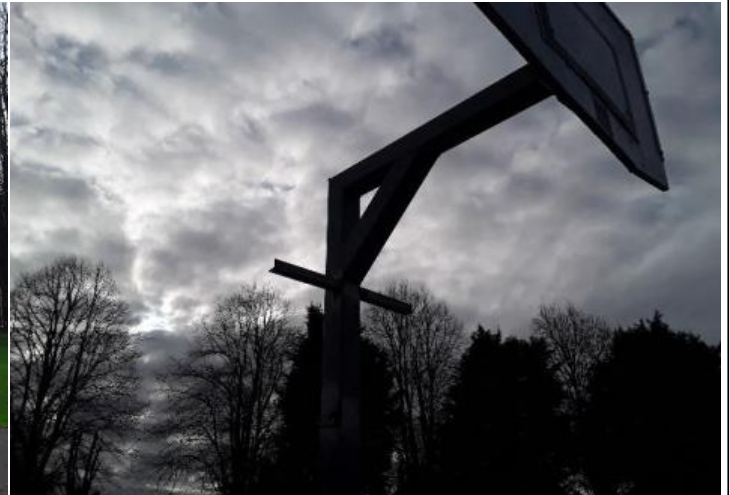
Finding: The backboard braces are missing

Action: Replace the braces

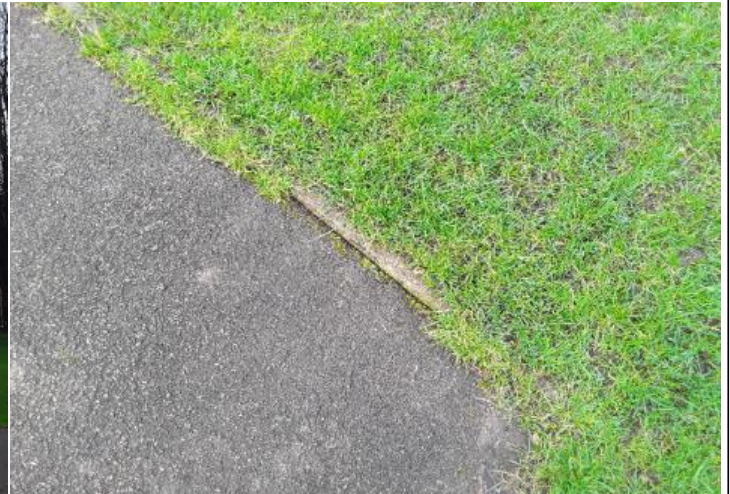
Finding: There are gaps opening between the surfacing and the edging surround or between the joints in the surfacing
Action: Monitor for any further deterioration and repair as required

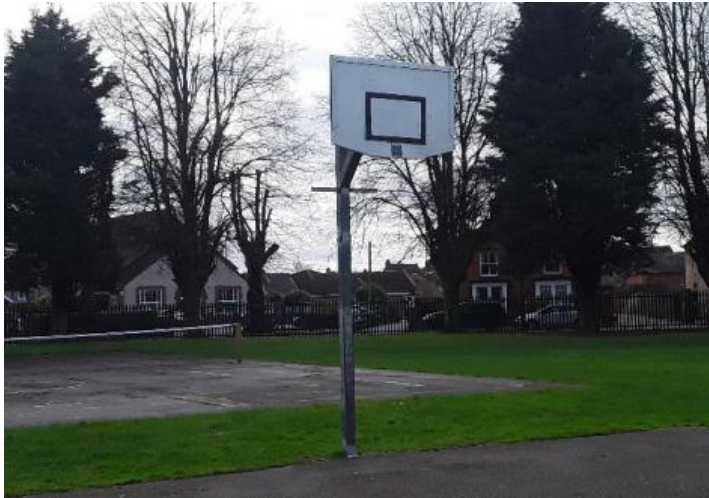
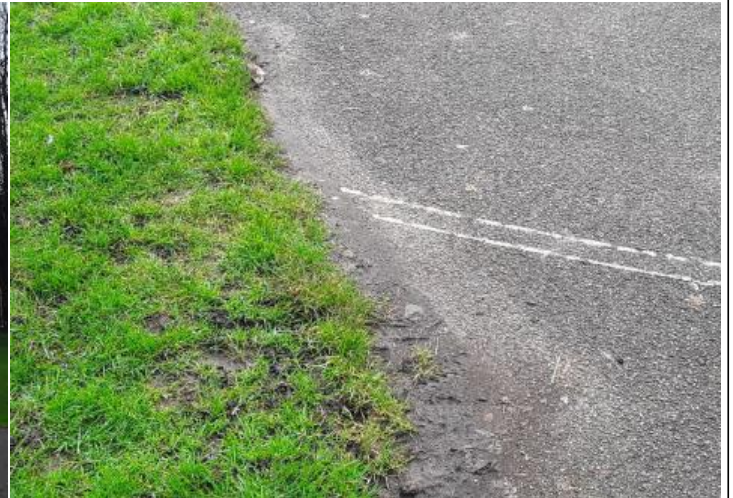
Finding: There is weed / vegetation growth on and around the surface

Action: Remove weed / vegetation growth
