CONDITION REPORT 2024

of
HOLBEACH CEMETERY CHAPELS

Date of inspection: 19th June 2024

**CONDITION REPORT: UPDATED 2024
HOLBEACH CEMETERY CHAPELS**

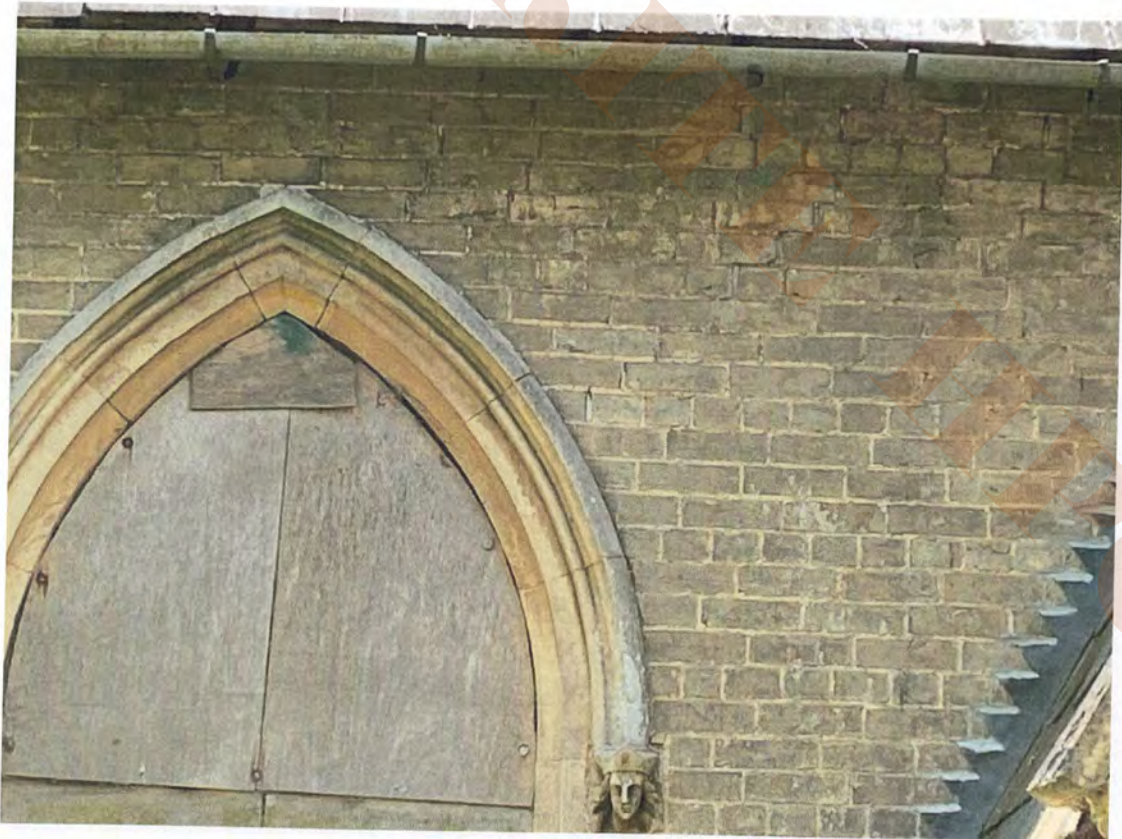
8.18 North chapel north elevation east of porch

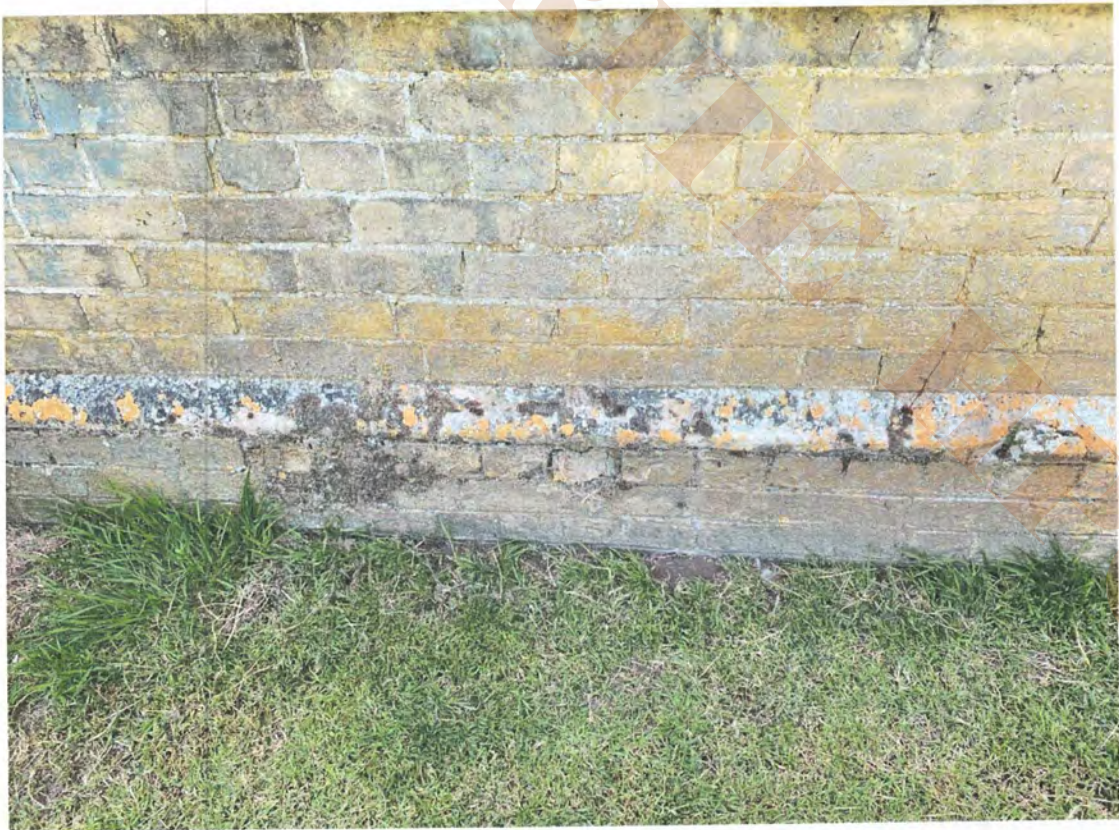
8.20 North chapel east elevation

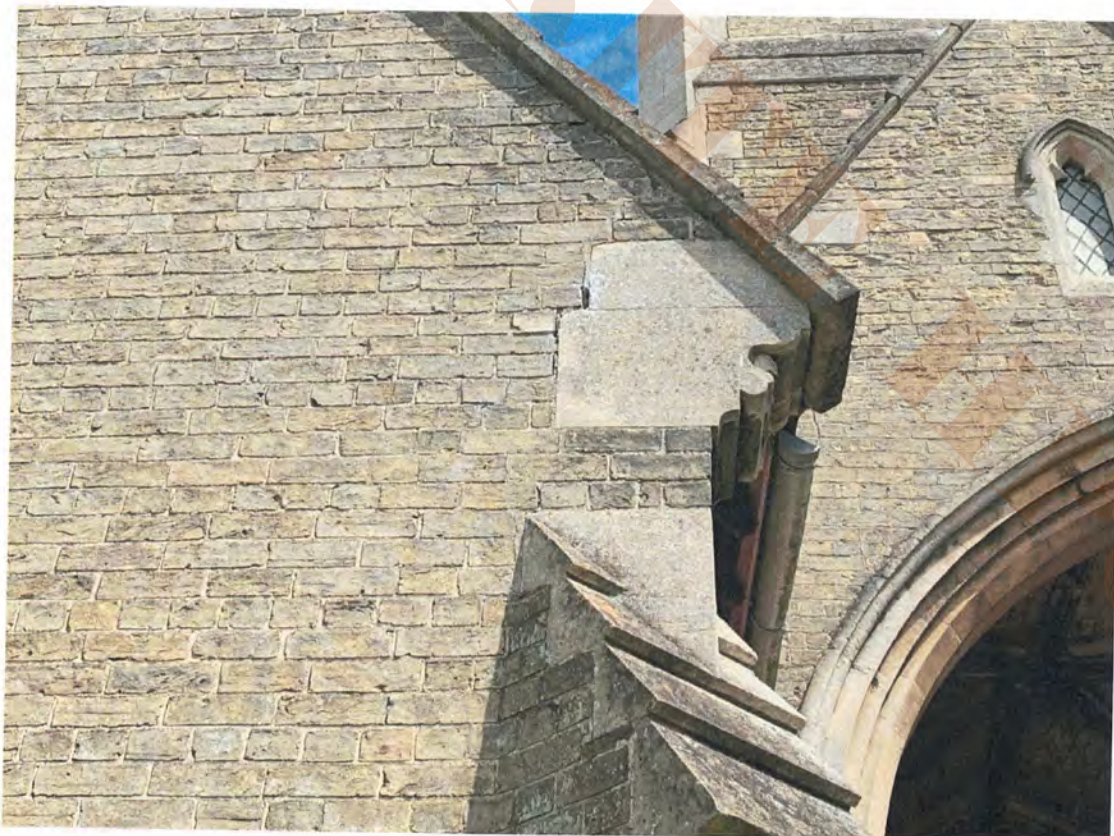
8.28 North chapel south west kneeler

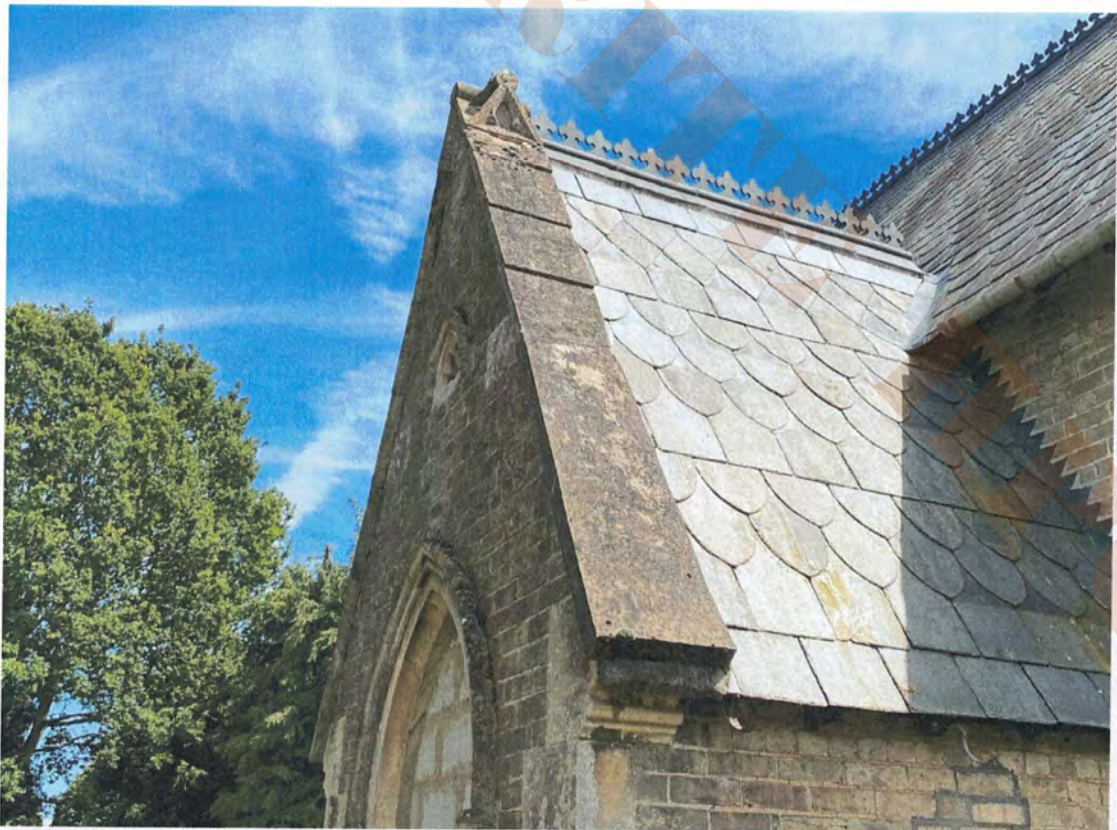
8.32 North porch west coping

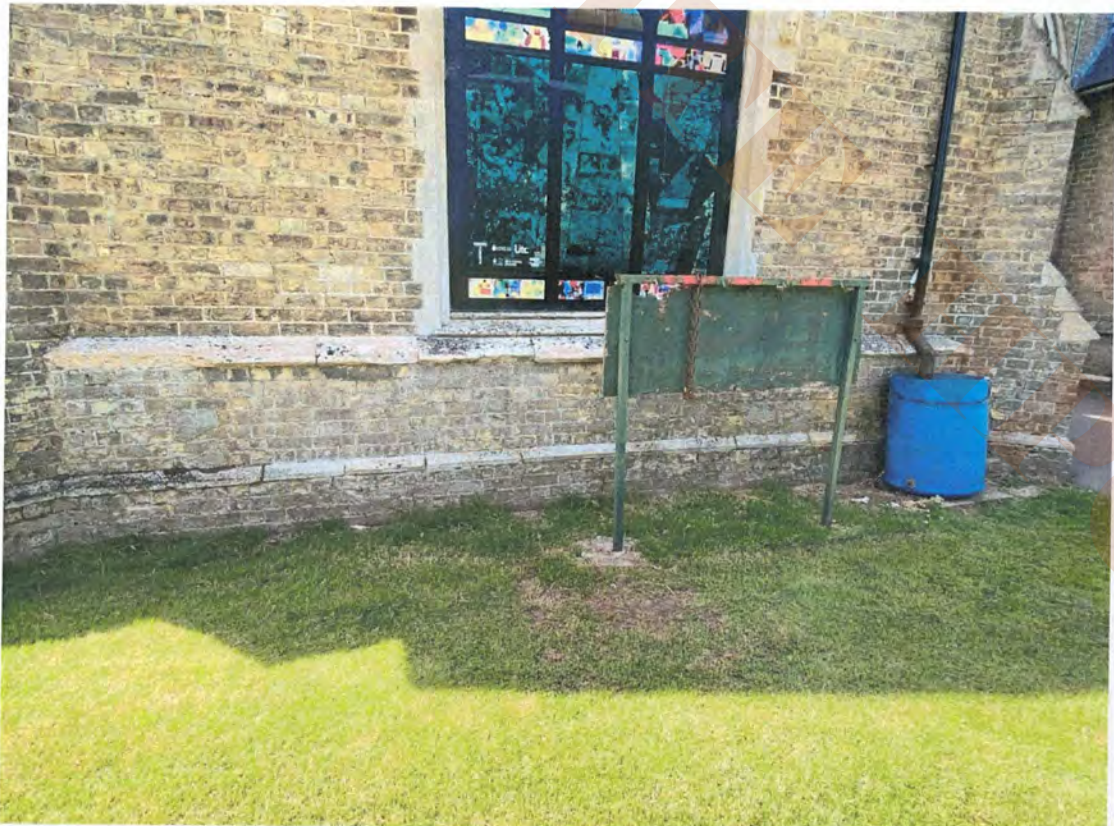
8.43, 8.44 South chapel east elevation

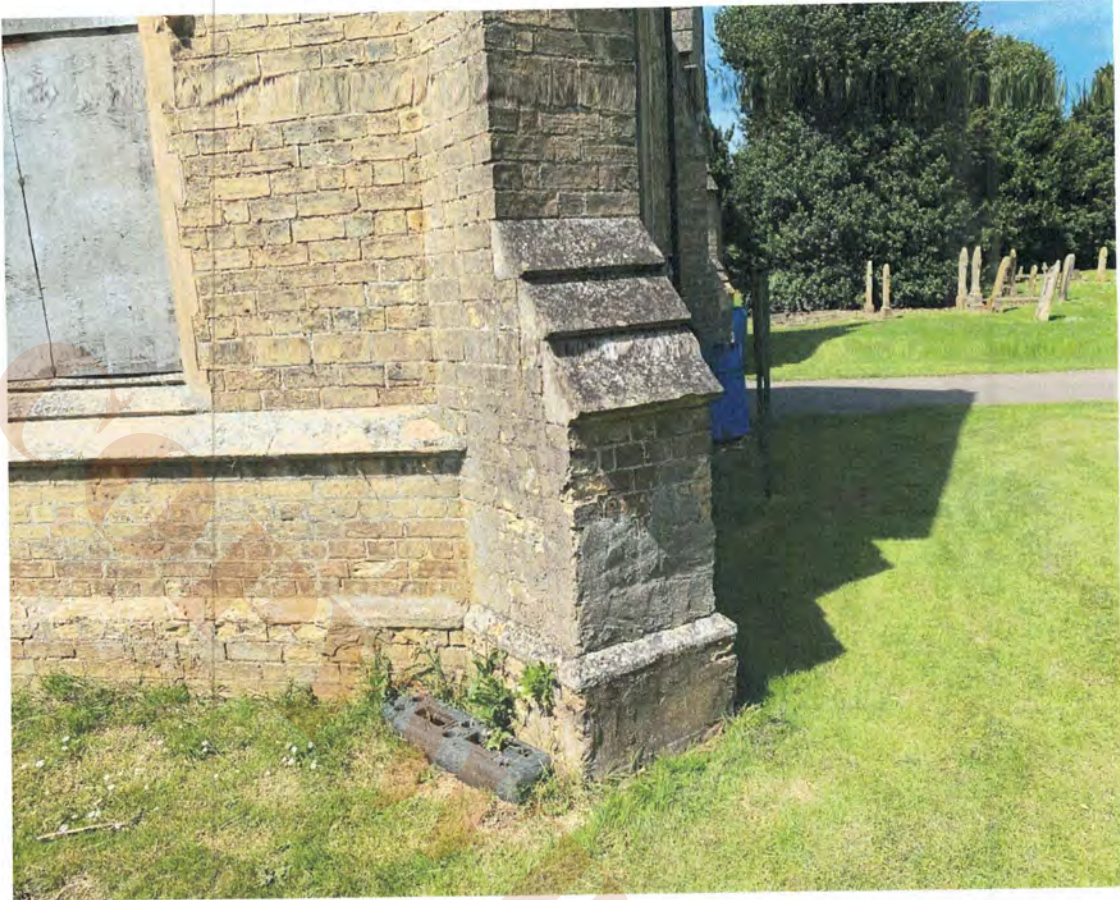
8.45 South chapel south east elevation

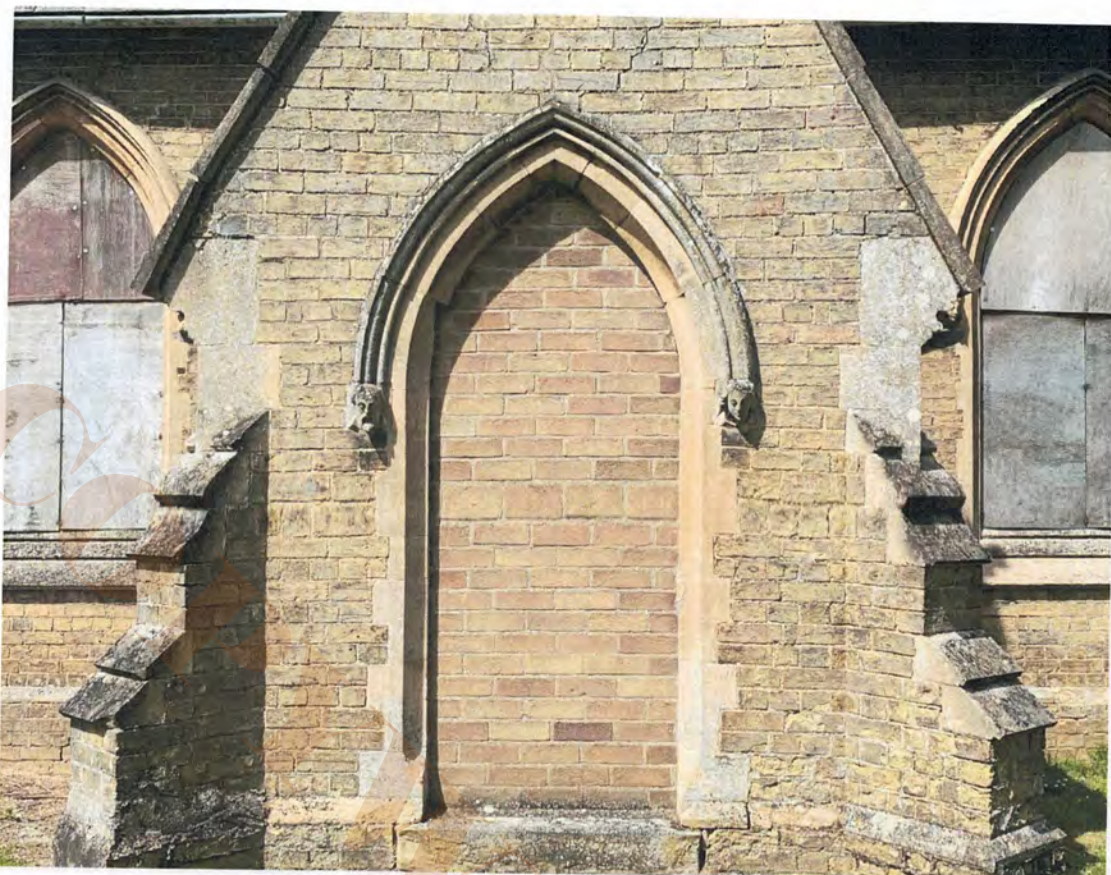
9.38 South chapel window high level opening

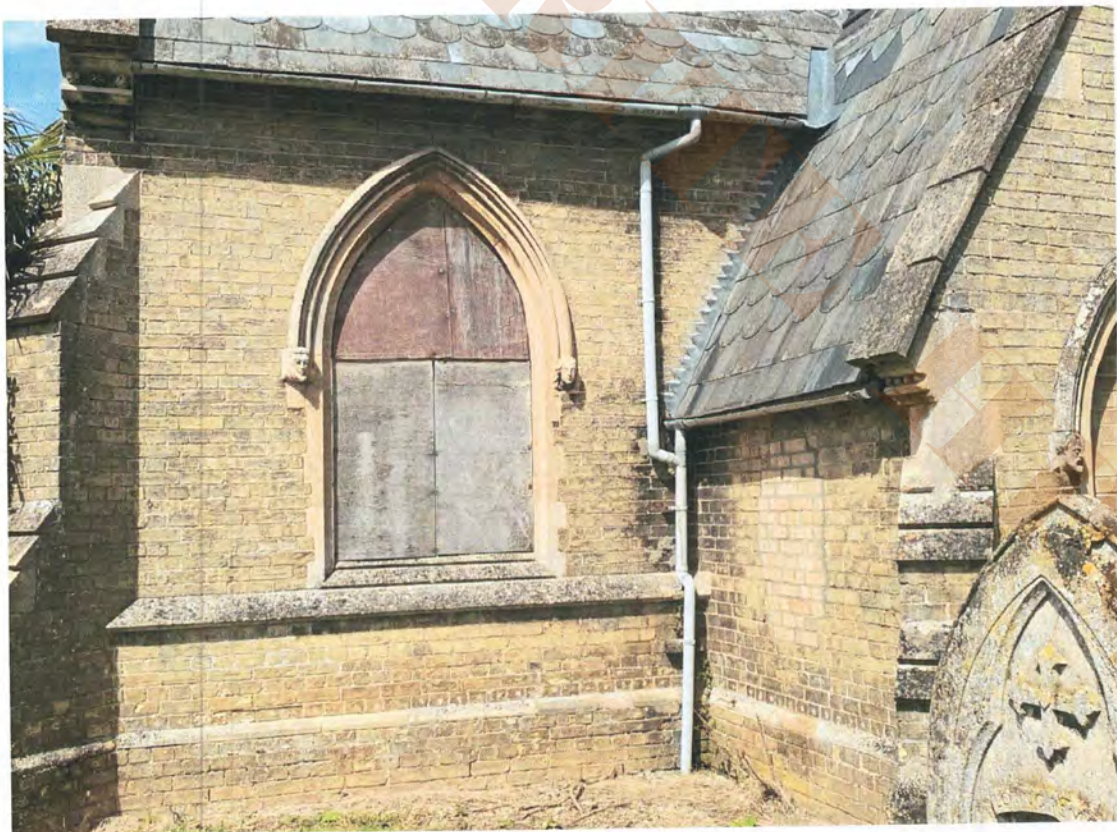
10.10 south chapel south rainwater goods east of porch

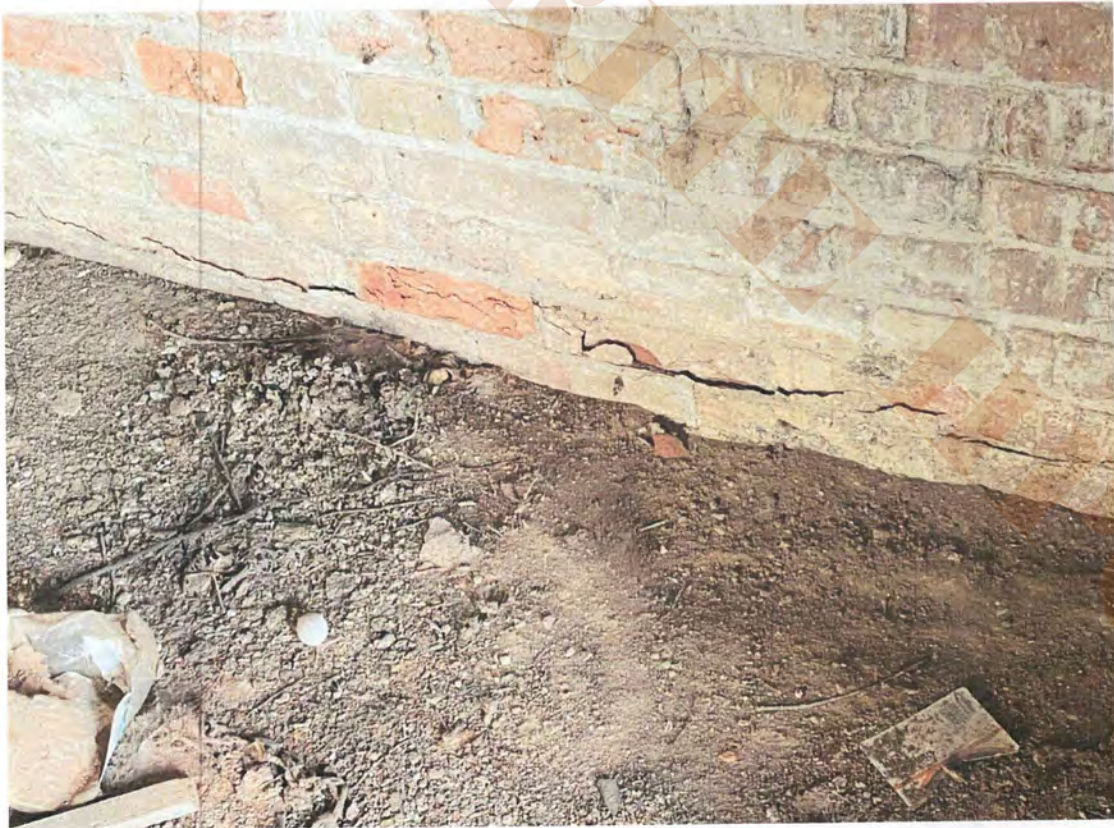
11.2 Tower interior mesh

- 11.2 **Tower octagonal section interior:** renew chicken wire in stainless steel mesh
- 11.6 **Carriage porch interior:** check south rib, allow to dowel fix cracked sections

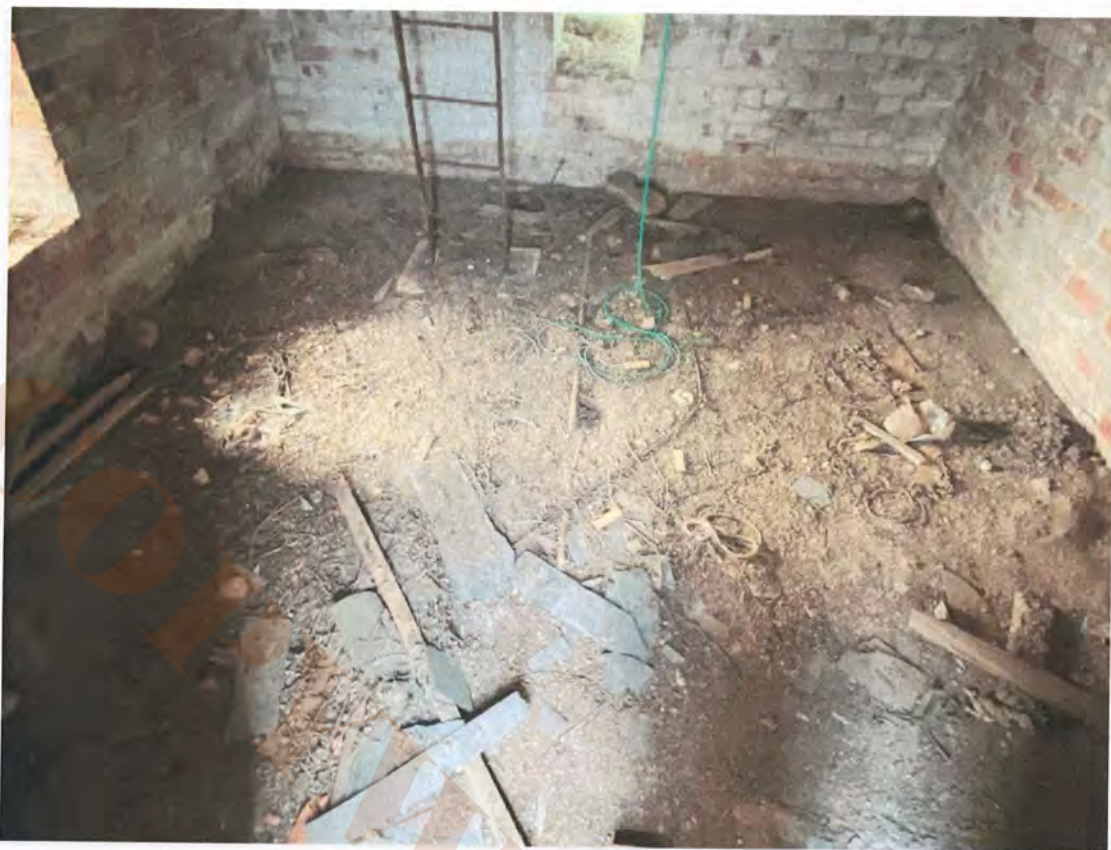
11.3 Tower lower chamber interior

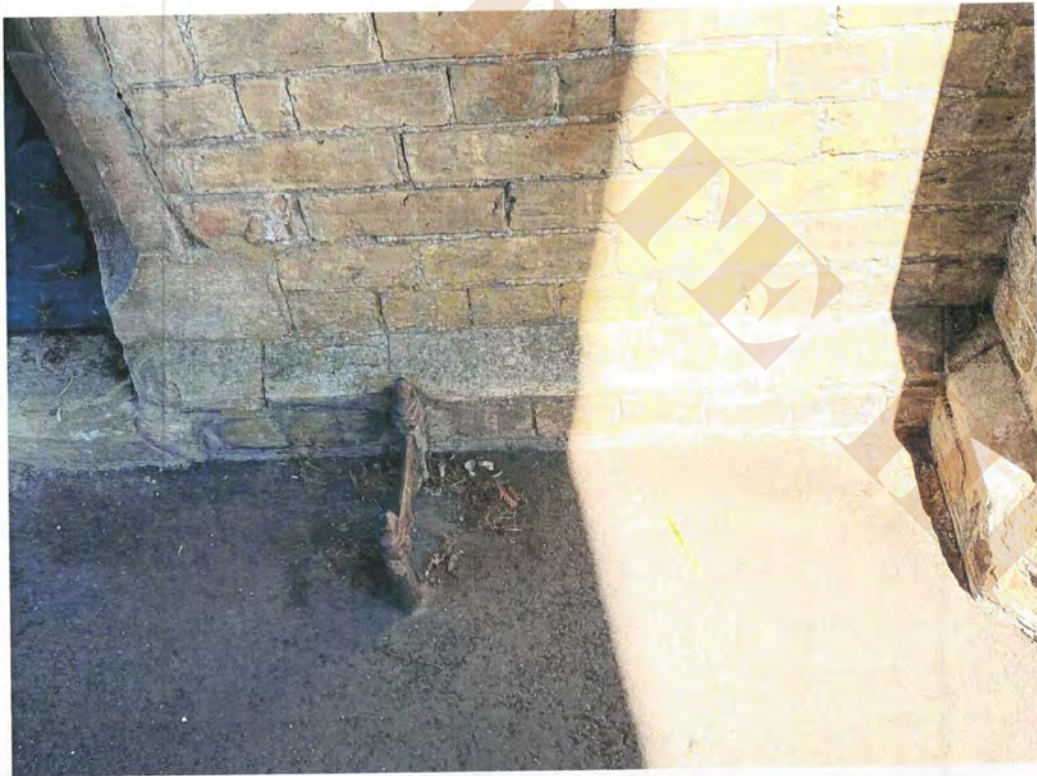
11.5, 11.6, 11.7 Carriageway vault

- 11.7 **Carriage porch interior:** stone renewals may be needed
- 11.8 **Ground floor of the carriageway:** boot scrapers could be repainted
- 11.9 **North internal wall:** point cracking above the door head and adjacent to the stonework of the door

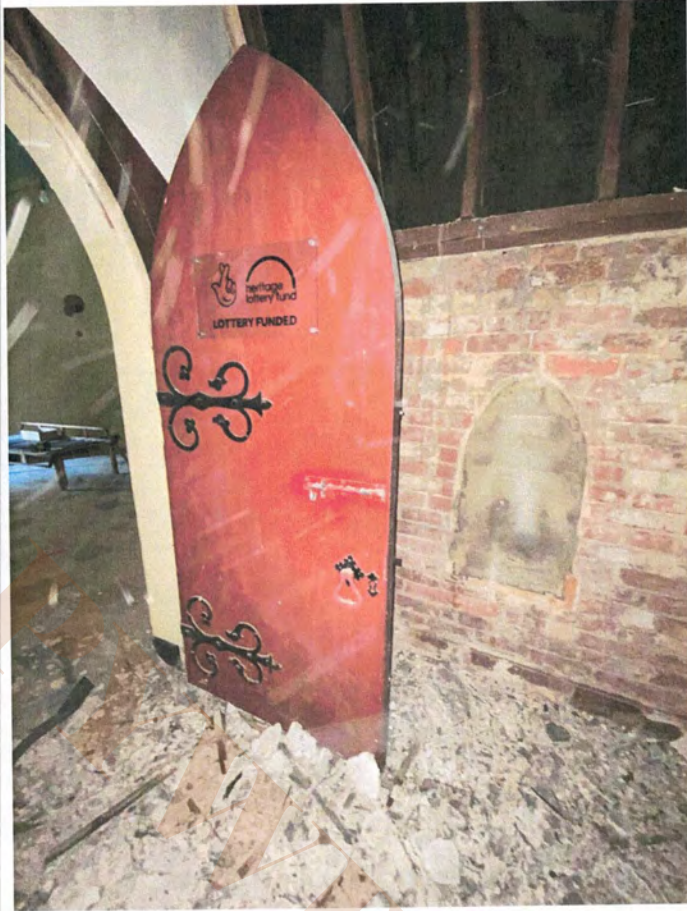
11.18 South porch floor

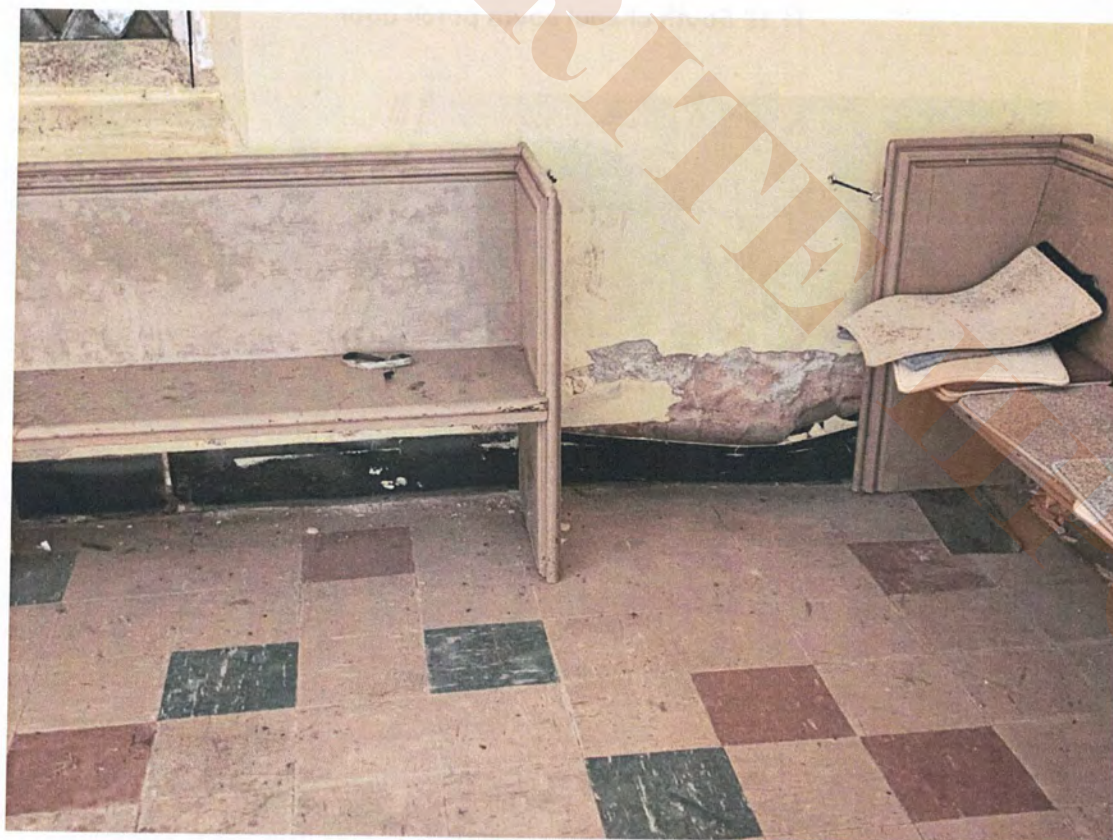
11.21 South chapel north wall

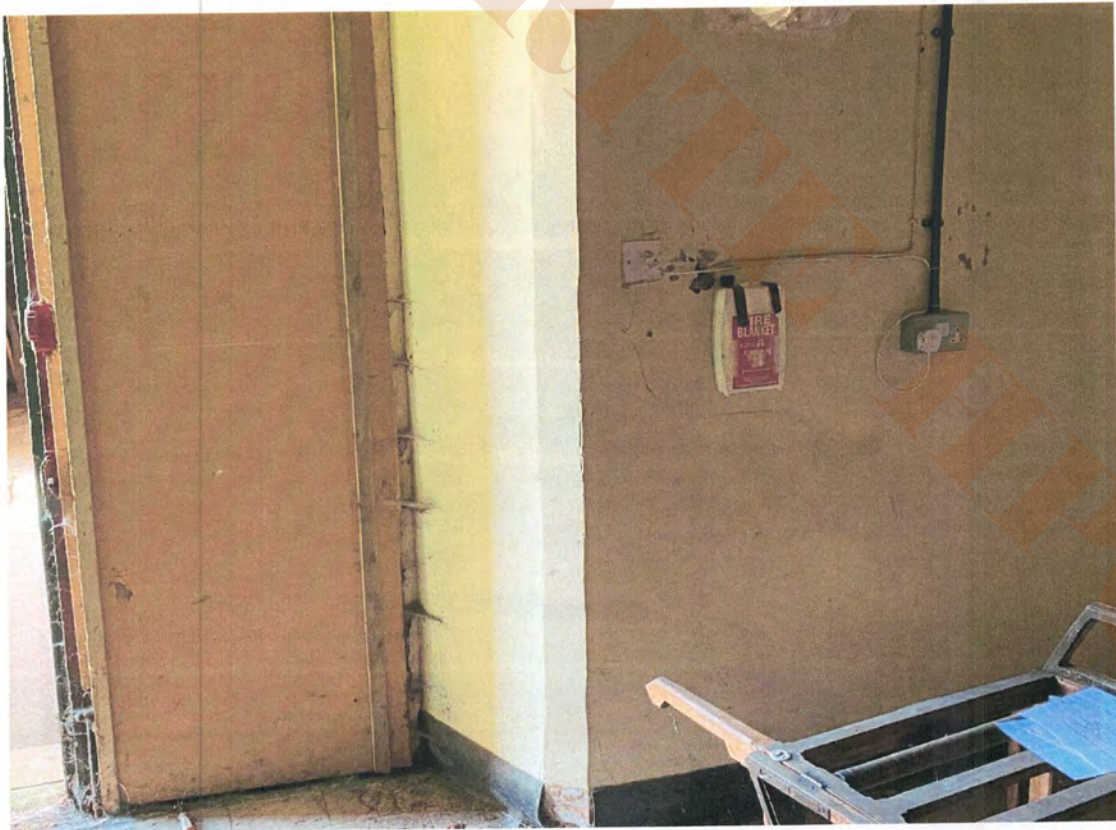
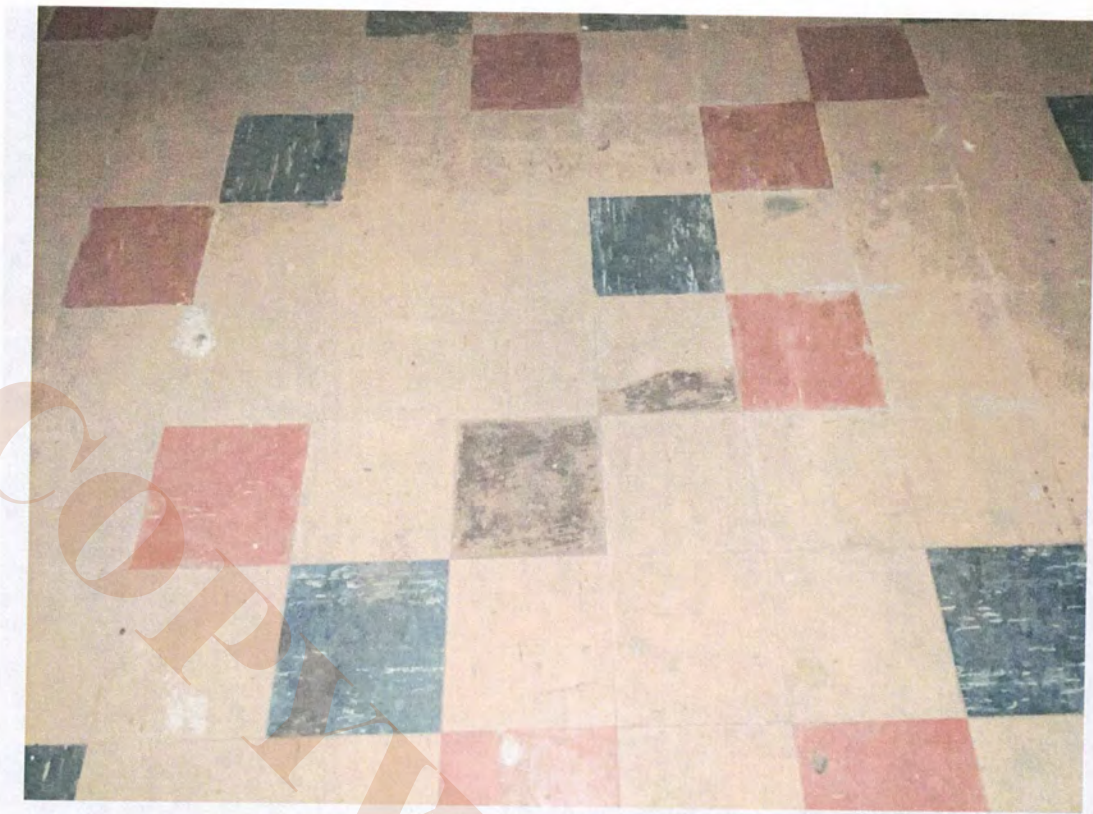
11.26 South chapel north door west reveal

11.26 South chapel north door east reveal

- 11.26 **South chapel interior:** probable iron straps buried in wall, drill out and renew in stainless steel
- 11.27 **South chapel interior:** full asbestos survey of building

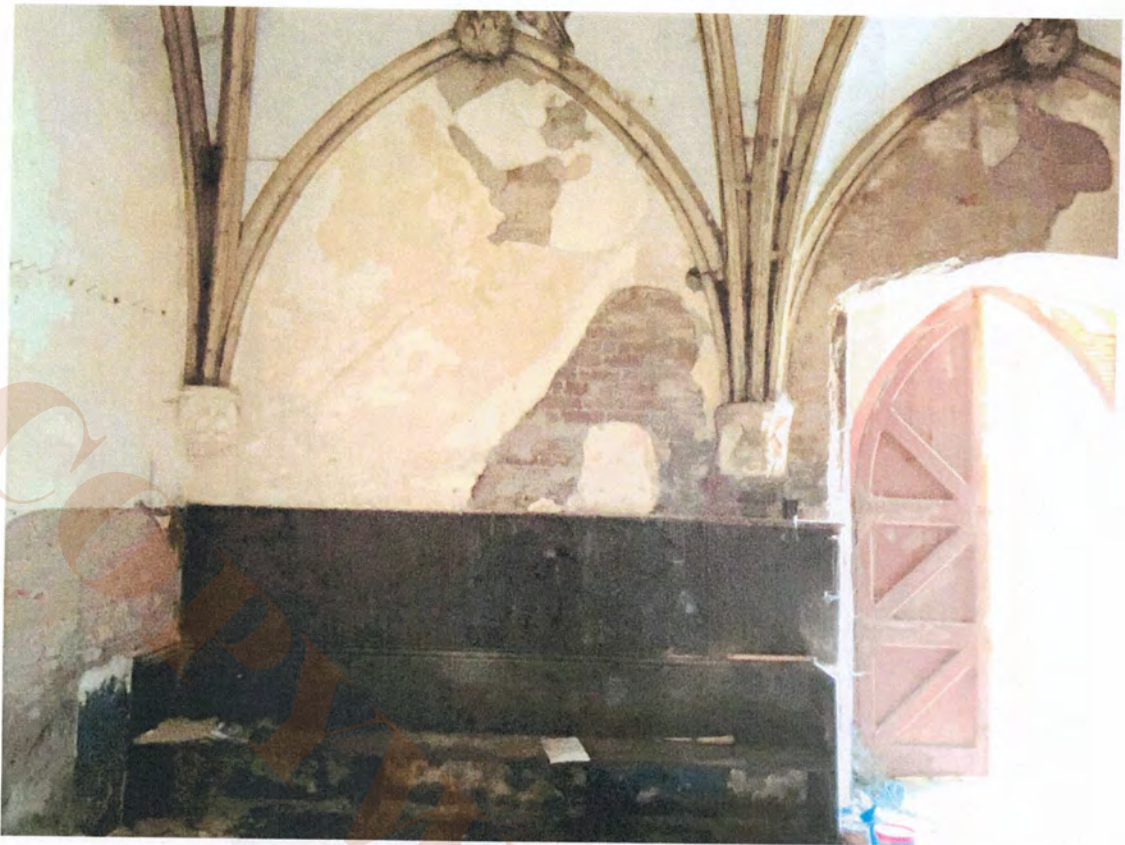
11.32 North porch interior door

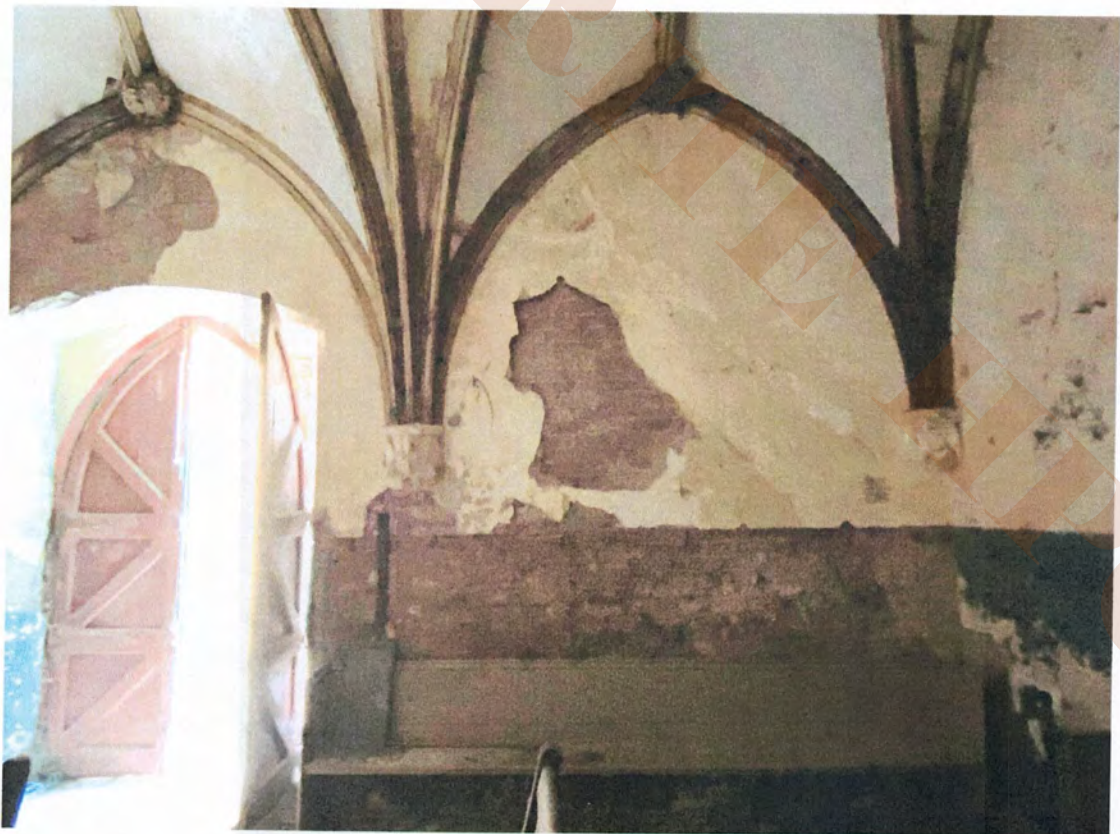
11.35 North chapel south interior

- 11.34 **North chapel interior:** renew defective plaster to the vault
- 11.35 **North chapel interior:** strip and renew plasterwork to south wall
- 11:36 **North chapel interior:** north and west wall plaster repairs. Redecorate generally

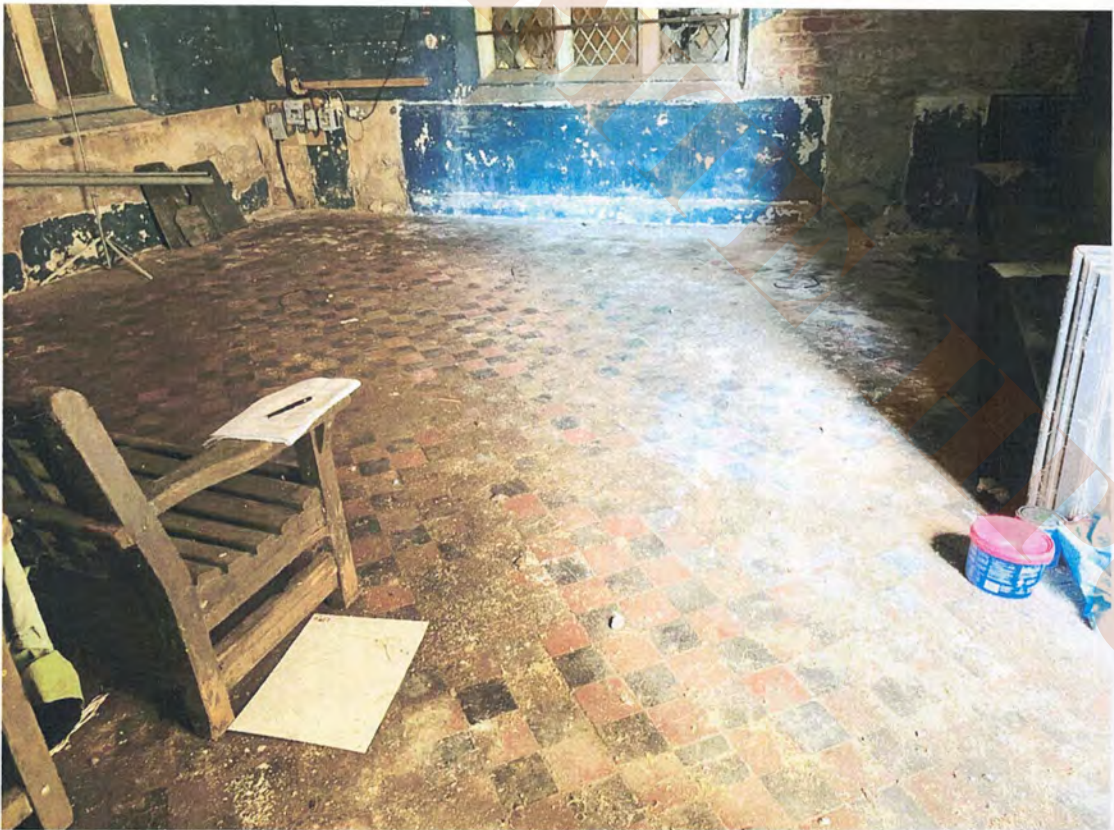
11.37 North chapel south wall ironwork

- 11.37 **North chapel interior:** replace iron tie bars with stainless steel
- 11.38 **North chapel interior:** wedge/point cracks
- 11.39 **North chapel interior:** replace broken/missing tiles

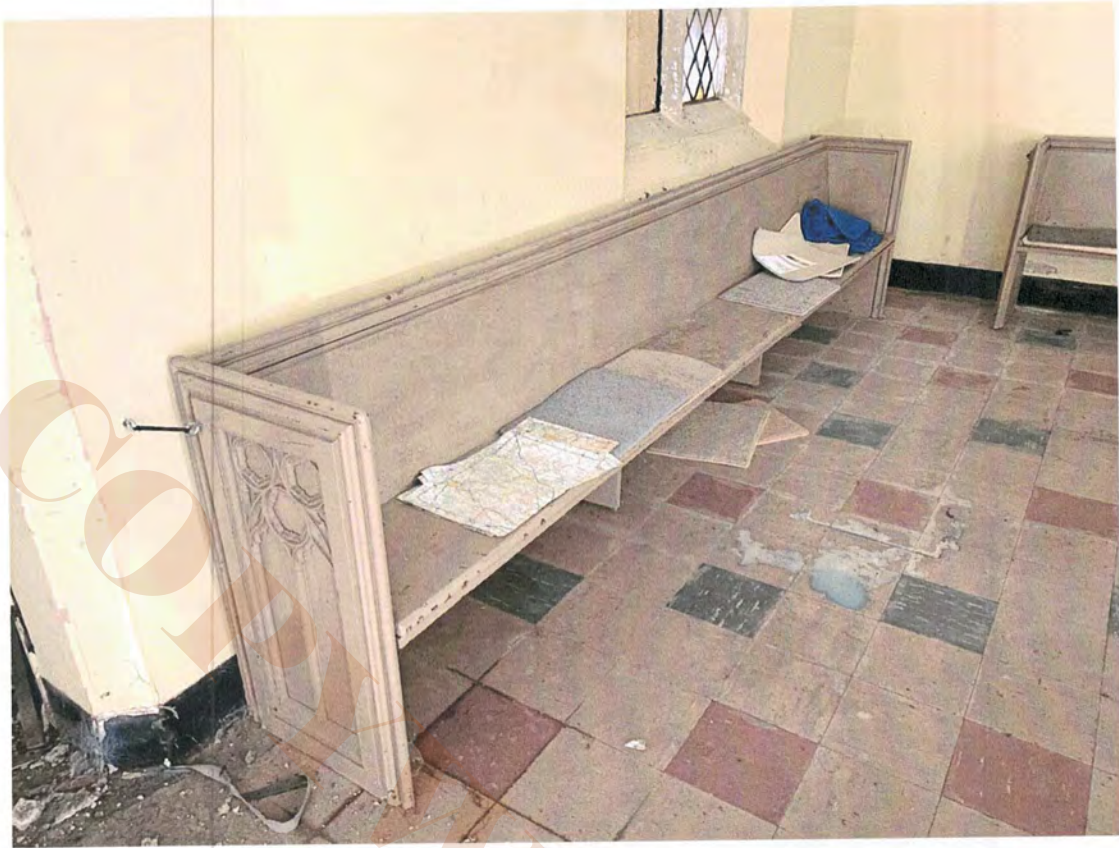
11.39, 11.40 North chapel floor

- 11.40 **North chapel interior:** renew floor screed, renew tiling
- 12.2 **South chapel fittings:** repair benches to make them serviceable
- 12.3 **North chapel fittings:** repair benches

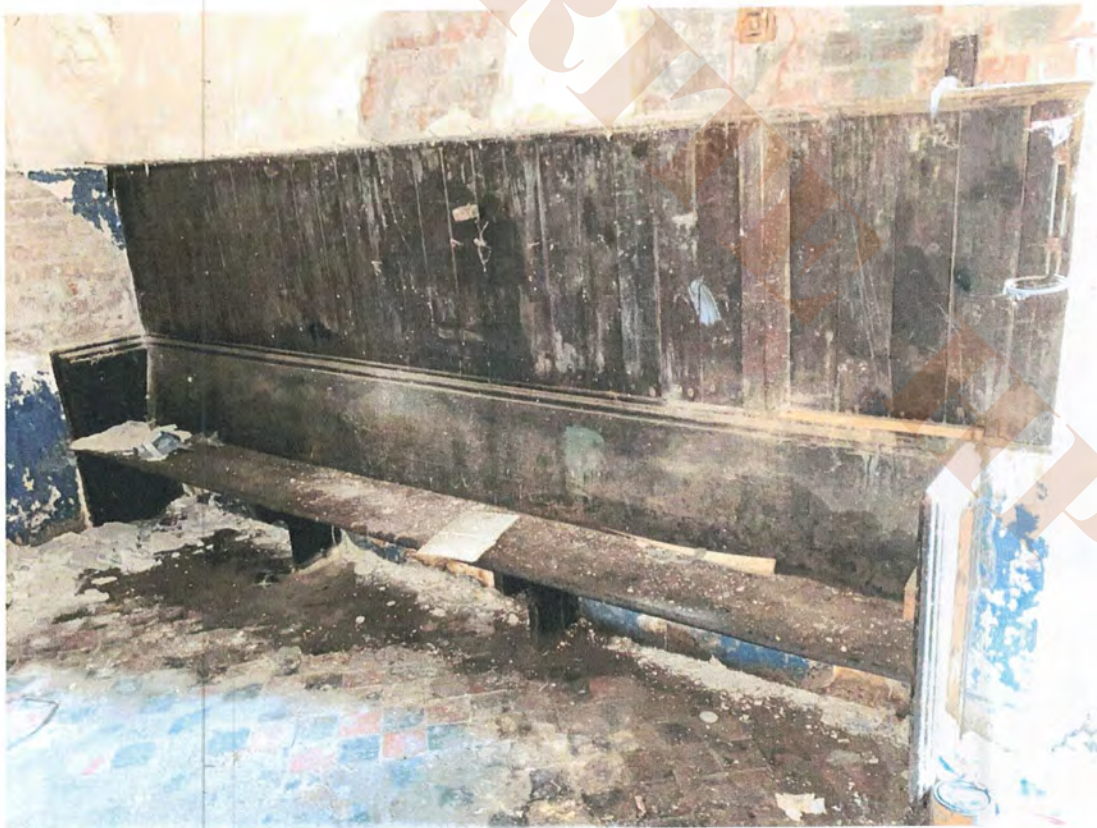
12.2 South chapel bench

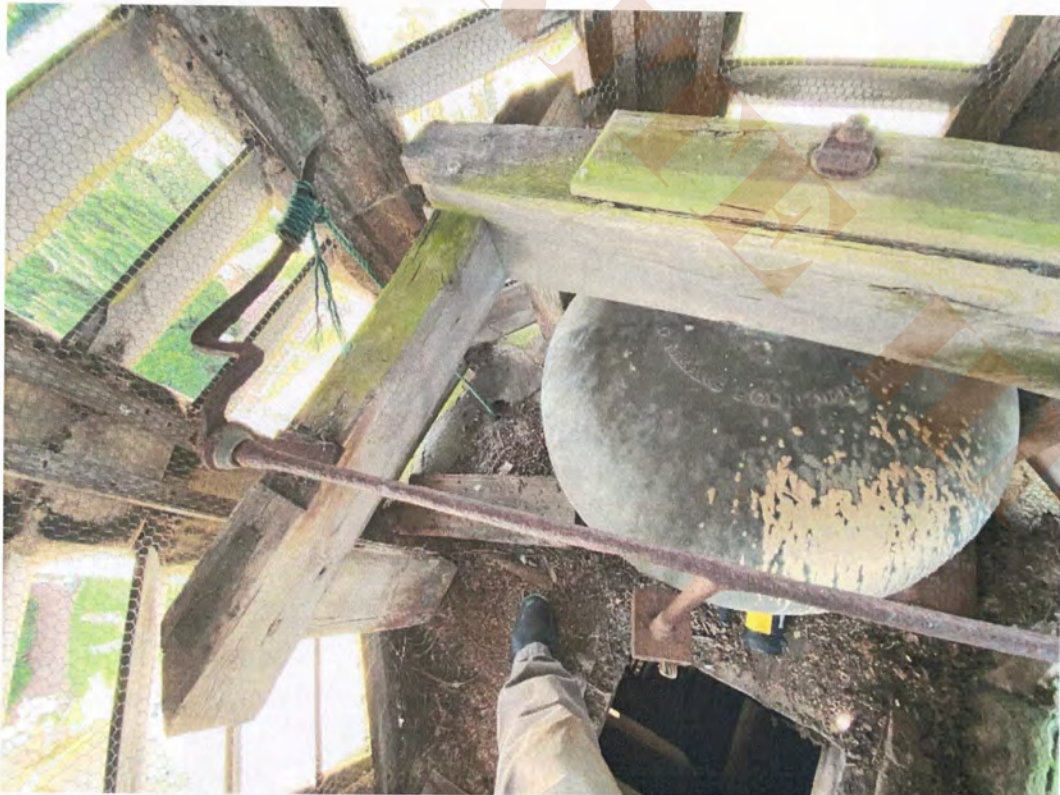
12.4 Tower lower chamber ladder

- 12.4 **Tower lower chamber:** provide a modern ladder fixed in position while access is available for north chapel re-roofing
- 12.5 **Belfry:** repair the chiming mechanism of the bell, refix the bell with stainless steel fixings
